Typology, current state and non-destructive testing of timber roof trusses of historic churches in the West Vistula Delta, Poland

Tomasz Zybała^{1*}, Monika Zielińska¹, Magdalena Rucka^{2,3}, Jarosław Przewłócki¹ and Karol Grębowski¹

Abstract

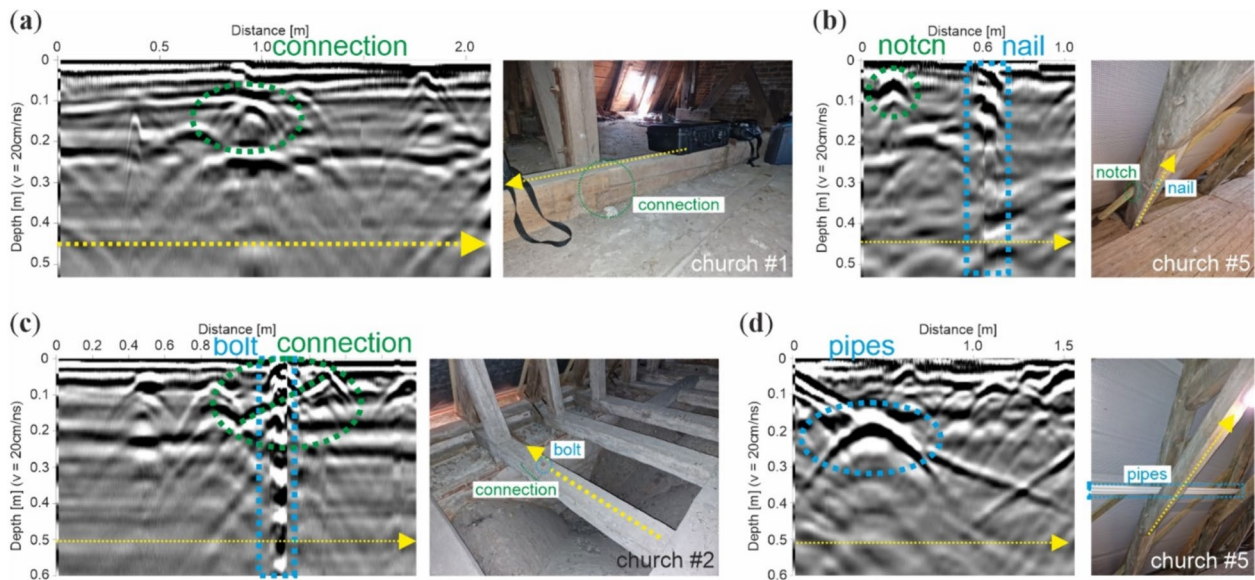
Fig. 9 GPR radagrams locating carpentry joints for electric cables in timber beams: **a**) Milobadz (#1); **b**) Koźliny (#5); **c**) Pruszcz Gdański I (#2); **d**) Koźliny (#5)

The joints of timber beams for roof trusses are usually carpentry joints (Fig. 9). Such connections are visible on the radargrams as the location of additional wave

reflections (Fig. 9a, c). A more pronounced effect can be seen where the beam was cut for wind girders. Examples of such reflections are shown in Fig. 9b. In the case of electrical cables, they are detected similar to screws and nails in the form of a single hyperbolas (Fig. 9d). In the case of wooden elements, the electrical cables are usually routed visibly on the beam, without cutting the wood.
