# Diagnosics and protection methods a residential building in connection with the reconstruction of a road located in its immediate neighborhood - case study

<sup>1</sup> *Department of Engineering Structures, Faculty of Civil and Environmental Engineering,  
Gdansk University of Technology, Gdansk, Poland*

The aim of the paper is to present the results of the analysis of the technical condition of a residential building located in the immediate vicinity of the road that was to be expanded.

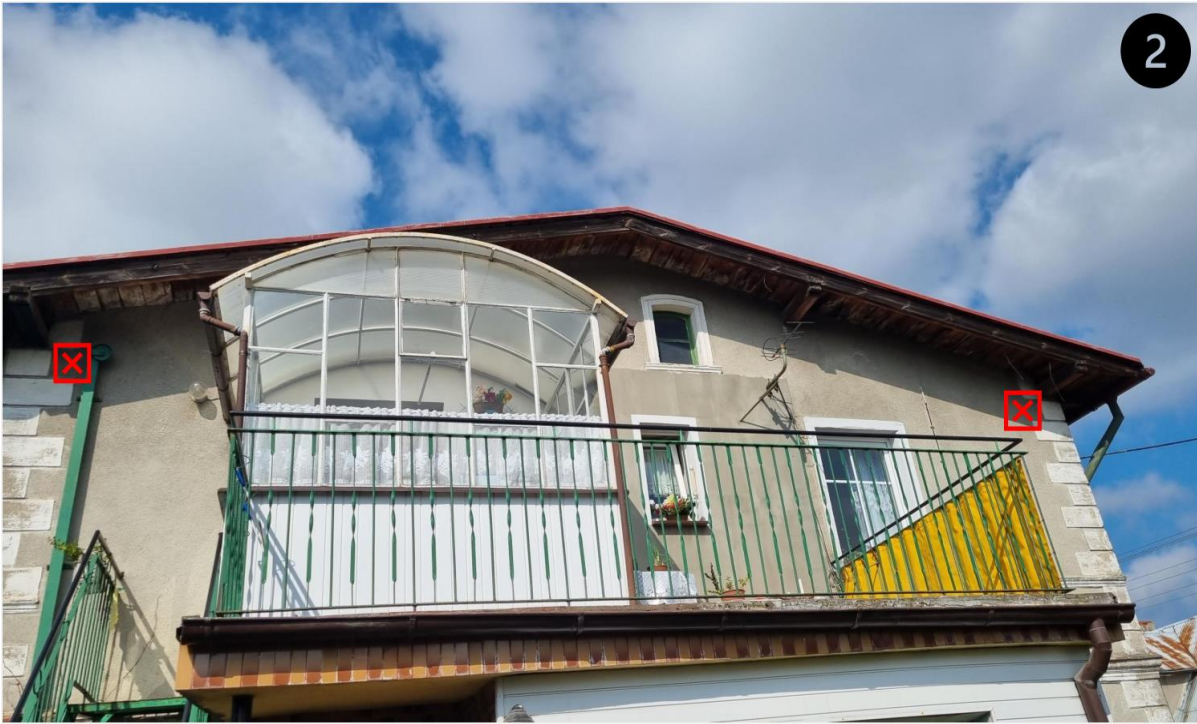
**SIDE ELEVATION (EASTERN)**

**Fig. 6:** Proposed location of target plates, benchmarks and feeler gauges on the external walls of a residential building: 1) front elevation (north), 2) side elevation (east), 3) garden elevation (south), 4) side elevation (west)

- start conducting geodetic monitoring of the building. The proposed location of target plates, benchmarks and feeler gauges is shown in Fig. 6,
- during installation of target plates and feeler gauges, care should be taken not to attach them to the plaster but directly to the wall,
