# **Diagnostics and protection methods a residential building in connection with the reconstruction of a road located in its immediate neighborhood - case study**

Maciej NIEDOSTATKIEWICZ <sup>1\*</sup>

<sup>1</sup> *Department of Engineering Structures, Faculty of Civil and Environmental Engineering,  
Gdansk University of Technology, Gdansk, Poland*

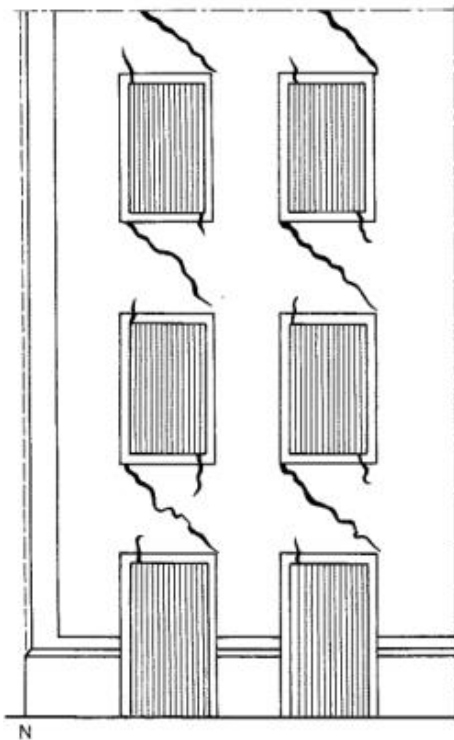
Rys. 3-11. Rysy spowodowane obniżeniem się narożnika budynku w punkcie N

**Fig. 5:** The mechanism of damage to external walls caused by uneven settlement according to: a) Mitzel A., Stachurski W., Suwalski J.: Failures of concrete and masonry structures, *Arkady Publishing House*, Warsaw 1973, b) Masłowski E., Spiżewska D.: Strengthening of building structures, *Arkady Publishing House*, Warsaw 2000
