Types of Surface Impurities versus the Quality of Brazed Joints

Abstract: Brazing is one of the primary joining processes increasingly often applied in industry. Because of their mechanical properties, overlap joints are particularly popular when making brazed structures. The use of brazed joints in structures of critical importance requires that particular attention be paid to joint quality, e.g. by the appropriate cleaning of surfaces to be joined. The article presents results of non-destructive tests of brazed joints made in steel S235JRG2. Surfaces used in the tests were deliberately contaminated to simulate the presence of welding imperfections. Afterwards, the test specimens were subjected to non-destructive (visual and radiographic) tests aimed to determine the effect of surface impurities on the quality of brazed joints.

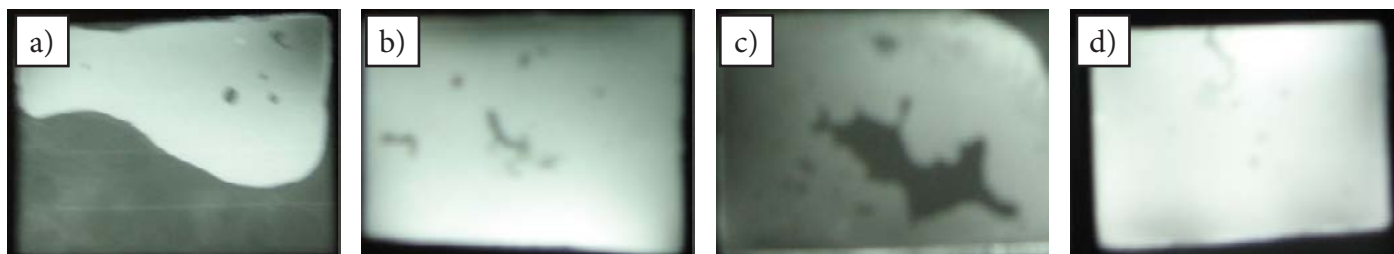
Fig. 3. Radiographic test results; a) specimen 1 – lack of the flux, a complete joint covering approximately 50% of the surface subjected to brazing, inclusions, oval gas cavities, b) specimen 3 – improperly cleaned surface, a longitudinal gas cavity having a length of 5 mm in its central part and oval gas cavities, c) specimen 8 – immersed in water, a gas cavity having a length of 20 mm and a width of up to 7 mm, oval gas cavities, d) specimen 10 – made properly, a longitudinal gas cavity having a length of 3 mm, small inclusions

Pb foil (0.05 mm) made by Kodak. The tests were performed using the following parameters: FFD = 700 mm, U = 130 kV, I = 4,5 mA and an exposure time of 3 minutes. The radiographic tests revealed that the most numerous imperfections were present in the specimens, the surfaces of which were intentionally contaminated with pieces of copper foil. The above-named inclusions precluded the formation of a complete joint and led to the formation of smaller inclusions located nearby. A similar result was observed in relation to specimen no. 9 provided with the flux used in the SAW method. The above-presented results confirmed the

results of the previous tests concerning the effect of impurities during joining processes [15]. Figure 3 presents examples of radiographic test results. Table 3 presents the test results in relation to all of the specimens.
