# Types of Surface Impurities versus the Quality of Brazed Joints

**Abstract:** Brazing is one of the primary joining processes increasingly often applied in industry. Because of their mechanical properties, overlap joints are particularly popular when making brazed structures. The use of brazed joints in structures of critical importance requires that particular attention be paid to joint quality, e.g. by the appropriate cleaning of surfaces to be joined. The article presents results of non-destructive tests of brazed joints made in steel S235JRG2. Surfaces used in the tests were deliberately contaminated to simulate the presence of welding imperfections. Afterwards, the test specimens were subjected to non-destructive (visual and radiographic) tests aimed to determine the effect of surface impurities on the quality of brazed joints.

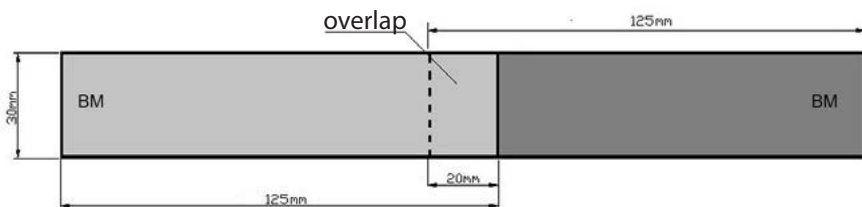
Fig. 1. Schematic overlay brazed joints, BM – base material

The tests aimed to determine the effect of surface contamination types on the quality of gas (oxy-acetylene) overlay brazed joints. The tests involved the use of 1.5 mm thick sheets (125 × 30 mm) made of steel S235JRG2. The sheets were used to make 10 joints presented schematically in Figure 1. Table 1 presents the chemical composition of the base material.

The brazing process was performed using silver brazing metal grade Ag203 (B Ag-44CuZn-675/735) according to PN-EN ISO 17672:2016 (having the form of a wire) and flux 1802 N Atmosin (Castolin), used to dissolve oxides present in the base material. The presence of the flux provided the wetting of elements in the joint by the molten brazing metal and intensified the capillary action in the brazing gap. The flux was used to cover the area referred to as an “overlap” (Fig. 1).
