Types of Surface Impurities versus the Quality of Brazed Joints

Abstract: Brazing is one of the primary joining processes increasingly often applied in industry. Because of their mechanical properties, overlap joints are particularly popular when making brazed structures. The use of brazed joints in structures of critical importance requires that particular attention be paid to joint quality, e.g. by the appropriate cleaning of surfaces to be joined. The article presents results of non-destructive tests of brazed joints made in steel S235JRG2. Surfaces used in the tests were deliberately contaminated to simulate the presence of welding imperfections. Afterwards, the test specimens were subjected to non-destructive (visual and radiographic) tests aimed to determine the effect of surface impurities on the quality of brazed joints.

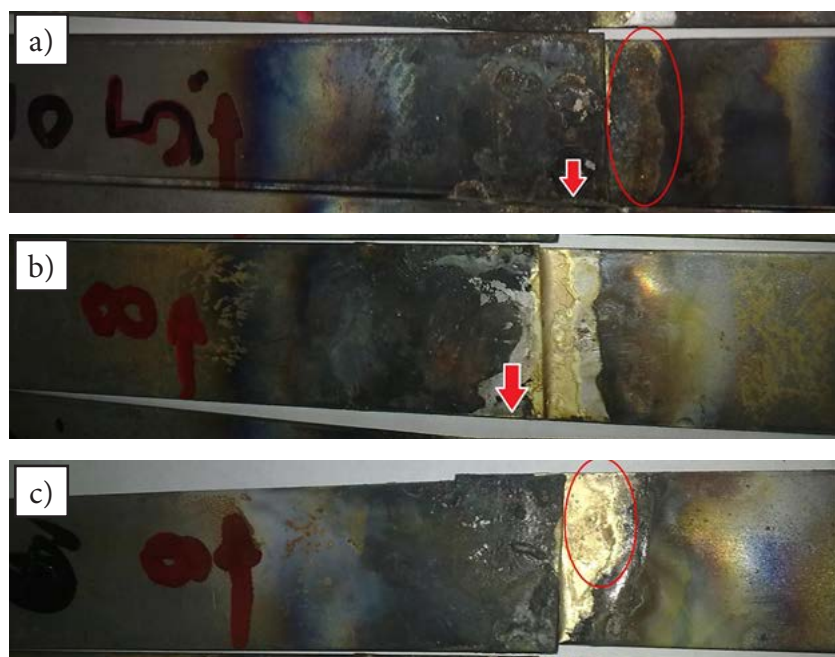
Fig. 2. Visual test results; a) specimen 5 – three copper inclusions, excessive spread of the brazing metal (ellipse), a crack of the braze and gas pores (arrow), the overlap on the upper edge not filled with the filler metal, b) specimen 8 – immersed in water, a crack of the braze (arrow), the overlap on the left edge not filled with the filler metal c) specimen 9 – provided with the flux used in the SAW method, excessive spread of the brazing metal (ellipse), gas pores, the overlap on the upper edge not filled with the filler metal

The visual tests revealed a number of brazing imperfections including primarily shape-related imperfections, porosity and discolorations. The most numerous imperfections were present in the specimens, the brazing of which proved most problematic. The intentionally contaminated surfaces of specimens led to the excessive spread of the brazing metal. Visual tests results related to brazed joints are presented in Figure 2.
