# Comparison of Surface Quality and Tool-Life of Glulam Window Elements after Planing

### Original scientific paper • Izvorni znanstveni rad

**Key words:** planing process, pine wood, window frame, surface quality, 2D/3D surface texture

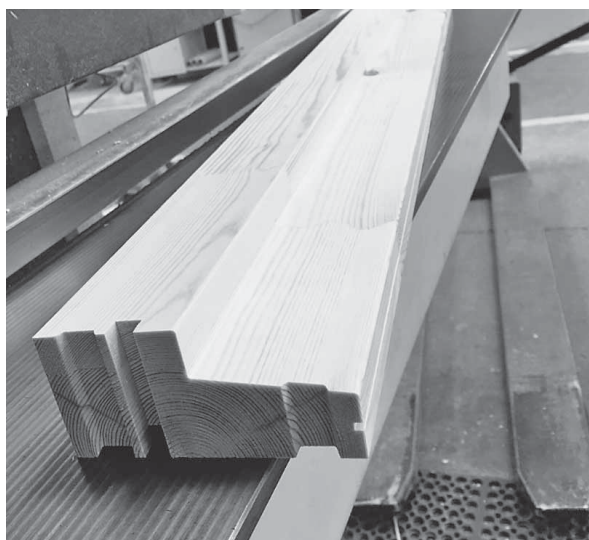
**Figure 2** View of the material after machining  
**Slika 2.** Izgled drvenoga lameliranog elementa nakon strojne obrade

ducted on the first out of three operations in the production process and was associated with shaping of the workpiece (Fig. 2).

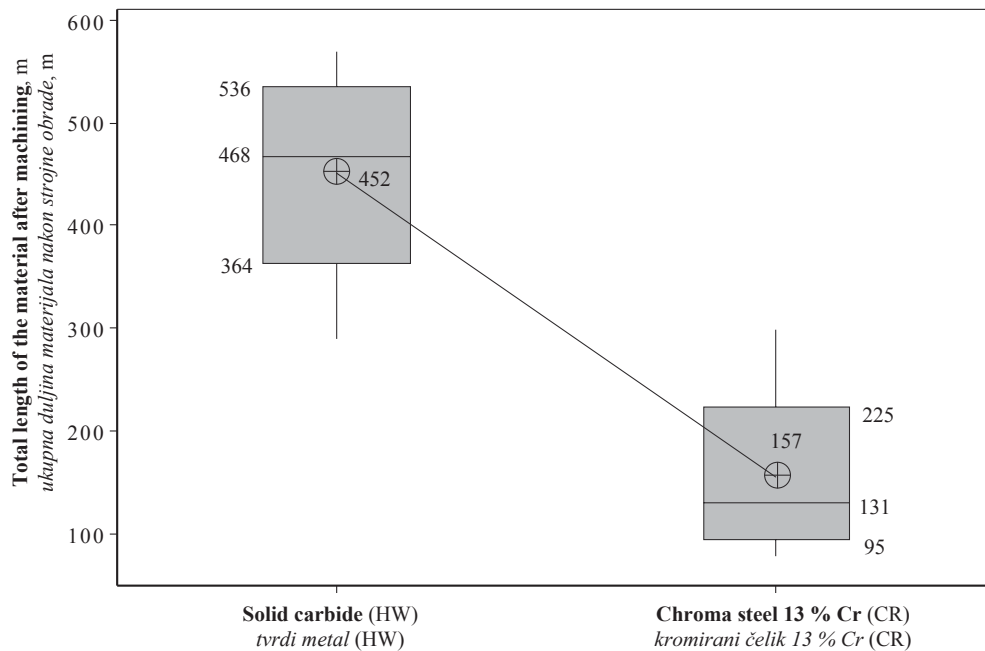
**Figure 4** The mean value and value dispersion of total length of machined frame beams vs. selected types of blade material (box plot presents: the mean, median, interquartile range box and data range)

compared with results from the same test performed with blades made of chrome steel (CR). It should be emphasized that the productivity of the process in the first case is nearly 3.5 times higher than in the second one (length Median (HW) = 468 m and length Median (CR) = 131 m) (Fig. 4). The analysis took into account the cost of production and especially the difference in the cost of equipping the machine with a given type of knife. The total cost of equipping the heads with knives made of HW was almost twice higher than with knives made of CR. Nevertheless, the average production cost of 1 meter of material in the first case (the head equipped with HW knives) was about 30 % less than the second one (CR knives used).

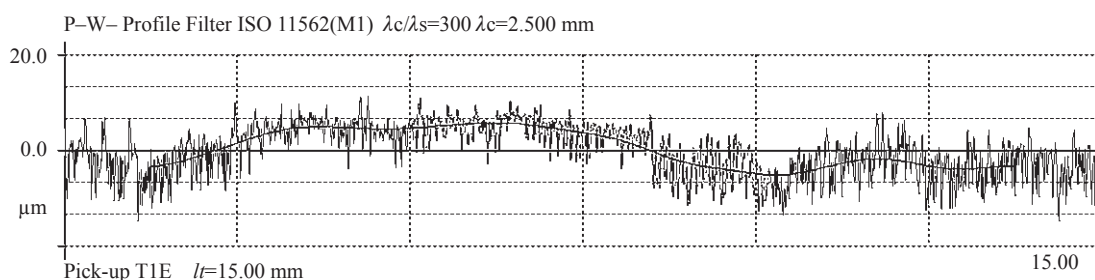
**Figure 5** Example of P- and W- profile of the first machined sample  
**Slika 5.** Primjer profila P i W za prvi obrađeni uzorak

Comparing the profiles between the sample manufactured with a set of new knives and the sample obtained after manufacturing n-meters of the product, significant changes can be noticed in the appearance of the primary profile (the profile of waviness was added for better visualisation). The profiles of the first samples, i.e. after manufacturing 6 m long beams, were smooth and the knives wear was not observed (Fig. 5). The surface texture parameters for the primary and roughness profiles were:  $R_a = (2.48 - 3.20 \mu\text{m})$ ,  $R_z =$

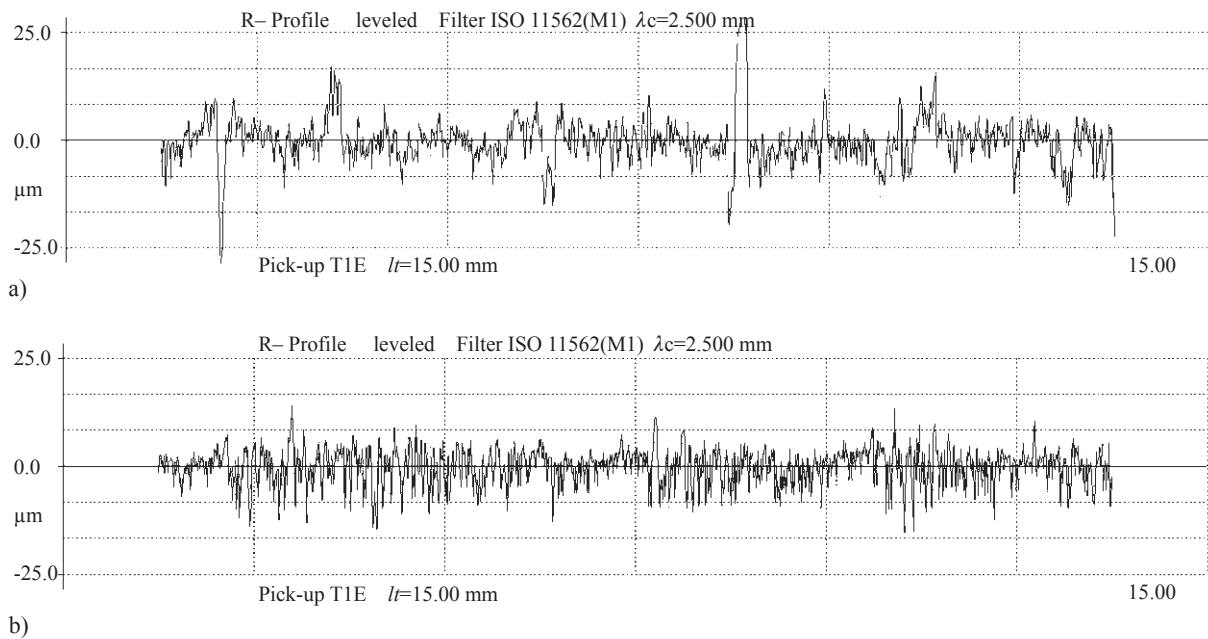
**Figure 7** R-profiles of Sample #2 machined with HW blades (a) and Sample #5 planed with CR blades (b)  
**Slika 7.** a) R-profil uzorka #2 obrađenoga nožem od tvrdog metala, b) R-profil uzorka #5 obrađenoga nožem od kromiranog čelika

Therefore, both minimum and maximum heights are characterised by particular maximum height of the profile ( $Rz$ ) in the range of 20 – 45 % for HW blade, and 12-45 % for CR blade, which is smaller than corresponding values of profile total height ( $Rt$ ). The maximum difference of 45 % is presented by the example of the profile of Sample #2 second area (HW) (Fig. 7a). Moreover, the profile for the minimum value of 12 % observed in Sample #5 second area (CR) is pictured in Figure 7b. Scratches, pull-outs and other damages to the machined wooden material could be distinctly ob-

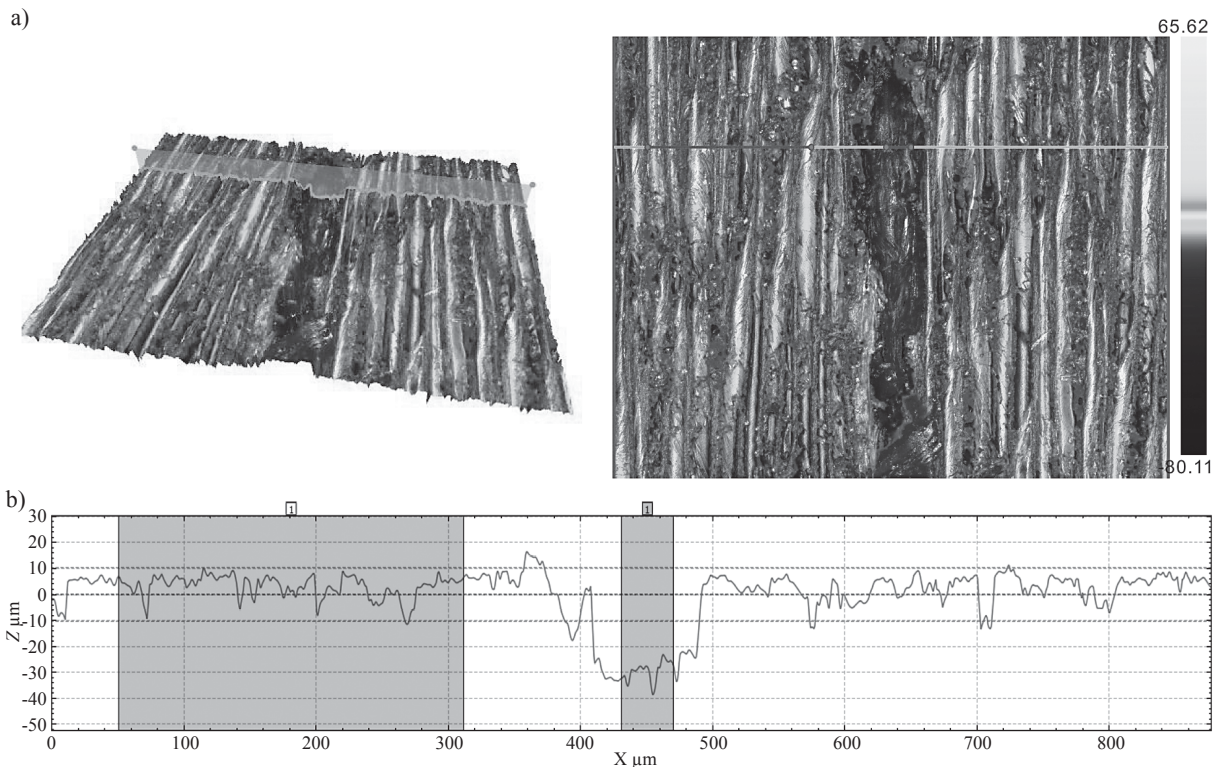
**Figure 10** 3D surface topography (a) and 2D profile (b) of the 6<sup>th</sup> test sample  
**Slika 10.** a) 3D topografija površine, b) 2D profil šestoga ispitnog uzorka

For a more detailed analysis of the damage to the surface, some 3D measurements of the surface condition were made with 3D Optical Profiler S Neox (f. Sensofar 2017) (Fig. 9 and 10). Moreover, the 3D measurements have given a complete image of the surface condition as a critical element of the entire machining process. The obtained results are in agreement with findings by Zongh *et al.* (2013). The results of selected 3D surface texture parameters are shown in Table. 5.

$Sa$ . This was particularly noticeable in Sample #2 and Sample #6, when these differences increased to about 55 – 65 %. The unevenness evaluated using the above height parameters  $Sq$  and  $Sa$  reflects general texture of the machined wood having considered scratched areas caused by worn blades.
