B. Trybus¹, J. M. Olive², N. Lenoir³, A. Zieliński^{1*}

X-RAY COMPUTER TOMOGRAPHY STUDY OF DEGRADATION OF THE ZIRCALOY-2 TUBES OXIDIZED AT HIGH TEMPERATURES

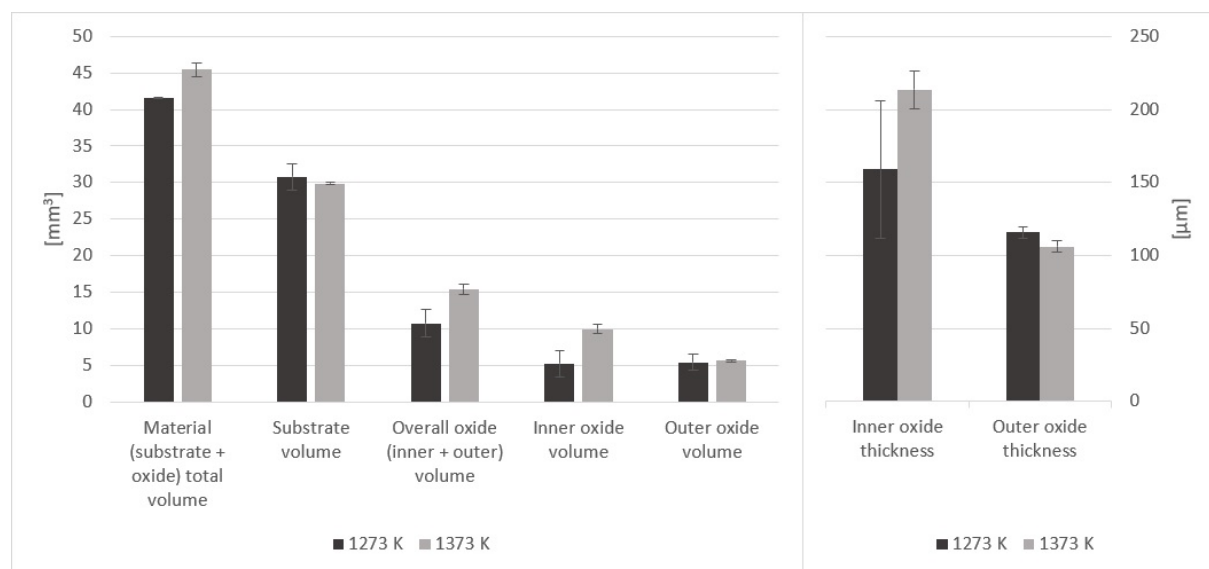
Fig. 2. Relation of the oxide layer volume and thickness on oxidation temperature and oxide layer placement (outside or inside the tube)

Relationships between the volumes and thickness of the oxide layers, and oxidation temperature and a place of oxidation (oxides grown on the internal or external surface of the tube, called later inner and outer oxides) are presented in Fig. 2. The increasing temperature resulted in an increasing oxide volume and thickness. Both surfaces revealed similar thickness of oxide layer after oxidation at lower temperature, and higher on internal surface after oxidation at 1373 K.

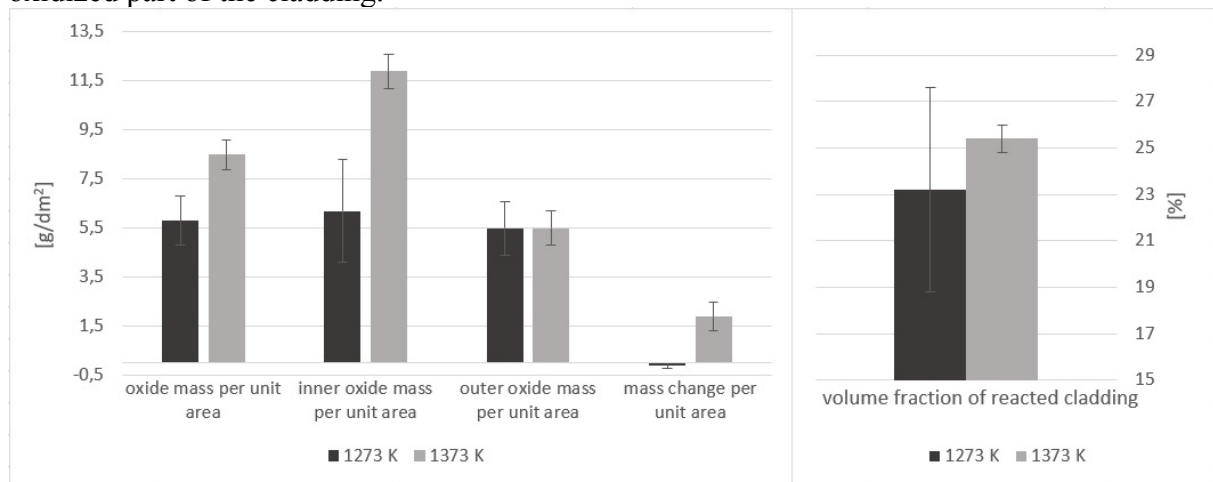
Fig. 4. Oxide mass per unit area and volume fraction of reacted cladding obtained at different oxidation

Based on the estimated number and volume of cracks in the oxide layer, the volume of oxide layer was arbitrarily reduced for each temperature and the place of layer, internal or external, e.g. about 20% for specimens oxidized at 1273 K. Figure 4 presents a change in mass per unit area in the middle section of the oxidized tube in comparison to the non-oxidized sample. The presented values were calculated based on the previously measured volumes of the middle section and volumes of oxide, and densities of the substrate alloy and the zirconium dioxide. The volume of reacted zirconium cladding determines previously oxidized part of the cladding.
