Analysis of the Ways to Identify Rail Running Surface Defects by Means of Vibration Signals

Summary

The article discusses a preliminary concept of a method enabling the identification of chosen rail running surface defects, such as squats, spalling, and running surface defects, by analysing the parameters of vibration signals. It features a description of the methodology of the conducted tests, the scope thereof, and the selection of the measurement points with specific defect types. The article covers selected results of vibration tests, the results of analyses of recorded signals for defective track sections and those for control track sections. The presented measurement results have been obtained for the technical–operating conditions occurring on railway line no. 213 Reda – Hel and line no. 131 Chorzów Batory – Tczew. The preliminary test results and conclusions included in the article show that it is reasonable to pursue further research into the phenomena involving the utilisation of vibroacoustics in rail performance diagnostics.

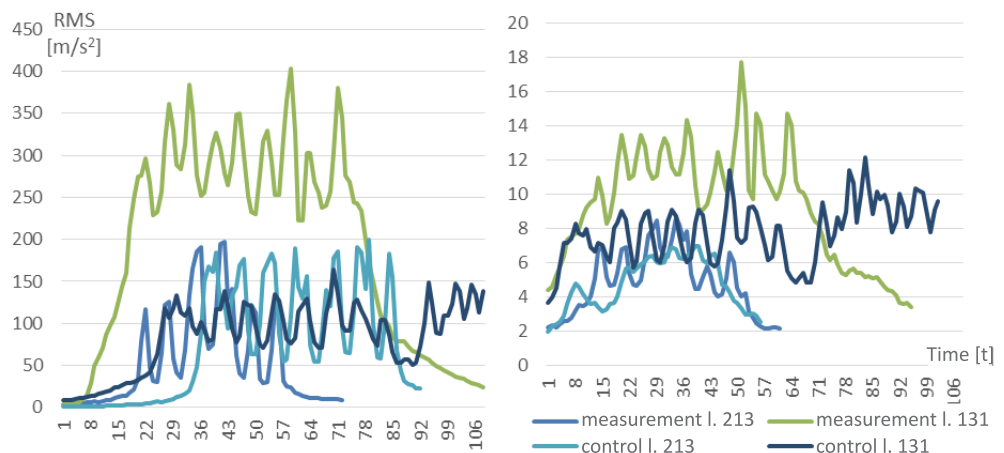
Figure 5 presents a comparison of the RMS values of vibration acceleration for the control track section with a track section featuring a squat defect on lines no. 213 and no. 131. The results were recorded by a 4513-B-001 single-axis sensor placed under the

Fig. 5. Measurement results recorded by a single-axis sensor (left) and a three-axis sensor, direction X (right) for a track section with a squat defect – RMS acceleration values [authors' own work]

rail foot and by a three-axis sensor in direction X – according to the train movement direction.

The maximum values recorded by the single-axis sensor for the track section with a squat defect on line no. 131 amounted to 400 m/s². In the case of line no. 131, the values of acceleration of travel over the squat defect were four times higher than the values of signals recorded on the control track section. In the case of line no. 213, the recorded values were two times higher than those recorded on the control track section. The acceleration values recorded by the three-axis sensor for direction X were twenty times lower than the acceleration values recorded by the single-axis sensor. In the case of line no. 131, the maximum RMS value obtained for the three-axis sensor in direction X was 18 m/s², which is two times more than the values obtained for the control track.

Figures 5–10 show a compilation of measurement results of the RMS values of vibration acceleration for selected running surface defects, including measurements of vibration for control track sections. The curves represent the values over time for the average values of vibration for all measurement samples during train travel.
