# Damage Development on the Surface of Nickel Coating in the Initial Period of Erosion

**Abstract:** The common occurrence of the phenomenon of cavitation in many industries and the multitude of factors affecting the resistance to cavitation erosion of used materials contribute to the search for methods and appropriate parameters of coating application that are able to minimize the effects of erosion. To determine the validity of the developed application parameters and the method used, cavitation studies and microscopic observations of the development of erosion during the cavitation test were carried out. There was a clear lack of incubation time and a linear increase in losses after 60 min of the test. Moreover, the damage observed during the test overlapped, widening the area of erosion and thus leading to damage to the integrity of the coating.

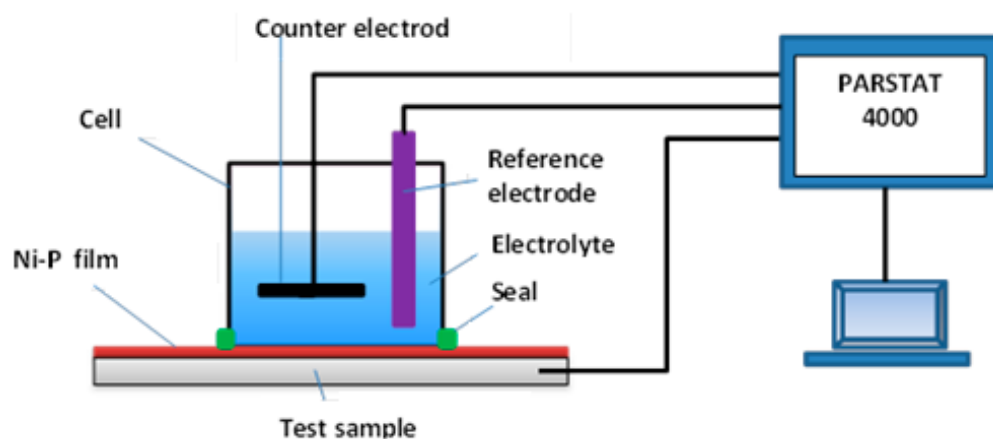
Figure 1. Scheme of the system for measuring the resting potential.

The electrochemical measurements of the nickel coatings were performed in  $35 \text{ g dm}^{-3}$  NaCl electrolyte. The solution was prepared from ppa chemicals. The electrochemical measurements were performed with the potentiostat galvanostat EIS Analyzer PARSTAT 4000 made by AMETEK (Oak Ridge, TN, USA). A dedicated cell working with three-electrode mode was used (Figure 1). A platinum foil was used as a counter electrode and an Ag | AgCl electrode in the saturated KCl solution was used as a reference electrode. The coated sample was used as a working electrode.

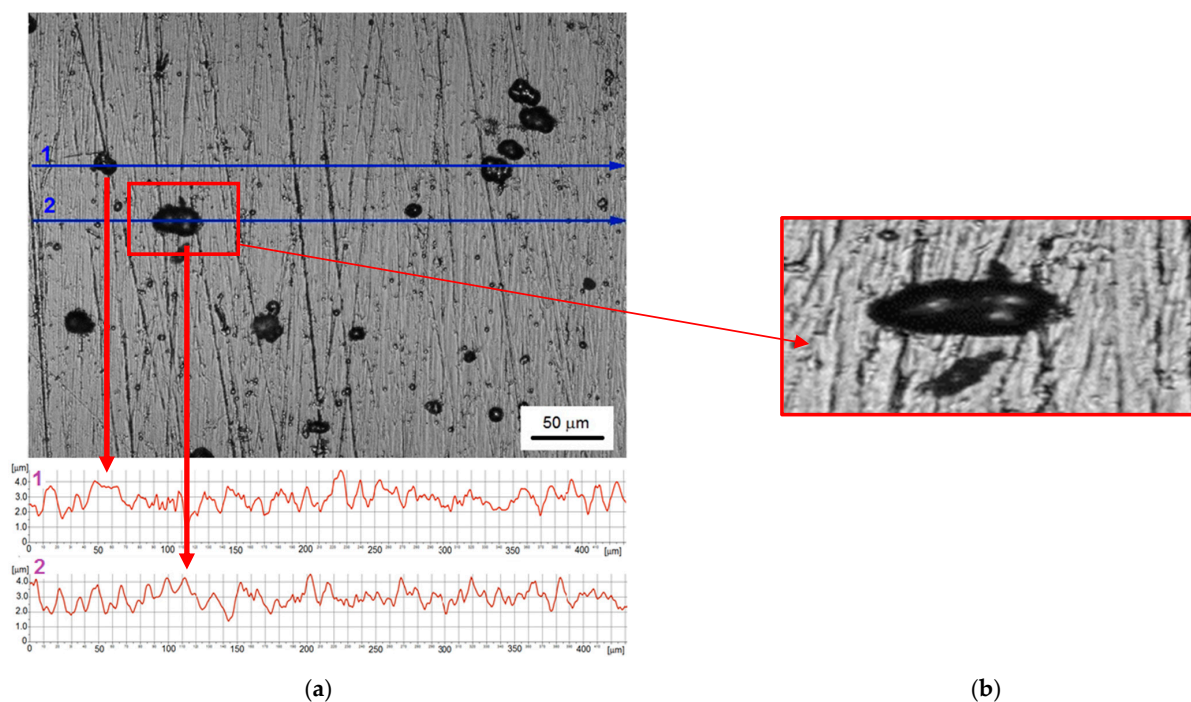
**Figure 2.** Nickel coating before cavitation erosion tests: (a) surface morphology with roughness profiles along the selected measurement lines; (b) 3D profile of a surface defect.

The Ni coating investigated in the presented studies is shown in Figure 2. The microscopic observation revealed the coating reflected the substrate very well and numerous defects with diameters ranging from 2  $\mu\text{m}$  to even 46  $\mu\text{m}$  were formed. The median size of defects was 9.6  $\mu\text{m}$  the standard deviation was 8.7  $\mu\text{m}$ . In addition, the roughness measurements showed that the surface unevenness had a height up to 2.5  $\mu\text{m}$  and the defects were convex. Nevertheless, the coating was applied evenly to the substrate, and the observed unevenness was due to the unevenness of the substrate surface due to the low thickness of the nickel coating (about 10  $\mu\text{m}$ ).

The microscopic observations of the coating before cavitation tests showed that the surface irregularities were reflected by the coating due to its small thickness. However, the height of surface unevenness decreased by about 0.8  $\mu\text{m}$ : from  $2.63 \pm 0.29 \mu\text{m}$  to about 2  $\mu\text{m}$ . In addition, defects with a wide range of diameters were formed during coating deposition. According to [49], defects in electroless Ni coatings are related to the phosphorus content and coating thickness. Thus, the cause of the numerous and large defects was likely the high content of phosphorus.

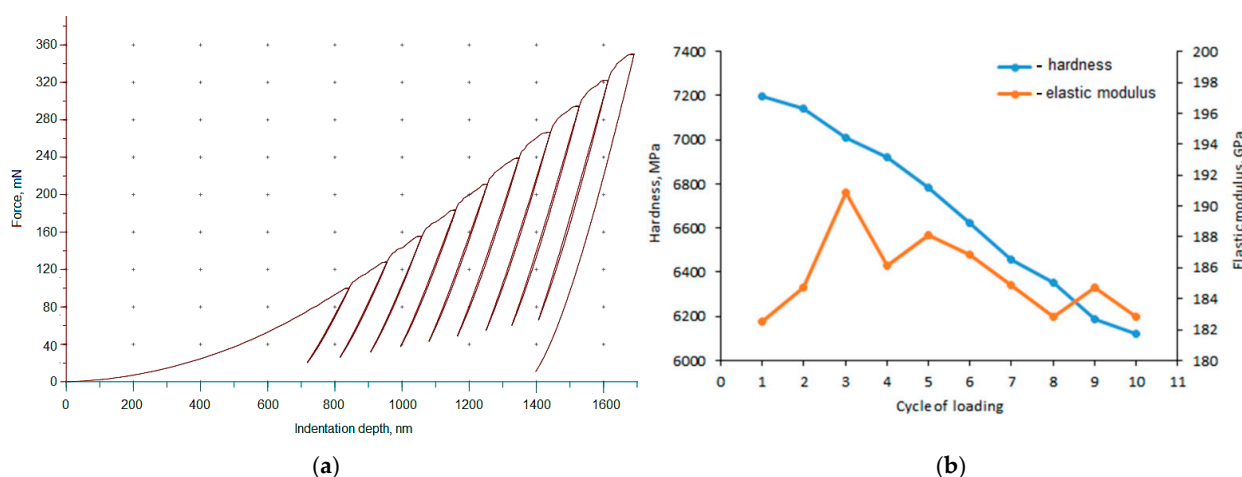
**Figure 3.** Force versus indentation depth curves for a Ni–P coating: (a) hardness and elastic modulus change with loading cycle (b).

The results of cycling loading are shown in Figure 3. The first load caused an indentation depth of about 0.8  $\mu\text{m}$ , so it was less than 1/10 of coating thickness. With increasing cycles of load, the indentation depth increased as well. The maximum indentation depth during the third cycle was approx. 1.05  $\mu\text{m}$ . Thus, starting from the third cycle, the indentation depth was higher than 1/10 of the coating thickness and the substrate began to have an influence on the results obtained. After all cycles, the maximum indentation depth was approx. 1.7  $\mu\text{m}$  and the permanent indentation depth was 1.4  $\mu\text{m}$ . With the increasing number of cycles, hardness decreased. After 10 cycles, hardness decreased over 1000 MPa. Thus, the softening effect occurred. In addition, the bigger drop of hardness arisen at the third cycle, which is related to the depth of indentation. However, the subsequent cycles resulted in a steady drop in hardness at a rate of 150 MPa per cycle. The modulus of elasticity increased during the first three cycles but then decreased. This study shows that the cyclic load significantly influenced the hardness and modulus of elasticity of the tested Ni–P coating and steel substrate, especially after the 3rd cycle, when the depth of the indentation is so deep that the substrate influences the deformation process of the entire coating-substrate system. Changes in hardness and modulus of elasticity made the coating more susceptible to plastic deformation.

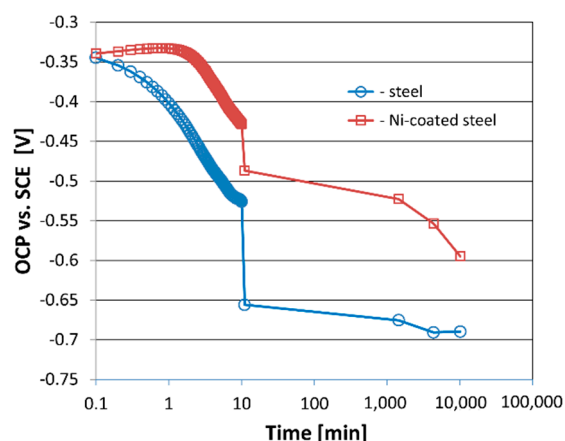
Figure 4. The dependence of the electrode potential versus the time after immersion to 3.5% NaCl solution.

The open circuit potential (OCP) value and its change within immersion time indicate resistivity of the coating against corrosion processes. The OCP data acquisition was started immediately after the introduction of the sample to the solution (c.a. 10 s after immersion of the sample). The measurements were recorded non-linearly. In the first 10 min, the measurement was performed every second. Then the period between the following measurements was extended to 1, 5, 24, 72, and 168 h, respectively. The OCP results are collected in Figure 4. The OCP measurements on Ni–P layer coated steel are compared to the Nimax steel substrate. The OCP value for Ni–P coated steel is found higher more than 100 mV when compared to the Nimax steel. Such behavior indicates corrosion protection of steel substrate by Ni–P coating. The observed slight increase of the OCP value for Ni–P coated steel at the very beginning of corrosion process can be assigned to the change in corrosion process at Ni–P surface caused by adsorption of  $[\text{PO}_4]^{3-}$  ions as suggested by Lee et al. [40]. The observed lack of stabilization of the corrosion process for Ni–P coating after relatively long time of 10,000 min, can be a result of pits formation under the coating layer [40–42].

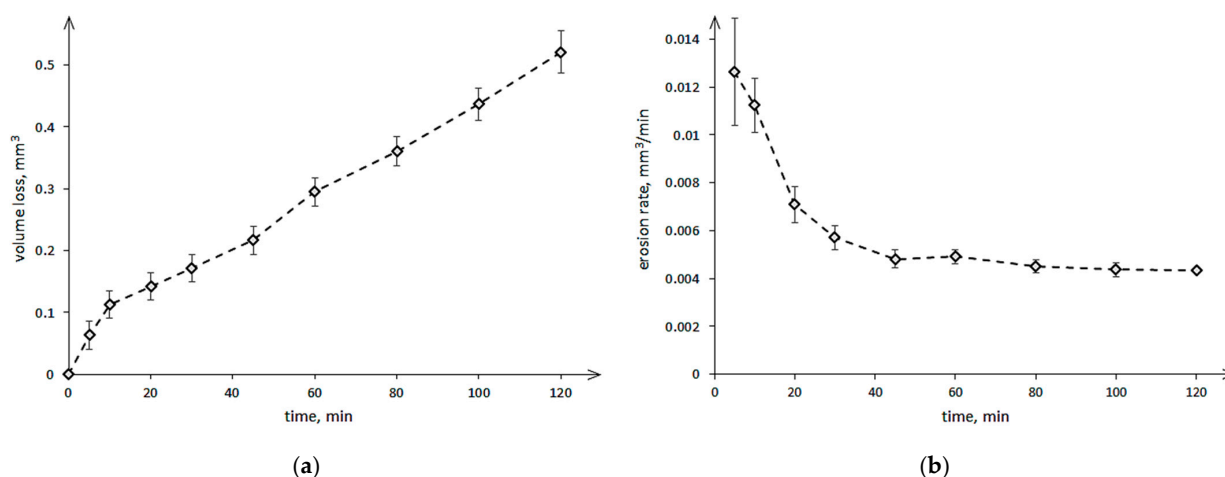
Figure 5. Results of the cavitation erosion of nickel coating: (a) volume loss in time and (b) cumulative erosion rates in time.

The results of the cavitation erosion of nickel coating are as a curve of volume loss in time (Figure 5a) and as a curve of cumulative erosion rates in time (Figure 5b).

The curve in Figure 5a shows a large increase in volume loss during the initial 10 min of the test, which is well reflected in the curve of the erosion rate in time (Figure 5b). After 5 min of the test, the erosion rate reached the highest value and was  $0.0126 \text{ mm}^3/\text{min}$ . There is no obvious incubation period. Subsequent measurements of the volume losses at 20, 30, and 45 min of the test showed a continuous, almost linear increase in the volume losses with decreasing erosion rate. Beginning from 40 min of the test, the erosion rate remained unchanged, indicating a stabilization value of  $0.0045 \pm 0.00026 \text{ mm}^3/\text{min}$  (Figure 5b). Stabilization of the erosion rate and a high increase in the volume losses of the nickel-based coating at the initial stage of the cavitation erosion test were also observed by Meng et al. [26] and Lampke et al. [33], although they have used a different test device—an ultrasonic test apparatus. Meng et al. [26] have obtained that a stabilization erosion rate was reached after about 50 min of testing, so after comparable test duration. Lampke et al. [33] have obtained a stabilization erosion rate only after 5 h of testing. The difference between these two tests was the test method used (sample position). Meng et al. [26] have used the direct method, while Lampke et al. [33]—the indirect method.

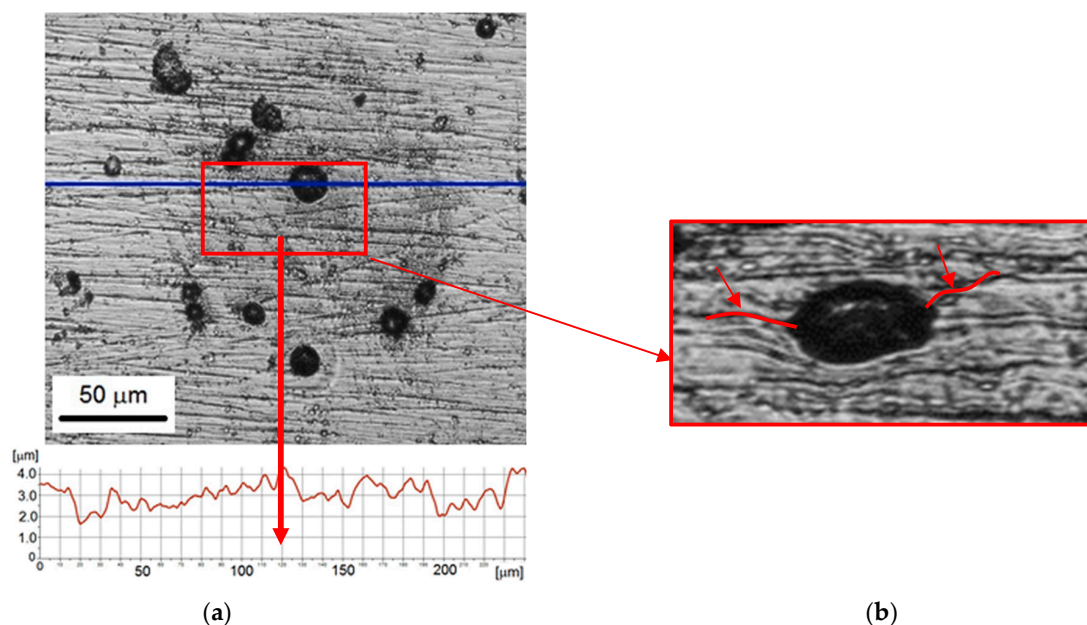
**Figure 6.** Nickel coating after 5 min of the cavitation erosion tests: (a) surface morphology with roughness profile along the selected measurement line; (b) 3D surface profile of a pit.

The development of Ni coating degradation starting from 5 min up to 60 min of the test was shown in Figures 6–9. Observation performed after 5 min of testing revealed two types of damage formed on the coating surface: damage surrounded by circular shadings and small pits without such circular shadings. The pit surrounded by shadow is shown in Figure 6a. The diameter of this pit was  $30\ \mu\text{m}$  and the depth was about  $1\ \mu\text{m}$ . The 3D profile (Figure 6b) confirmed a concave shape of the edge of this pit (arrows). Other surface defects had a diameter of approximately  $18\text{--}25\ \mu\text{m}$ . The circular shadings had a diameter of about  $150\ \mu\text{m}$  and did not affect the 3D profile and the roughness profile, which was close to the roughness profile before cavitation tests. Very slight damage (pit depth) was likely an effect of the high hardness of the Ni coating.

the selection of the test conditions was correct. The diameter of the pits and shadows reached 30 and 150  $\mu\text{m}$ , respectively. The depth of the pits was up to 1  $\mu\text{m}$ , and the edge of the pit had a concave shape. The concave shape was probably the result of compression by the micro cavitation structured. As described in Section 3.4, the shadows were likely the thin film of nickel oxide, which was the product of nickel oxidation (nickel corrosion), which is common in Ni–P coatings [54].

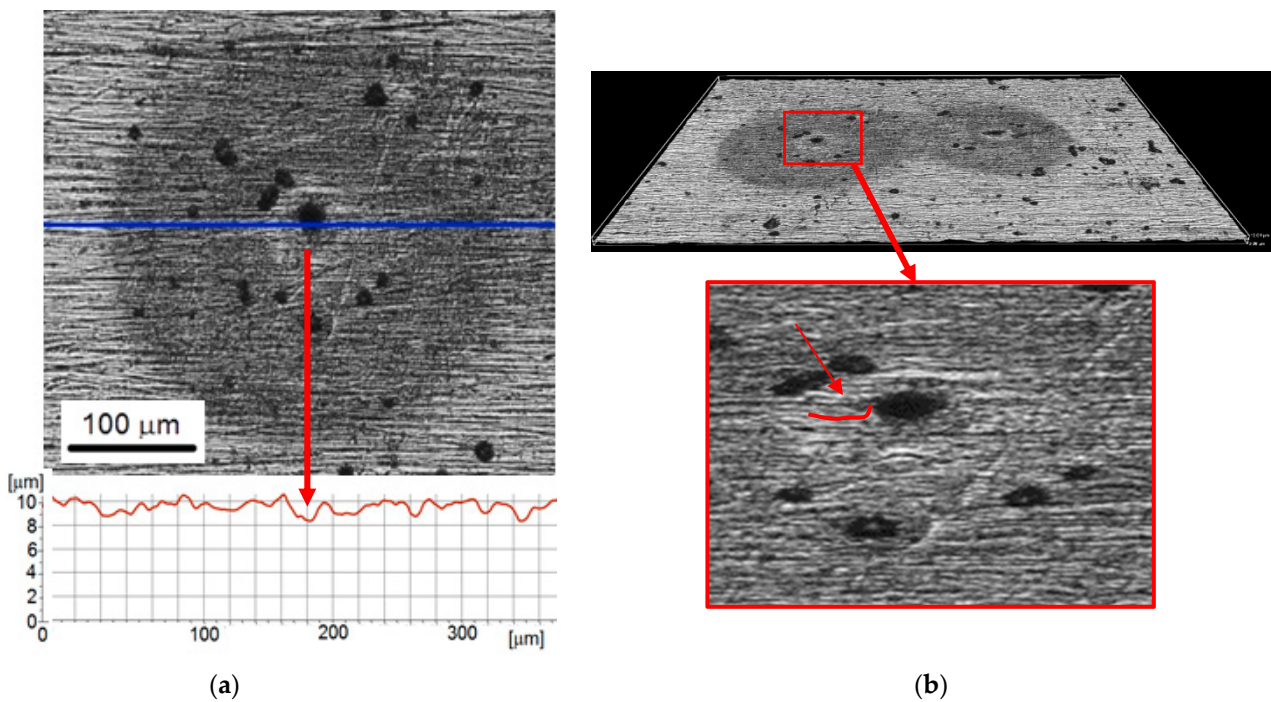
**Figure 8.** Nickel coating after 30 min of the cavitation erosion tests: (a) surface morphology with roughness profile along the selected measurement line; (b) 3D surface profile.

Extending the test duration to 30 min slightly affected the diameter of the shadows but had a significant effect on the change in the diameter of the pits (Figure 8). The diameter of shadows was about 300–400  $\mu\text{m}$ , while the diameter of the pits was in the range from 20 to 40  $\mu\text{m}$ . Thus, the diameter of the pits increased. In addition, Figure 8b shows that pits had a characteristic shape: the surface just around the pit was slightly convex, and next to it was concave. The roughness profile (Figure 8a) shows the pit depth of about 2  $\mu\text{m}$ . As the possibilities of surface analysis with an optical profilometer are limited, the formation of a microcrack at the bottom of this pit cannot be excluded. This damage shape was likely the reason for corrosion development. Corrosion tests (c.f. Section 3.2) have shown lower corrosion resistance of the steel substrate in comparison to the Ni coating. The other factor influencing the development of corrosion was an increase in stress level in the coating. Elongation of the test duration means an increase in the number of impacting cavitation pulses. Although some of them are too weak to cause a pit in the hard nickel coating, they are able to supply some of the impact energy and stresses to the surface layer. The increase in stresses promotes the acceleration of corrosion processes.

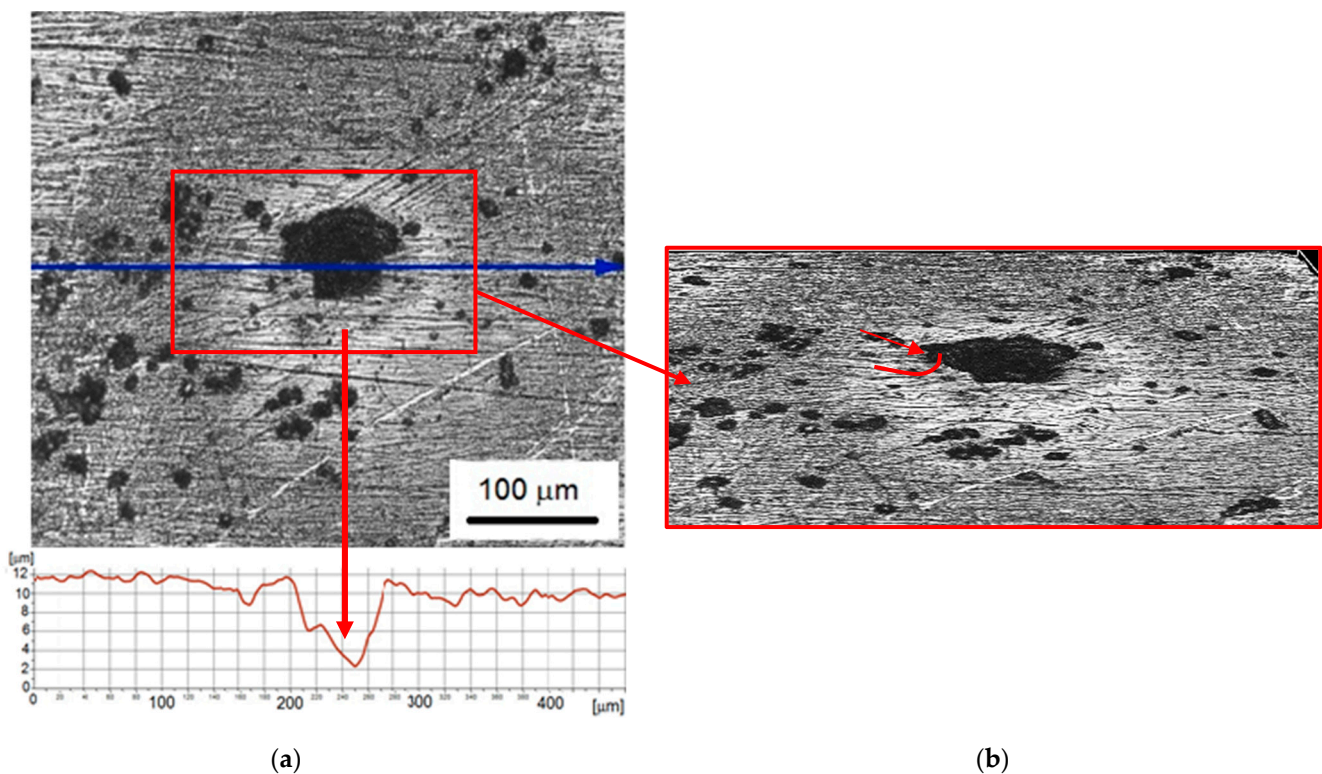
**Figure 9.** Nickel coating after 60 min of the cavitation erosion tests: (a) surface morphology with roughness profile along the selected measurement line; (b) 3D surface profile.

With the increase of the exposure time to 60 min, the previously formed pits increased in diameter and depth (Figure 9a). The diameter of the pits ranged from about 35  $\mu\text{m}$  to about 75  $\mu\text{m}$ , the depth of the pit shown was 10  $\mu\text{m}$ . Moreover, the diameter of the shadows around the pits increased even to 450  $\mu\text{m}$ . The volcanic shape of the rim of the pit is even more visible—the edge of the pit became more and more convex. The conducted research shows that pitting corrosion accelerated with the increase of the duration of the cavitation erosion test. Pitting corrosion occurred in the form of pits initiated at the site of damage to the passive oxide layer. The damaged pits were the anode where the steel dissolves. Due to the small area of the anode, corrosion developed deeper into the tested steel. Moreover, the surroundings of the pitting were the cathode, and oxygen reduction could take place there. Corrosion pits can also have a negative effect by acting as stress risers. Fatigue and stress corrosion cracking may start at the base of corrosion pits [24,36,37].

Further extending the test duration to 60 min increased the pit diameter to 75  $\mu\text{m}$ , the pit depth to 10  $\mu\text{m}$ , and the diameter of the shadows to 450  $\mu\text{m}$ . Thus, the diameter of the pits and round shadows still increased with the duration of the test. More than a twofold increase in the pit diameter (from 30 to 75  $\mu\text{m}$ ) indicates that the decrease in coating hardness was so great that the micro-jet was able to cause puncture and removal of the coating. This development of the degradation process was also influenced by the difference in the electronegativity of the coating and the substrate and the increase in a complex stress state, which favored galvanic corrosion. The steel becomes the anode and the coating becomes the cathode. The resulting galvanic currents concentrate on the anode with a small area, which accelerates the anodic dissolution reaction [55,56]. Due to the lower corrosion resistance of the substrate steel and the introduced state of stress, the degradation of the coating-substrate system developed mainly in the steel substrate.
