Article

Damage Development on the Surface of Nickel Coating in the Initial Period of Erosion

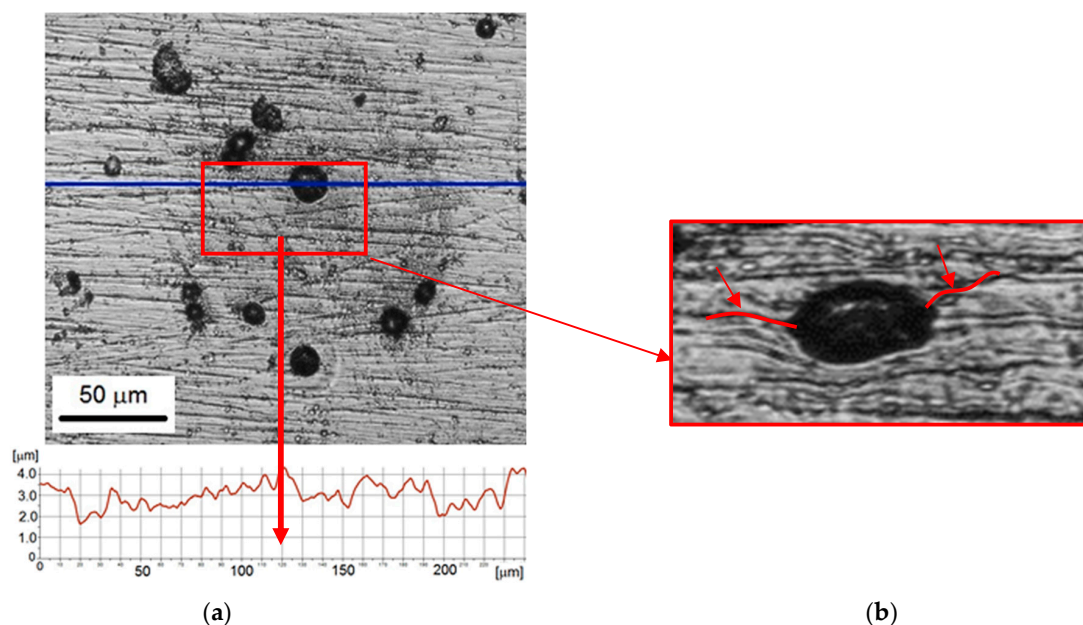
The development of Ni coating degradation starting from 5 min up to 60 min of the test was shown in Figures 6–9. Observation performed after 5 min of testing revealed two types of damage formed on the coating surface: damage surrounded by circular shadings and small pits without such circular shadings. The pit surrounded by shadow is shown in Figure 6a. The diameter of this pit was $30\ \mu\text{m}$ and the depth was about $1\ \mu\text{m}$. The 3D profile (Figure 6b) confirmed a concave shape of the edge of this pit (arrows). Other surface defects had a diameter of approximately $18\text{--}25\ \mu\text{m}$. The circular shadings had a diameter of about $150\ \mu\text{m}$ and did not affect the 3D profile and the roughness profile, which was close to the roughness profile before cavitation tests. Very slight damage (pit depth) was likely an effect of the high hardness of the Ni coating.

Figure 6. Nickel coating after 5 min of the cavitation erosion tests: (a) surface morphology with roughness profile along the selected measurement line; (b) 3D surface profile of a pit.

First damages and volume loss were recorded after 5 min of the cavitation erosion test, despite the high hardness of the coating and low inlet pressure. The lack of the incubation period can be related to the uneven surface of the coating and coating defects. High roughness and surface defects contribute to the faster development of cavitation erosion [28,47,53]. According to [28], surface defects accelerate the loss of volume in the initial stage of cavitation tests. However, studies in [47] have shown that the number of defects, not their size, has such an effect on initial surface degradation in cavitation tests. Moreover, after 5 min of testing, individual pits surrounded by circular shadows were formed. This is evidence of a small number of strong cavitation impulses in the flow. Thus,

the selection of the test conditions was correct. The diameter of the pits and shadows reached 30 and 150 μm , respectively. The depth of the pits was up to 1 μm , and the edge of the pit had a concave shape. The concave shape was probably the result of compression by the micro cavitation structured. As described in Section 3.4, the shadows were likely the thin film of nickel oxide, which was the product of nickel oxidation (nickel corrosion), which is common in Ni–P coatings [54].

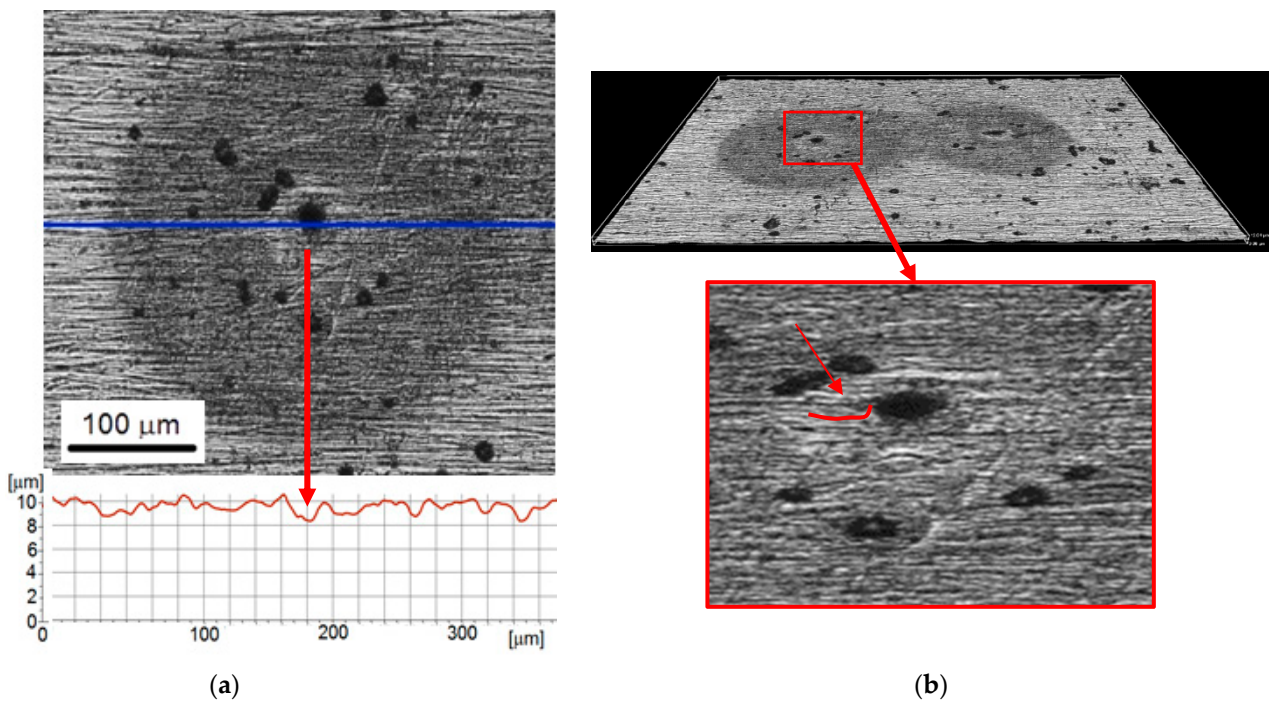
Figure 8. Nickel coating after 30 min of the cavitation erosion tests: (a) surface morphology with roughness profile along the selected measurement line; (b) 3D surface profile.

Extending the test duration to 30 min slightly affected the diameter of the shadows but had a significant effect on the change in the diameter of the pits (Figure 8). The diameter of shadows was about 300–400 μm , while the diameter of the pits was in the range from 20 to 40 μm . Thus, the diameter of the pits increased. In addition, Figure 8b shows that pits had a characteristic shape: the surface just around the pit was slightly convex, and next to it was concave. The roughness profile (Figure 8a) shows the pit depth of about 2 μm . As the possibilities of surface analysis with an optical profilometer are limited, the formation of a microcrack at the bottom of this pit cannot be excluded. This damage shape was likely the reason for corrosion development. Corrosion tests (c.f. Section 3.2) have shown lower corrosion resistance of the steel substrate in comparison to the Ni coating. The other factor influencing the development of corrosion was an increase in stress level in the coating. Elongation of the test duration means an increase in the number of impacting cavitation pulses. Although some of them are too weak to cause a pit in the hard nickel coating, they are able to supply some of the impact energy and stresses to the surface layer. The increase in stresses promotes the acceleration of corrosion processes.
