Assessment of Wooden Beams from Historical Buildings Using Ultrasonic Transmission Tomography

The main goal of this study was non-destructive evaluation of wooden elements using ultrasonic waves. The inspection was carried out on wooden beams from a historical object. Elastic wave signals were processed by ultrasonic transmission tomography to obtain imaging of the internal structure of tested elements without disturbing their state and integrity. The focus was on the influence of wood anisotropy on the propagation of ultrasonic waves. A novel method of determining the position of the cross-section pith was proposed. The study presented that the proposed imaging approach was capable to assess the technical condition of historic wooden beams by determining the degree of wood damage and the location of discontinuities, scratches or fibrosis in the tested cross-section.

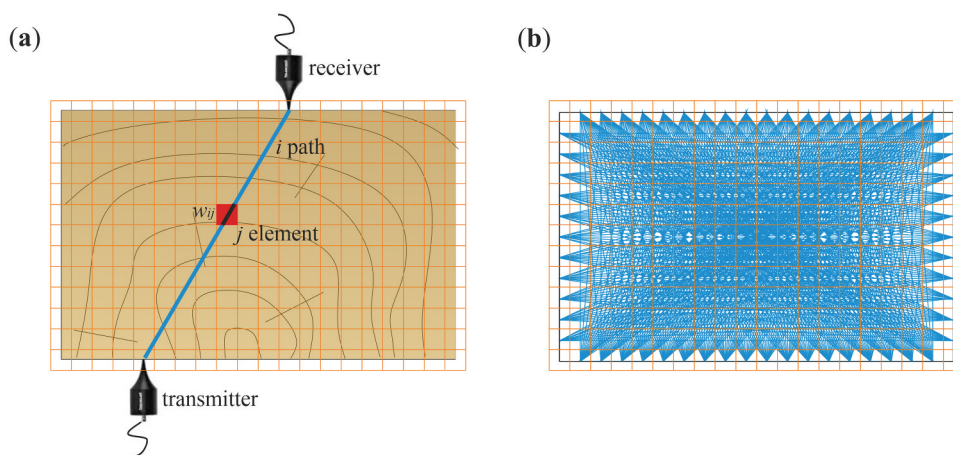
Figure 1. Scheme of passing: (a) i path through j element, (b) several paths through the object.

Travel-time ultrasonic tomography is an imaging technique that allows obtaining the internal image of an element structure in terms of the velocity of an elastic wave propagating within the medium. At first, the examined object is divided into finite area elements called cells or pixels (Figure 1). The resolution of the final image depends on the number of pixels. Then, the time-

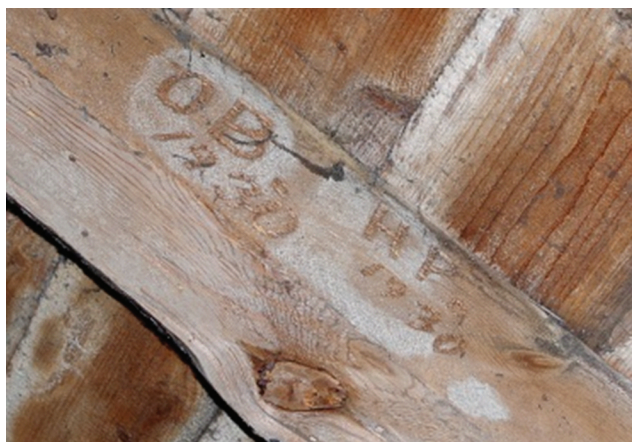
Figure 3. A rafter at the top of the roof of the monastery's west wing. (Hliwiadczyń, Cholewska, and Grunwald 2018).

its urban layout. The location of the monastery in the 17th-20th century is shown in maps and photos in Figure 2. The building structure underwent numerous damages and fires. It was renovated and modernized many times. The date of the last renovation before World War II can be found on the rafters of the roof truss of the west wing along with the contractors' initials. There are "OB HP" monograms and the date 1930 on the beam (Figure 3).

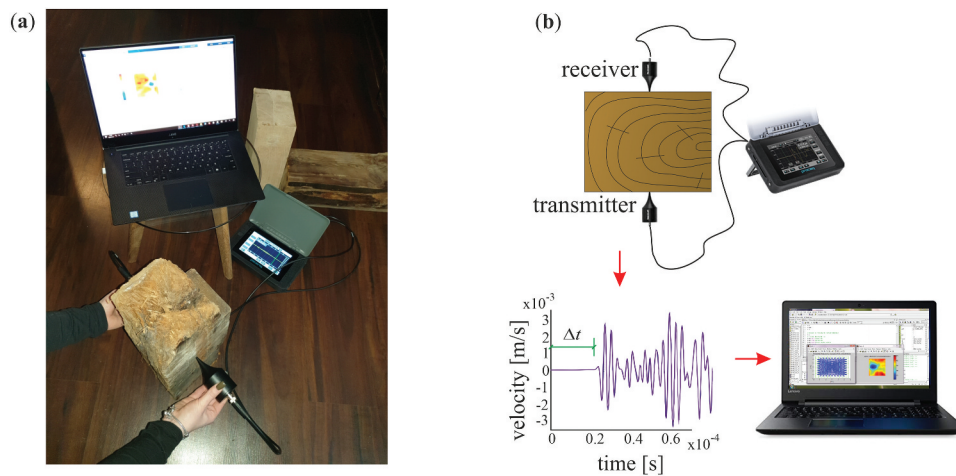
Figure 6. Experimental setup: (a) testing in through-transmission mode; (b) scheme of image reconstruction by ultrasonic tomography.

Ultrasonic tomography was performed based on the measured times-of-flight (TOFs) for waves passing through the tested element. Wave signals were measured by the PUNDIT PL-200 instrument (Proceq SA, Schwerzenbach, Switzerland). Two exponential transducers of 54 kHz were used in the through-transmission mode. The experimental setup and scheme of image reconstruction are shown in Figure 6.

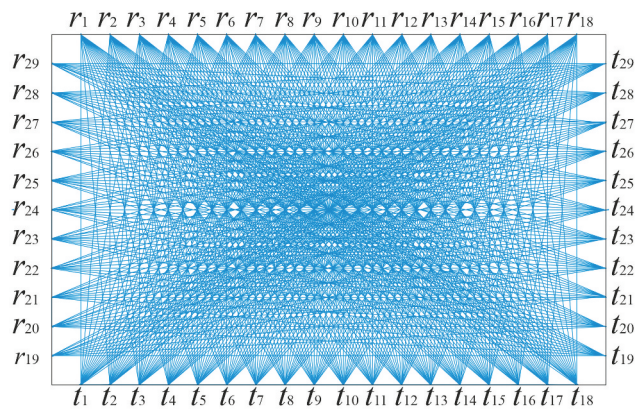
Figure 7. Configuration of the wave paths from transmitters (t) to receivers (r).

Measurements were carried out in the cross-section located in the mid-height of each beam. The configuration of transmitters (t_1 – t_{29}) and receivers (r_1 – r_{29}) is shown in Figure 7. The transmitters and receivers were placed at the edge, with an interval of 1 cm between each other. The TOF for each transmitter was recorded at the receiver points lying on the opposite wall. For each of the beams, 445 TOFs were obtained.

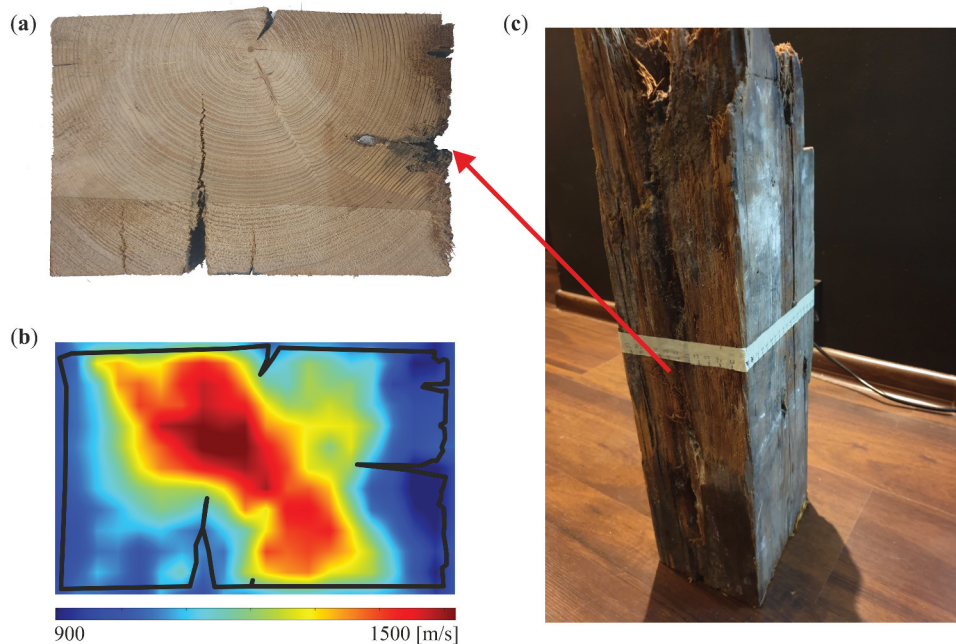
Figure 9. Results obtained for beam #2: (a) top view of the beam, (a) ultrasonic tomography image, (c) side view of the beam.

Beam #2 was taken from the historical roof framework. One of its sides included major wood fibrosis (see **Figure 9a**). The remaining three contained cracks. The ultrasonic tomography image clearly indicates the places where the beam is damaged (**Figure 9b**). The edge with the wood fibrosis showed the reduced wave transfer velocity. A similar effect was observed in the places where the cracks were located. Furthermore, an increased velocity may be spotted at the location of the pith, similar to the reference beam (#1). The wave propagation velocity varied between 632.7 m/s and 1442.3 m/s. The difference between the minimum and maximum velocity was, therefore, greater than in the reference beam (#1) and equal to 809.6 m/s. The average velocity of wave propagation was 1093.3 m/s, the standard deviation was 137 m/s. Both of these values are smaller than in the undamaged beam. The coefficient of variation was equal to 12.5% and it was at the same value as for reference beam #1. However, it should be noted that the pith of the undamaged beam is outside the cross-section, while in beam #2, the pith is within the tested cross-section.

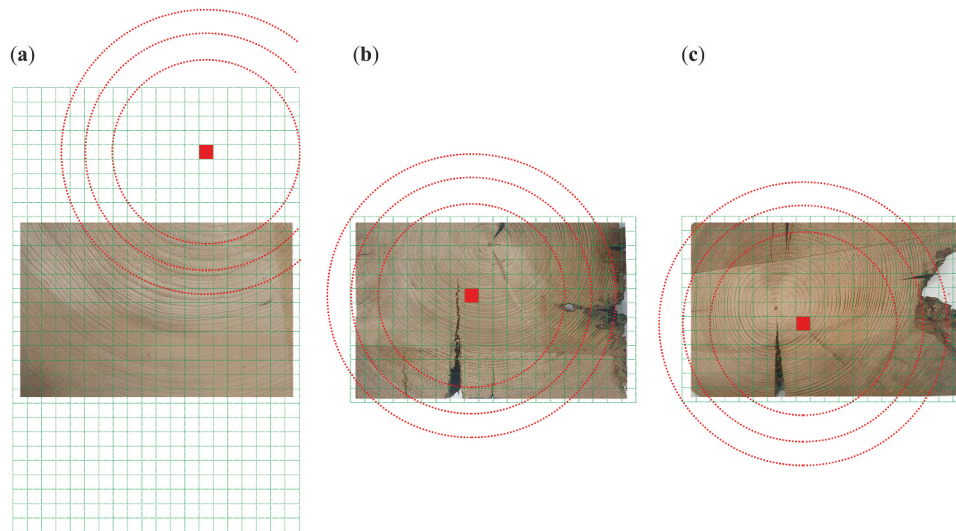
Figure 12. Determining the location of the pith from beams #1-#3.

The wood pith was searched independently for each pixel into which the element was divided. In the case of the element for which the pith was expected to be outside, the pixel grid was enlarged along the edge from where the fastest rays propagated. The pixel grid was therefore enlarged 3 times for element #1 (Figure 12a). In beams #2 and #3 the pixel grids remained unchanged (Figure 12b-c). For each of the pixels, the closest path from each transmitter t_1-t_{29} and each receiver s_1-s_{29} was selected. Thus, 58 rays were assigned to each pixel. The pixel for which the sum of the velocities of these rays was the highest indicated the positions of the pith. Selected pixels are shown in red in Figure 12. In beam #1, it coincides with the actual location of the pith. In beams #2 and #3, it is slightly shifted due to the failures in the beams affecting the course of the rays.
