# Failure characterisation of sandwich beams using integrated acoustic emission and digital image correlation techniques

Lukasz Pyrzowski<sup>a,\*</sup>, Magdalena Knak<sup>a</sup>, Magdalena Rucka<sup>a,b</sup>

<sup>a</sup> Department of Mechanics of Materials and Structures, Faculty of Civil and Environmental Engineering, Gdańsk University of Technology, Narutowicza 11/12, 80-233 Gdańsk, Poland

The paper presents the experimental study of the failure behaviour of sandwich beams subjected to bending. The samples examined are sandwich beams made of polyethylene terephthalate foam core and glass fibre-reinforced polymer laminate face sheets. In a series of experiments, it has been proposed to integrate diagnostic techniques with acoustic emission and digital image correlation to accurately track the cracking process on the surface as well as in the entire volume of the beam. The research programme carried out allowed observing various modes of failure in composite specimens. The results obtained showed that the integration of acoustic and optical diagnostic techniques provided complementary results and can be used successfully for failure monitoring in sandwich beams.

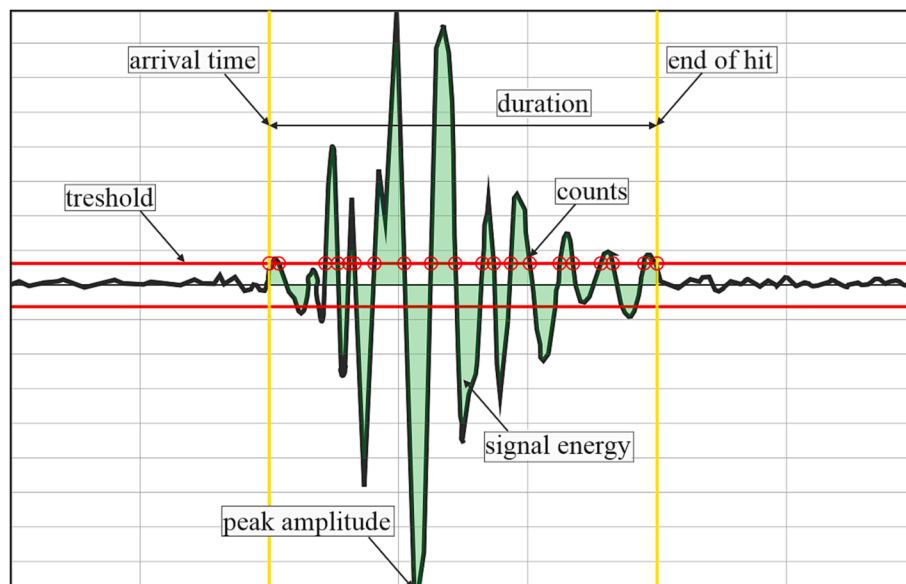
Fig. 4. Typical AE waveform.

The typical AE waveform is presented in Fig. 4. It gives the commonly used characteristics of the AE signals, including the duration, counts, amplitude and energy. In this study the fracture monitoring was investigated using typical AE parameters like cumulative energy, hits and cumulative hits.

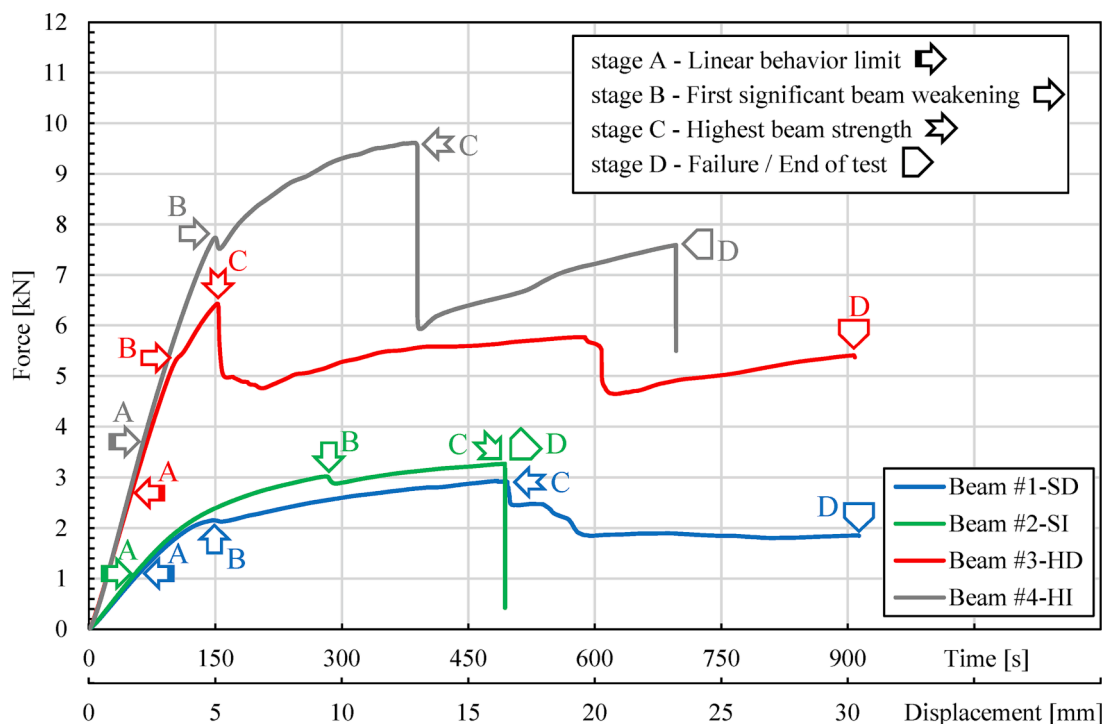
Fig. 5. Load-time(displacement) curve for Beams #1÷#4.

The bending tests were performed with the constant cross-head displacement rate. Therefore, the displacement–time curves in all tests are the same and linear. The obtained load-time(displacement) curves of all performed tests are presented in Fig. 5. In each test result, four characteristic stages can be observed, they are: A - linear behaviour limit; B - first significant beam weakening; C - highest beam strength; D - failure or end of the test. All stages are marked in Fig. 5.

Beam #1-SD behaved linearly until the force reached a value of 1.10 kN (stage A). The first significant beam weakening appeared after gaining 2.15 kN (stage B). Later, the force continued to increase, but much slower. After reaching the maximum force of 2.94 kN (stage C), there was a sharp drop in its value. Visual observation indicates that the reason for this was a sudden drop in the flexural stiffness of the upper laminate or a sudden increase in the core crush zone under the applied force. In Fig. 7 it can be noticed that the beam thickness decreased right below the punch and increased in its direct neighbourhood. The test was stopped after reaching the cross-head displacement of 30 mm (stage D). There was no abrupt failure that ended the beam bending. At the end of the test, very large crushing of the core and significant deformation of

The Beam #2-SI bending process in the initial phase proceeded in a similar way as in Beam #1-SD. The identified linear behaviour limit of 1.10 kN (stage A) is the same. However, the first significant beam weakening (stage B) appeared much later, when the force reached the value of 3.02 kN. On the other hand, the maximum force of 3.27 kN (stage C) was achieved at about the same time as in Beam #1-SD, at the moment when the cross-head reached the displacement of about 16 mm. Right after reaching the maximum force, both Beams #1-SD and #2-SI experienced a sharp drop in force, in the case of Beam #2-SI it was the destructive moment (stage D). The core has been sheared throughout the entire width of the sample; see Fig. 6h and Fig. 8. The shear crack started under the top laminate, on the right side of the loading flat bar. Then, at an angle of about 45 degrees, it descended to the lower laminate. And finally, it caused a complete debonding of the core and the lower laminate. The test ended with a sudden beam failure.

The identified force of the linear behaviour limit (stage A) in Beam #3-HD is more than twice as high as in the previous beams and amounts to 2.70 kN. Furthermore, the behaviour of the beam was close to linear until the first weakening (stage B), which is 5.21 kN. Similarly to Beam #1-SD and #2-SI, after reaching the maximum force (stage C) of 6.43 kN, there was a sharp drop in its value. Visual observation indicates that the reason for this was a sudden delamination in the upper laminate that resulted in a local drop in its flexure stiffness on the right side of the punch; see Fig. 10a-b. Further, in the bending process, a second sharp drop in force was observed in about 600 s of the test duration. Fig. 10c-d shows how the damage propagated on the right side and how the new delamination occurred on the left side. There was no abruptly terminating the test failure during beam bending. The test was stopped after reaching the cross-head displacement of 30 mm (stage D). At the end of the test, very large crushing of the core and significant deformation of the upper laminate was observed, and the increase in force was very slow.

The process of bending Beam #4-HI in the initial phase proceeded in a similar way as in Beam #3-HD due to similar flexural stiffness. However, the force identified in the linear behaviour limit (stage A) has a much higher value of 3.70 kN. The same as in Beam #3-HD, the relationship between force and displacement was close to linear until the first weakening (stage B) of 7.74 kN. After this, the beam behaved nonlinearly up to the maximum force value (stage C) of 9.61 kN. Beam #4-HI had the highest load capacity of all the tests. After the maximum force was obtained, there was a sharp drop in its value. Visual observation indicates that the reason for this was the delamination of the laminate; see Fig. 11a-b. Despite the severe damage to the upper laminate, the beam still retained its partial load-bearing capacity until the core was sheared off, causing the final sudden failure (stage D); see Fig. 11c-d.

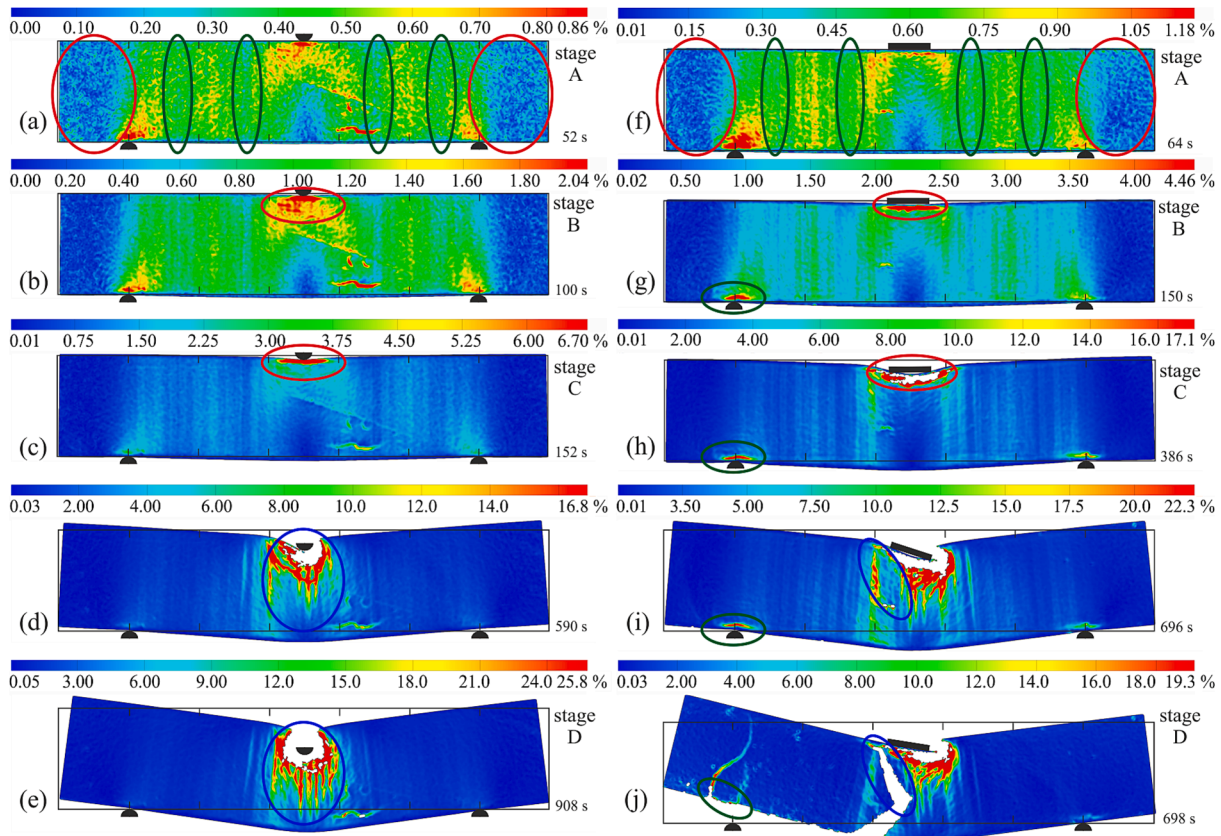
Fig. 15. DIC analysis results: (a)-(e) Beam #3-HD, (f)-(j) Beam #4-HI.

The selected results of the DIC analysis on the side surface of the beams made of 'hard' foam (Beams #3-HD and #4-HI) are presented in Fig. 15.

The sequence of results presented is the same as for the 'soft' foam beams. Initially, the field strain distributions in an early stage of bending (stage A) are presented in Fig. 15a and Fig. 15f, for Beams #3-HD and #4-HI, respectively. Similarly to previous results, strains in the core areas outside the support points almost do not increase (marked with red borders). The difference from the previous results is that the strains were much more clearly concentrated around the support points and the applied force from the early beginning of the bending process. The location of the welded surfaces in the core structure can be noticed, but in the 'hard' foam it is much less visible (marked with green borders). The moment of the first significant beam weakening (stage B) occurred when the strains in the core under force reached their value of the conventional elastic zone (2.0%) in Beam #3-HD (Fig. 15b) and was

close to the value of the strain corresponding to the compressive strength (5.3%) in Beam #4-HI (Fig. 15g). The application of the distributed force caused Beam #4-HI to weaken later, but this interval is not as long as in beams made of 'soft' foam. What is characteristic at this stage of the bending process in Beam #4-HI is a very asymmetric concentration of strains over the supports. The strain values above the left support were much higher (green border in Fig. 15g). They were growing with the

bending process and at the same time becoming more and more concentrated; see Fig. 15h-i. Finally, the core fractured at this point during the final failure; see Fig. 15j. This effect was not visible before its final destruction; see Fig. 16.

When the maximum force was reached (stage C), the concentration of strains around the applied force became even more apparent (red border in Fig. 15c and Fig. 15h). Their values exceeded the strain

Beam #3-HD before the end of the bending process experienced a second sudden drop in strength in 590 s of the test (Fig. 10c). The result for that moment is presented in Fig. 15d.

At the end of the test (stage D), a large crushing of the core occurred directly under the force (Fig. 15e and Fig. 15j). In Beam #4-HI, the strain distribution just before the final failure makes it possible to recognize the location of a further fracture (blue border in Fig. 15i). It actually occurred at the indicated place, leading to the final failure (blue border in Fig. 15j).
