**B. Majkowska<sup>1</sup>, W. Serbiński<sup>1</sup>, I. Skalski<sup>2</sup>**

<sup>1</sup>Gdansk University of Technology, Faculty of Mechanical Engineering, Department of Materials Science and Engineering, Gdansk, Poland

<sup>2</sup>Ship Design and Research Centre, Gdansk, Poland

## **ASSESSMENT OF CAVITATION EROSION DAMAGE OF LASER REMELTED THE SUPERSTON ALLOY**

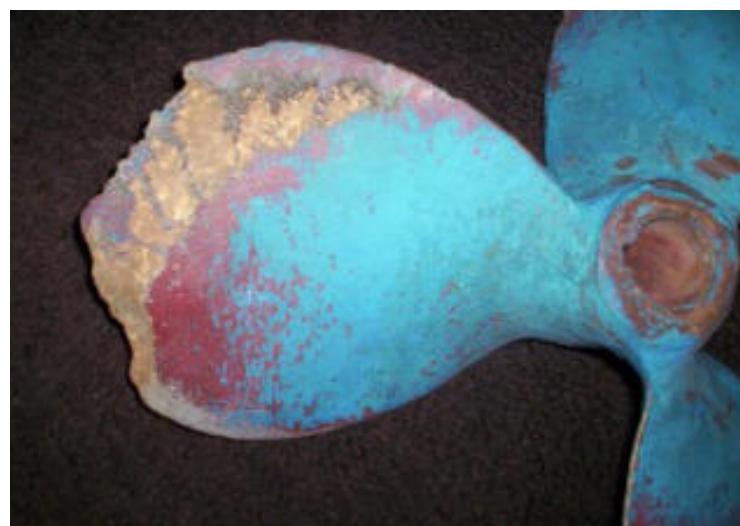
Degradation by the cavitation is very popular in ship propellers, usually made of copper alloys e.g. SUPERSTON alloy [1-3]. The cavitation phenomenon causes excessive vibrations, noise and finally degradation of the propeller blades (Fig. 1).

**Fig. 1.** Cavitation erosion damage of the ship propeller [4]

This phenomenon is the result of formation of vapour bubbles in the fluid in regions where the flow conditions produce fall of pressure and subsequent violent collapse of these bubbles on surface of these blades in neighbouring areas where the local pressure is higher.
