**D. Fydrych, T. Kozak**

## UNDERWATER WELDED JOINT PROPERTIES INVESTIGATION

### ABSTRACT

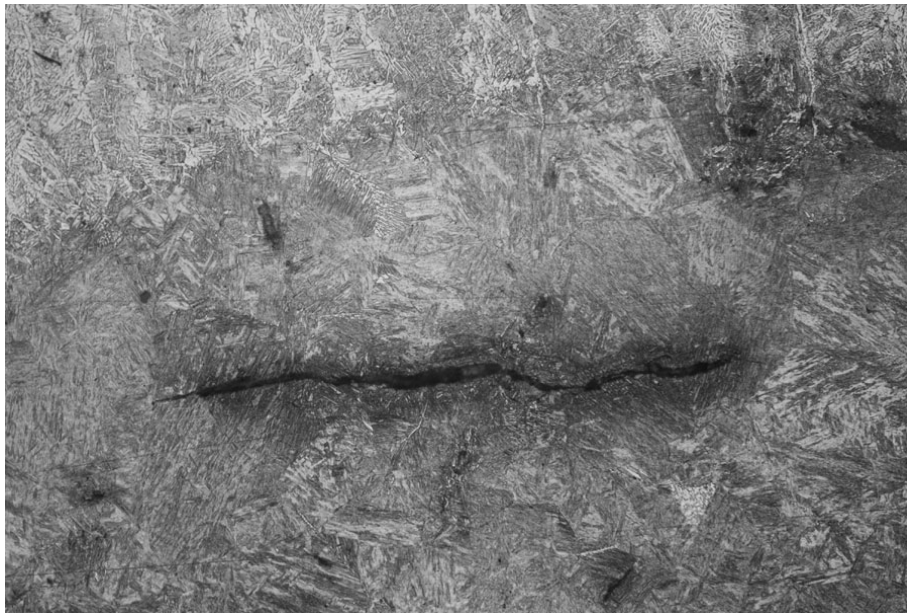
**Fig. 5.** Exemplary microphotograph of the cold crack in the bainite structure (magnification 200×)

Microscopic investigations of the structure of the tested joints were carried out using a metallographic microscope Neophot 32. An examination of the surface of metallographic sections revealed a number of cracks (fig. 5÷6). Fig. 5 shows micrograph taken from a metallographic section in the close proximity of cold crack path. In HAZ of investigated joints brittle structure - probably bainite is present. As can be seen from fig. 6 crack paths formed in specimen are irregular and branched. They run mainly perpendicularly to axis of implant specimen. In the range of investigation propagation of crack occurred both transgranularly and intergranularly.
