**D. Fydrych, T. Kozak**

Gdańsk University of Technology, Faculty of Mechanical Engineering, Department of Materials Technology and Welding, Gdańsk, Poland

## UNDERWATER WELDED JOINT PROPERTIES INVESTIGATION

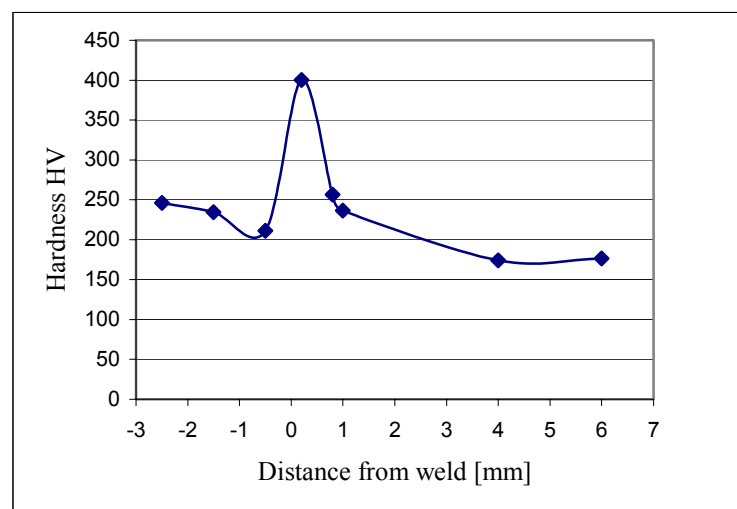
**Fig. 13.** Distribution of Vickers hardness on the investigated cross section:  $W_g=35$  l/min,  $e_L=15$  kJ/cm,  $HV_{max}=400$

Hardness penetration profiles were determined as Vickers hardness HV according to standard [8] in the way shown in fig. 12. The results of these experiments are collected in table 2 and presented in fig. 13÷15. The measured values of  $HV_{max}$  are in the range from 351 to 458 and are higher than the 350 HV level stated as typical for bainitic structure. The obtained results suggest that bainite or martensite transformations can
