# Acoustic emission for detecting deterioration of capacitors under aging

## Abstract

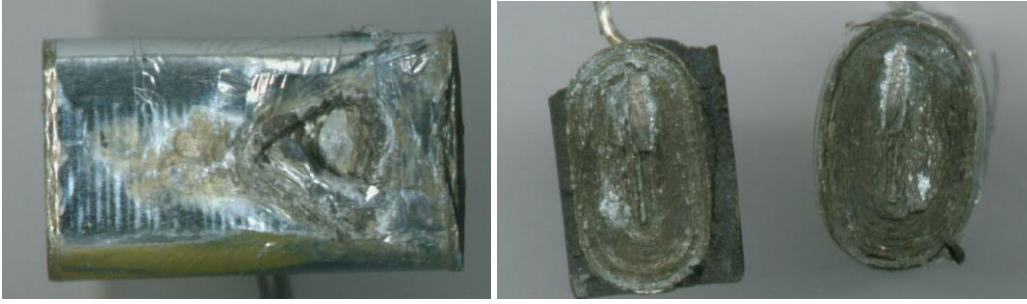
Figure 11

Fig. 11. Measurement results of the tested  $C_T=27$  nF capacitors: a) resistance isolation, b) power spectral density of the registered AE signal at 293 kHz.

The above mentioned results of correlation between the AE signal and other capacitors parameters are consistent with reasons of the capacitor failures observed after disassembling the failed capacitors (Fig. 11). The main reason of complete or substantial capacitance drop was a detachment of the metalized heads. Even harsh partial discharges were able to destroy only a part of the wound foil and consequently decreased the capacitance only slightly. We suppose that the detachment process is induced by local foil overheating due to intensive partial discharges and mechanical stress between the wound foil and the metalized head across a narrow boarder line (Fig. 12) . Additionally, partial discharges between the foil edge and the metalized heads lead to tiny metal losses only (Fig. 12) and cannot be considered as the main reason of the observed capacitor failure. Thus, we can suppose that capacitors of class X2 having intensive partial discharges would have shorter life span due to local overheating that induces process of metalized heads detachment. At the same time, a very thin dielectric is often completely destroyed locally when affected by partial discharges. The destroyed dielectric does not influence significantly on correlation between intensity of AE signal induced by partial discharges and resistance isolation of the tested capacitor. That result was observed experimentally for capacitors of class X2 having thin dielectric foil.
