**Aleksander Piwek\***

## *Dawny browar cystersów oliwskich*

### *The old brewery of Oliwa Cistercians*

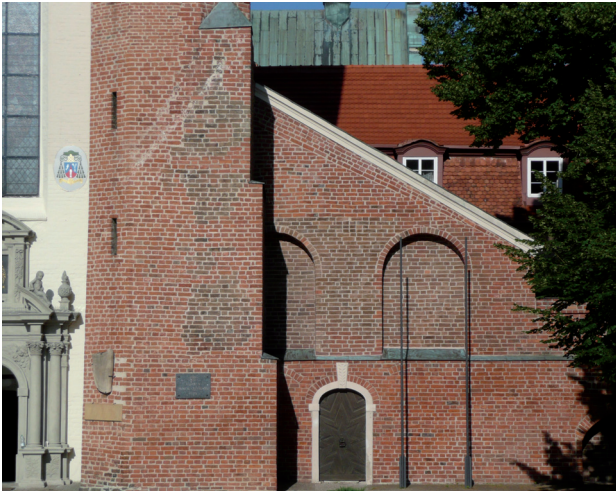
II. 1. Ściana wschodnia dawnego browaru przyległa do fasady kościoła pocysterskiego w Oliwie. Stan z 2010 r. (fot. A. Piwek)

Fig. 1. The eastern wall of the old brewery adjacent to the after-Cistercian church facade in Oliwa. Condition of 2010 (photo by A. Piwek)

Obecnie materialna pozostałość dawnego browaru – jego ściana wschodnia – od południa dochodzi do południowej klatki schodowej fasady. Zawiera ona po stronie zachodniej, w połowie swej wysokości, poziomy uskok. W partii poniżej niego występują drzwi z łękiem eliptycznym oraz wnęka zwieńczona łękiem odcinkowym. Znajdują się tutaj także fragmenty dwóch innych łęków. Powyżej poziomego uskoku jest duża wnęka z półkolistym łękiem, a także połowa podobnej wnęki, dochodząca do klatki schodowej. Ściana na długości około 9,8 m (licząc od klatki schodowej) zawiera skos zwieńczony profilowanym gzymsem. Jest on zakończony pionowym uskokiem

At present the remaining part of the former brewery – its eastern wall – in the south reaches as far as the southern staircase of the facade. At its mid-height in the western side it contains a horizontal fault. In a part below it there is the door with an elliptical arch and a niche surmounted by a segmental arch. There are also fragments of other two arches. Above the horizontal fault there is a large niche with a semicircular arch and a half of a similar niche reaching the staircase. The wall at a length of 9.8 m (starting from the staircase) has a bevel surmounted by a profiled cornice. It is finished with a vertical fault of 1 meter in height behind which there is a lower part of the wall with the next slightly protruding cornice.

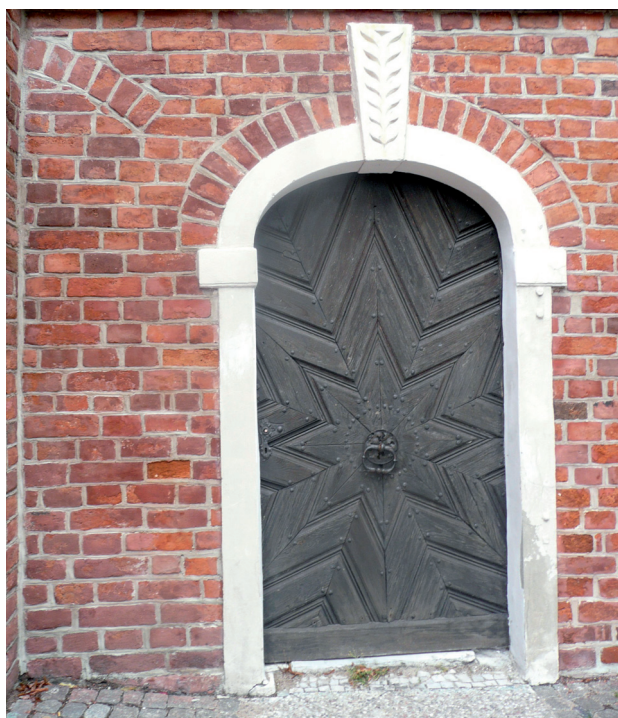
Il. 7. Dawne wschodnie wejście do parteru dawnego budynku gospodarczego po zmianach dokonanych w 1824 r. (fot. A. Piwek)

Fig. 7. Former eastern entrance to the ground floor of the old utility building after changes in 1824 (photo by A. Piwek)

There were considerable changes introduced to the brewery in the modern times. They can be seen on a detached wall in a part below the horizontal fault from the staircase up to a broken joint at the northern niche edge as well as in a small strip south of this niche. An entrance arch also belong to this part. The brick sizes here are as follows: 29.0–30.5×13.5–14.5×6.5–7.2 cm, 10c = 101 cm, and they are laid according to the modern brickwork (Fig. 7).
