## APPLICATION OF GUIDED WAVE PROPAGATION IN DIAGNOSTICS OF STEEL BRIDGE COMPONENTS

M. RUCKA<sup>1</sup>, B. ZIMA<sup>2</sup>, R. KĘDRA<sup>3</sup>

*Keywords:* non-destructive testing, damage detection, condition assessment, guided wave propagation, steel bridges

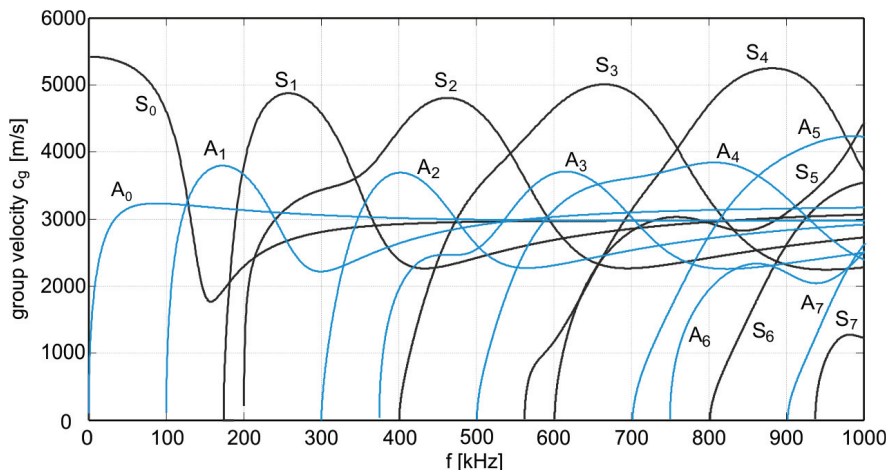
Fig. 2. Group velocity dispersion curves for steel plate of thickness  $d = 16$  mm ( $E = 210$  GPa,  $\rho = 7850$  kg/m<sup>3</sup>,  $\nu = 0.3$ )

The solutions of the Rayleigh-Lamb transcendental equations are not straightforward, because of dependence of  $q$  and  $p$  on the wavenumber  $k$ . Solutions of these equations can be presented as so called dispersion curves. Group velocity dispersion curves for a steel plate of thickness  $d = 16$  mm are presented in Figure 2. It can be seen that in the range from 0 kHz to 100.2 kHz only two fundamental modes exist. Above 100.2 kHz the antisymmetric mode  $A_1$  appears, while the symmetric mode  $S_1$  appears above 174.4 kHz. The knowledge of dispersion curves enables a proper choice of the frequency of the excited wave for damage detection purposes. The frequency of the input wave should not exceed the frequency where the second mode appears.

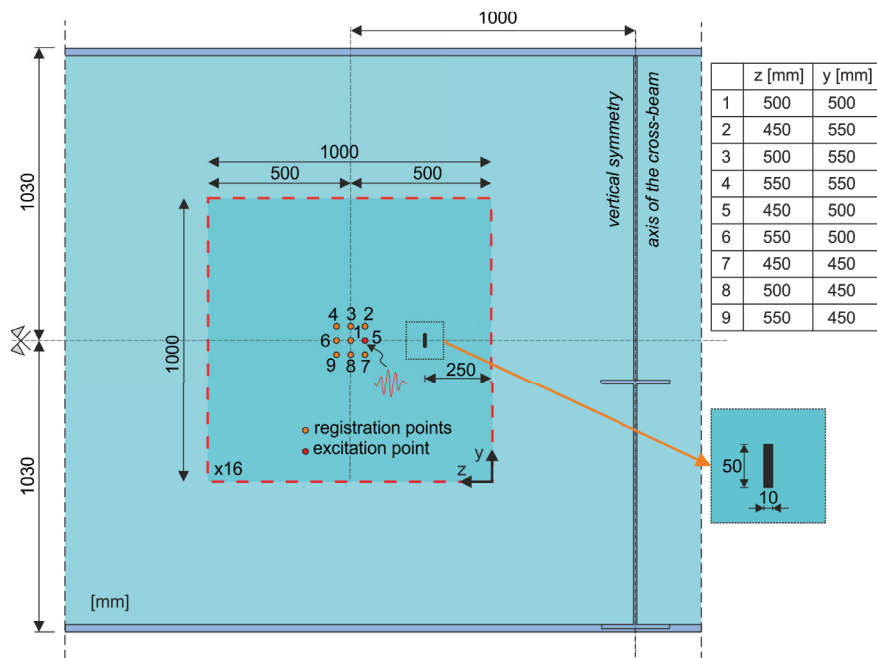
Fig. 4. Geometry of investigated part of plate girder

Two the most typical damage scenarios of the bridge girder were considered: damage of the plate girder because of the occurrence of corrosion and the reduction of the load capacity of the bolted splice due to the bolt loosening or fracture of fasteners in the threaded area. Damage of the plate girder was considered as a long notch through the plate with a relatively small surface area according to the girder area. The defect with dimensions 50 mm × 10 mm was located 250 mm from the plate edge (Figure 4).

part with positions of excitation and registration points is illustrated in Figures 4 and 5 for the plate girder and the bolted splice connection, respectively.

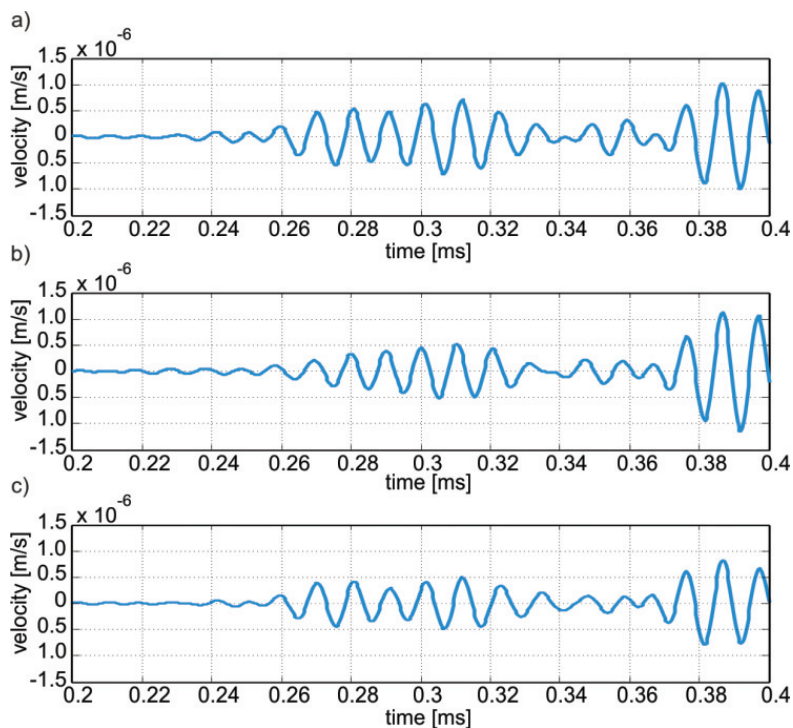
Fig. 12. Set of numerical wave propagation signals registered in bolted connection: a) damage scenario #1 (pristine joint), b) damage scenario #2, c) damage scenario #3

The examples of velocity signals received at point A in the case of damage absence (pristine joint) and after removing selected bolts (damage scenarios #2 and #3) are shown in Figure 12. There is no clear qualitative difference between obtained signals.

In all cases in the time interval 0.21–0.35 ms a clearly separate wave packet can be observed. However, comparing the signal registered for damage scenario #1 with scenarios #2 and #3, the decrease in signal amplitudes in the initial period of time (0–0.35 ms) can be seen. In order to compare the quantitative characteristics of propagated waves, energies of recorded velocity signals were determined. The signal energy  $E_s$  in the time interval  $\langle t_a; t_b \rangle$  can be defined as:

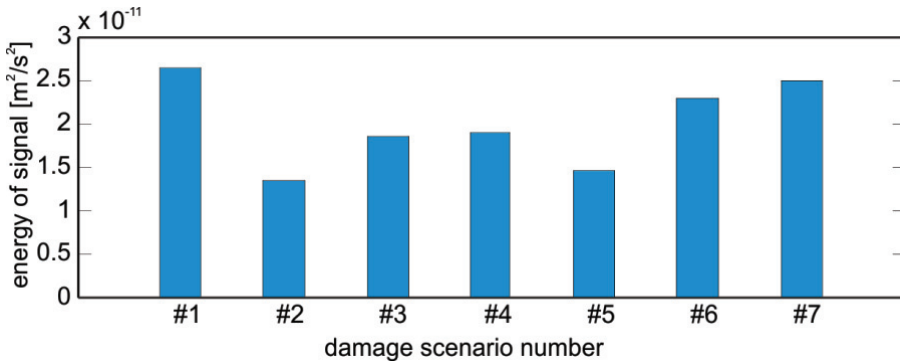
Fig. 13. Energy of numerical signals registered in bolted connection in time interval 0–0.35 ms for different damage scenarios

where  $x_i$  is the signal value at the discrete time instant  $t_i$ . The values of signal energies calculated in the time interval 0–0.35 ms are shown in Figure 13. This interval was chosen for comparing the energy of the separated wave packet. For all cases of bolt loosening scenarios a clear decrease in the amplitude was observed. The lower energy values (49%; 29,7 %; 28% and 45 %) were obtained when bolts lying directly on the section connecting the actuator and the sensor were removed (damage scenarios #2, #3, #4 and #5, respectively).

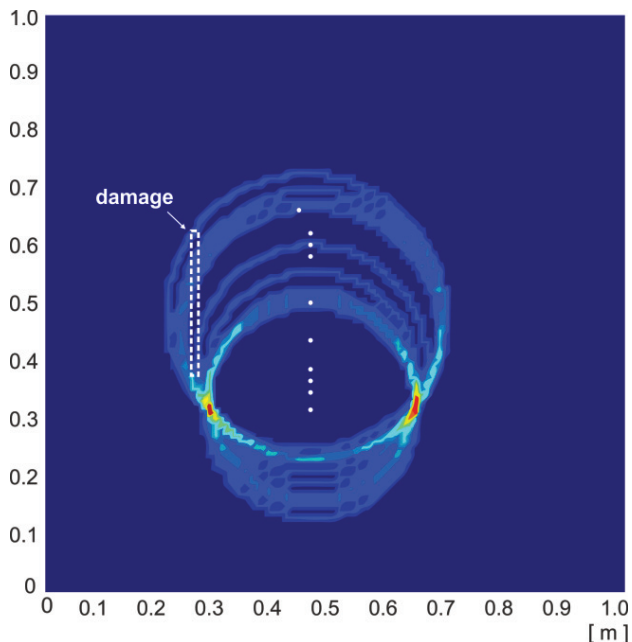
Fig. 17. Damage map for steel plate calculated on the basis of experimental wave propagation signals

The examples of obtained time signals are presented in Figure 16. It is distinctly visible that reflection from damage can be detected unambiguously. On the basis of all registered signals and occurred reflections, the damage map was created (Figure 17). The obtained map is symmetrical but one shifted registration point (point no. 10) let to assess of which side of the plate the notch lies. The ellipses intersect near the one end of damage. However, for such configuration of measurement points it is very difficult to assess the exact size of the crack.
