APPLICATION OF GUIDED WAVE PROPAGATION IN DIAGNOSTICS  
OF STEEL BRIDGE COMPONENTSM. RUCKA<sup>1</sup>, B. ZIMA<sup>2</sup>, R. KĘDRA<sup>3</sup>

The study deals with application of guided wave propagation in non-destructive diagnostics of steel bridge. The paper contains results of numerical analyses for a railway bridge. The ability of damage detection using guided Lamb waves was demonstrated on the example of a part of a plate girder as well as a bolted connection. In addition, laboratory tests were performed to investigate the practical application of wave propagation for a steel plate and a prestressed bolted joint.

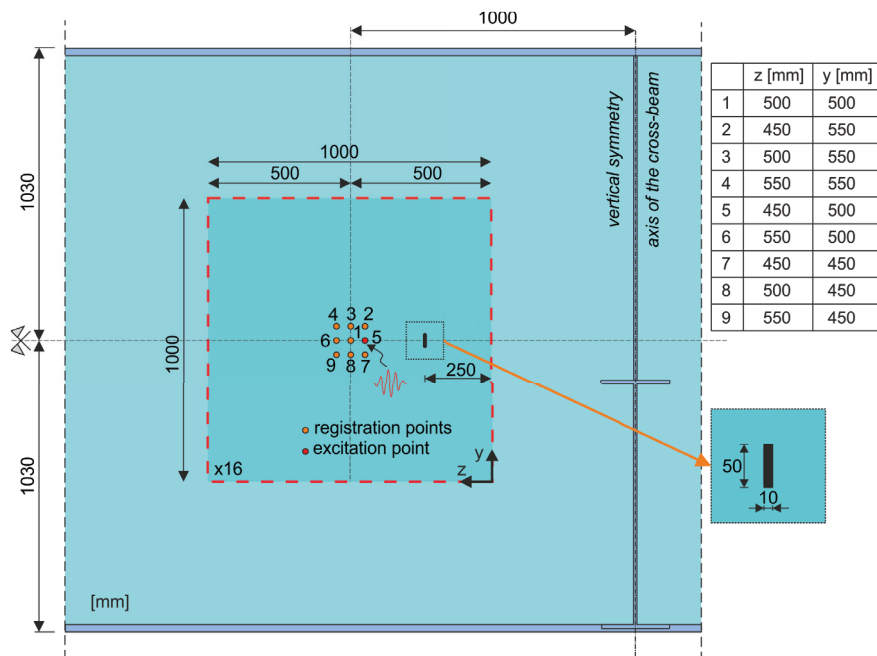
Fig. 4. Geometry of investigated part of plate girder

Two the most typical damage scenarios of the bridge girder were considered: damage of the plate girder because of the occurrence of corrosion and the reduction of the load capacity of the bolted splice due to the bolt loosening or fracture of fasteners in the threaded area. Damage of the plate girder was considered as a long notch through the plate with a relatively small surface area according to the girder area. The defect with dimensions 50 mm × 10 mm was located 250 mm from the plate edge (Figure 4).

part with positions of excitation and registration points is illustrated in Figures 4 and 5 for the plate girder and the bolted splice connection, respectively.

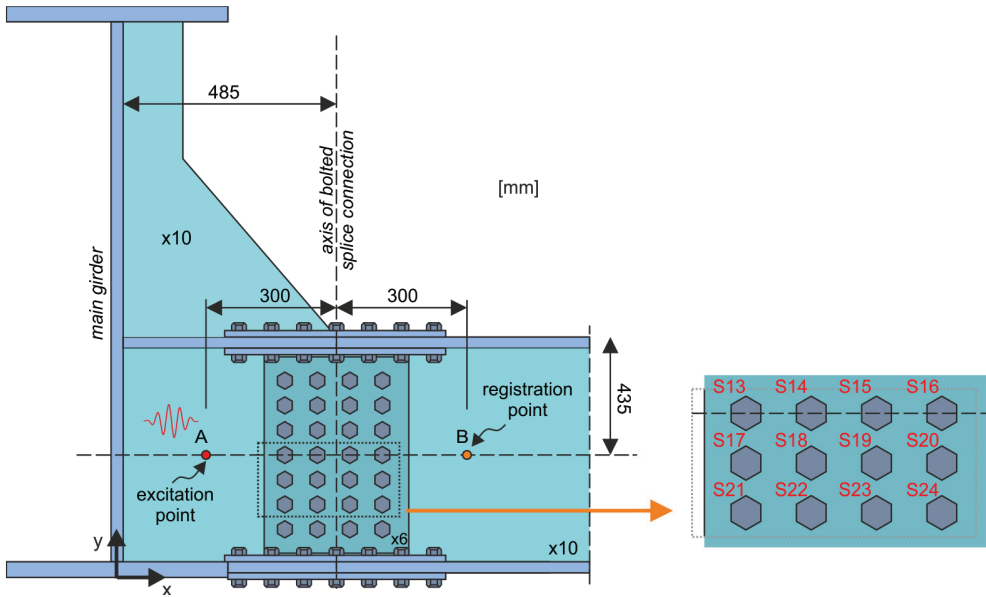
Fig. 5. Geometry of investigated bolted splice connection

For the bolted joint seven scenarios of damage were examined. A detailed list of considered scenarios of fasteners failure is given in Table 2 and the numbering of bolts is shown in Figure 5. Scenario #1 was a pristine joint. In scenarios #2 to #7 loosening of a single fastener was analysed. In damage scenarios #2 to #5 fasteners on the horizontal axis of bolted splice were removed. In damage scenarios #6 to #7 loosening of fasteners from the column closest to the main girder was simulated.

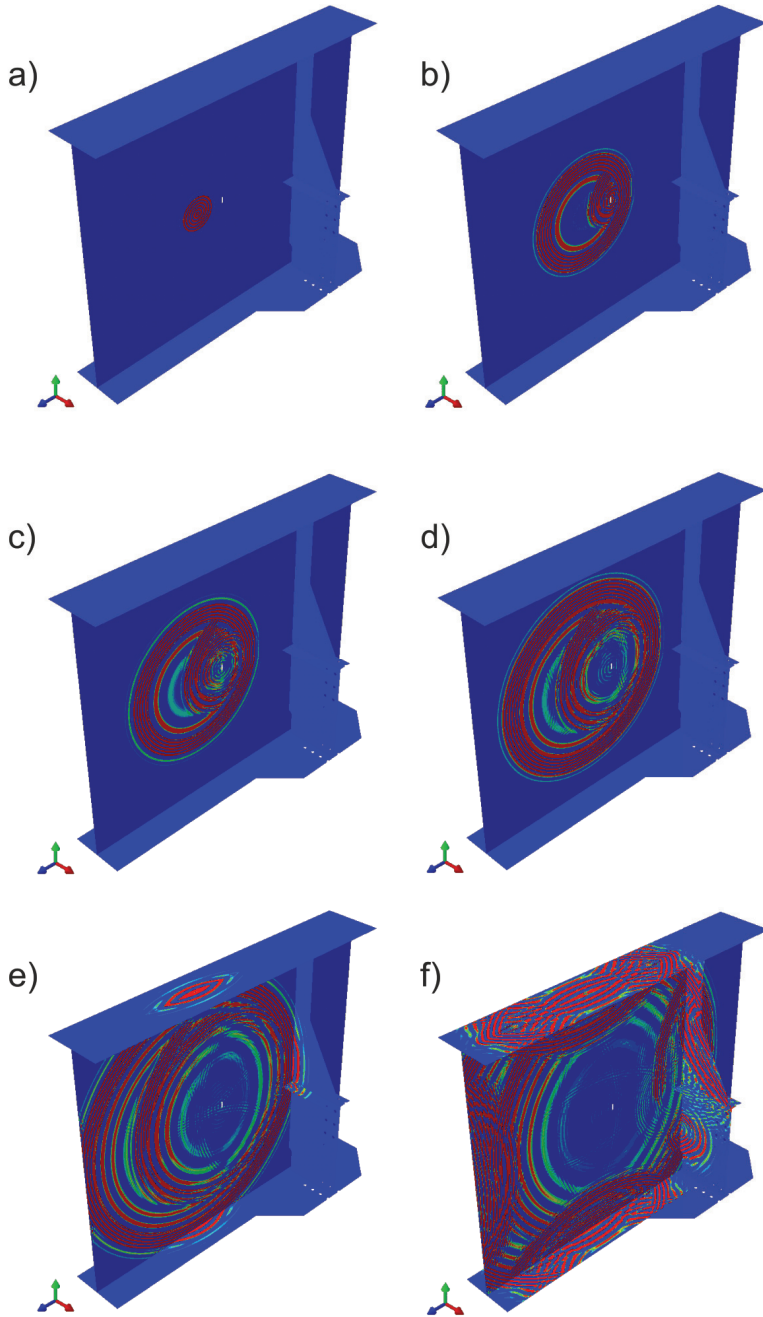
Fig. 6. Maps of velocity field propagated in plate girder at selected time instances: a) 0.05 ms; b) 0.15 ms; c) 0.20 ms; d) 0.25 ms; e) 0.35 ms; f) 0.45 ms

Visualization of the propagating wave in the form of maps of the velocity field (perpendicular to the surface of the plate) at the selected time instances is presented in Figure 6. In Figures 6b and 6c the disturbance reflection from the notch is visible and in Figure 6f wave with much higher energy is reflected from the edges. In the case of damage with small dimensions, the differences between amplitude values reflected from edges and reflected from damage are very high. Thus, a general problem of non-destructive testing based on the phenomenon of guided wave propagation is to extract appropriate information from the signal. Individual reflections interfere with each other that cause additional problems with interpretation of results. If the notch is located closer to the edge, a risk that the reflection from it would be unnoticed without special techniques of signal processing or without checking the same damage scenario for different configurations of sensors arises.

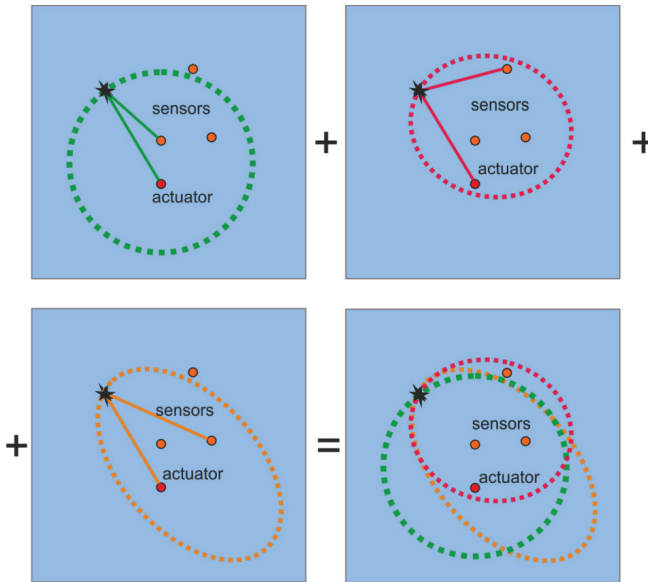
Fig. 8. Algorithm for damage detection in plate based on time-of-flight

It can be noticed that the distance is equal to the sum of position vectors in the ellipse which presents all possible damage locations in a plate (Figure 7). Because from a single signal only one value of the time-of-flight can be extracted, one solution in the form of the ellipse can be plotted. To obtain accurate position of damage, at least three ellipses must intersect with each other. A simple scheme of the procedure of determining the location of damage for configuration of three sensors and one actuator is presented in Figure 8.

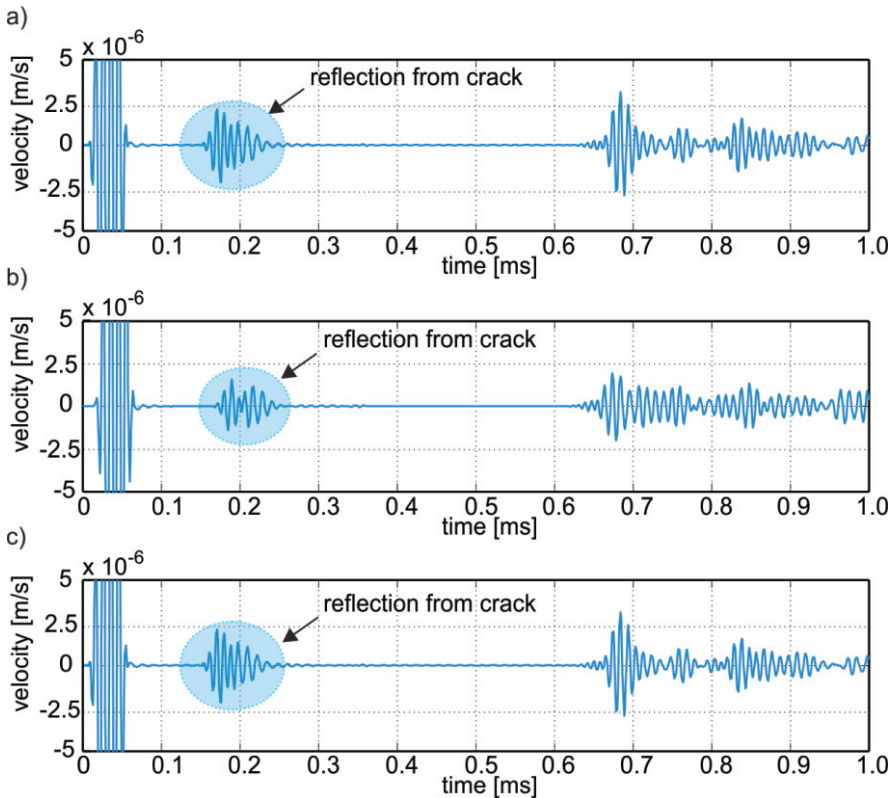
Fig. 9. Set of numerical wave propagation signals registered in plate girder by:  
a) sensor no. 3, b) sensor no. 6, c) sensor no. 8

In numerical analyses of damage detection two configurations of sensors were applied. In configuration #1 four PZT transducers were used: transducer no. 1 was applied as the actuator and transducers no. 3, no. 6, no. 8 were applied as sensors for registration of waves. In configuration #2 nine PZT transducers were used: transducer no. 5 was applied as the actuator and transducers of numbers from 1 to 4 and from 6 to 9 were applied as sensors (cf. Figure 4). Wave propagation signals for configuration #1 are shown in Figure 9. The reflections from the notch were identified and indicated. Then the three signals from Figure 9 were used in the procedure of creating a damage map. The damage map (Figure 10a) shows location of damage. The colours on the map are a measure of the probability of damage location in a particular place. Only these positions where all plotted ellipses intersect with each other should be taken into account as possible damage locations. Other intersection areas result from the geometrical way of solving the problem and they do not represent any characteristic feature of the testing structure.

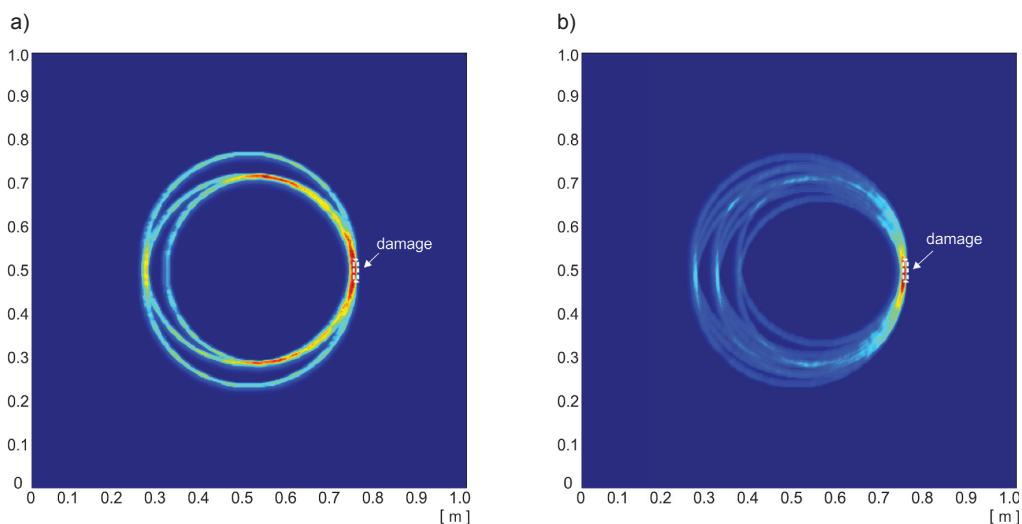
Fig. 10. Damage map for plate girder calculated on the basis of numerical wave propagation signals registered by: a) three sensors (configuration #1); b) eight sensors (configuration #2)

The sensitivity of damage localization algorithm is strictly correlated with the number of sensors and their configuration. The bigger number of signals is used during analysis, the more accurate results are obtained. To show the influence of the number of sensors which take part in investigation, the same damage scenario with another configuration of sensors (configuration #2) was examined. The location of the excitation point was shifted from the plate centre and additional registration points were taken into account. The damage map obtained for eight signals is presented in Figure 10b. The identification of damage position is much more precise than for configuration #1 as a result of non-symmetrical configuration of sensors and a large number of signals that were used in the process of damage map creation.

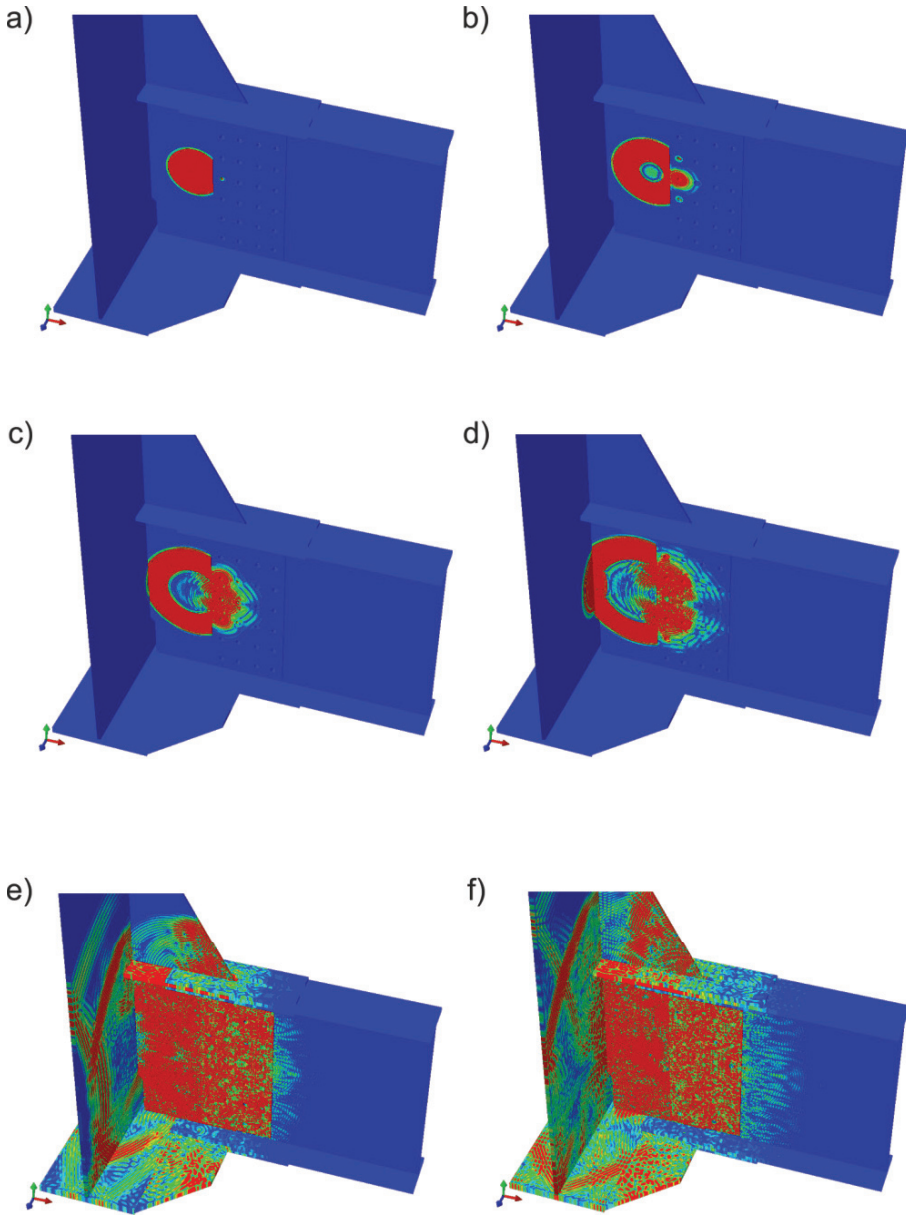
Fig. 11. Maps of velocity field propagated in bolted joint of cross beam at selected time instances: a) 0.048 ms; b) 0.68 ms; c) 0.88 ms; d) 0.108 ms; e) 0.26 ms; f) 0.32 ms

Visualization of propagating waves in the bolted joint at the selected time instances is presented in Figure 11. The wave packet was excited in the cross beam web, near the connection with the main girder. When the wave reached the location of the connection it propagated in the overlay plates by bolts. All connection points became sources of new waves and then disturbances passed into the attached part of the cross beam. Results of numerical analyses indicated strong scattering of waves in the bolted joints area.

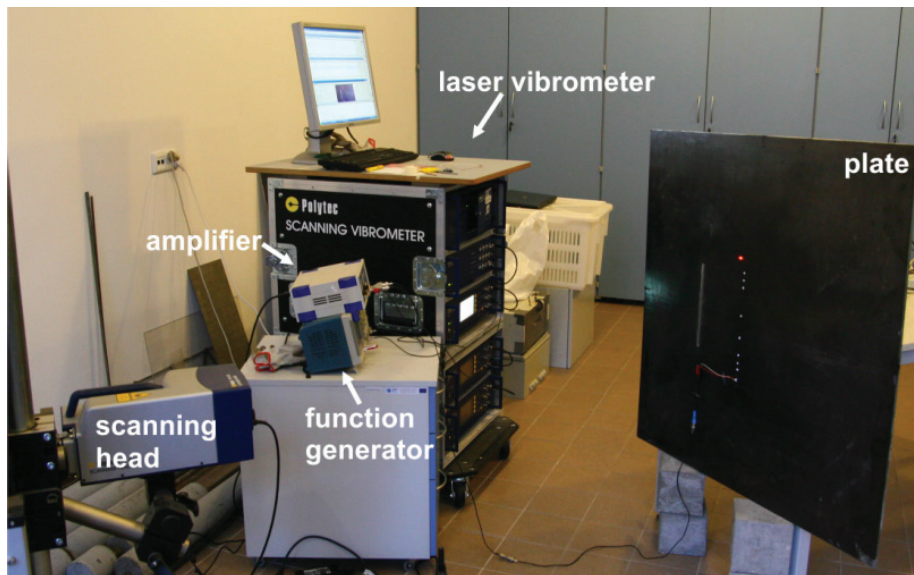
Fig. 14. Instrumentation for measurements of out-of-plane waves in steel plate

A steel plate of length  $L = 1000$  mm, width  $B = 1000$  and thickness  $d = 5$  mm was considered as a testing structure. The experimentally determined mass density  $\rho$  was equal  $7872 \text{ kg/m}^3$ , the modulus of elasticity  $E$  and the Poisson's ratio were 205.35 GPa and 0.28, respectively. Damage in the plate was introduced as a change of plate thickness on a rectangular area of  $250 \text{ mm} \times 12.5 \text{ mm}$ . The depth of the defect was equal to 2.5 mm. The photo of the experimental setup is given in Figure 14. Lamb waves were generated by the piezoelectric actuator Noliac CMAP11. The excitation was in the form of a five cycle sine modulated by the Hanning window. The value of the excitation frequency was equal to 150 kHz. Velocity signals  $v(t)$  (i.e. components perpendicular to the plate surface) were recorded by the scanning laser vibrometer Polytec PSV-3D-400-M. Measurements were characterized by a very high degree of repeatability.

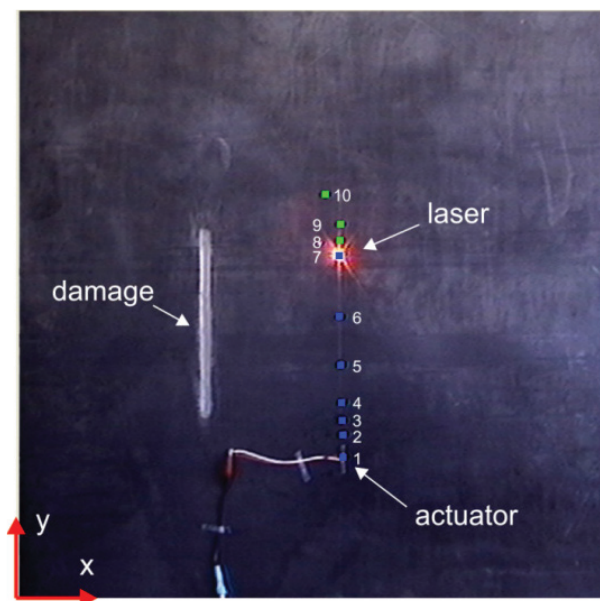
x [mm]	y [mm]
1	457.5	315
2	457.5	345
3	457.5	365
4	457.5	385
5	457.5	435
6	457.5	500
7	457.5	580
8	457.5	600
9	457.5	620
10	437.5	660

Fig. 15. Configuration of measurement points and actuator

During experiment one spatial configuration of measurement points was considered. The signal was generated at point no. 1 and sensed at points no.1 to 10. Almost all registration points were situated on a straight line, as it is shown in Figure 15. One point shifted from that line was required to assess the direction from which wave propagated. The difference between the value of the time-of-flight for point no. 9 and point no. 10 allowed avoiding the problem of the symmetry of results.

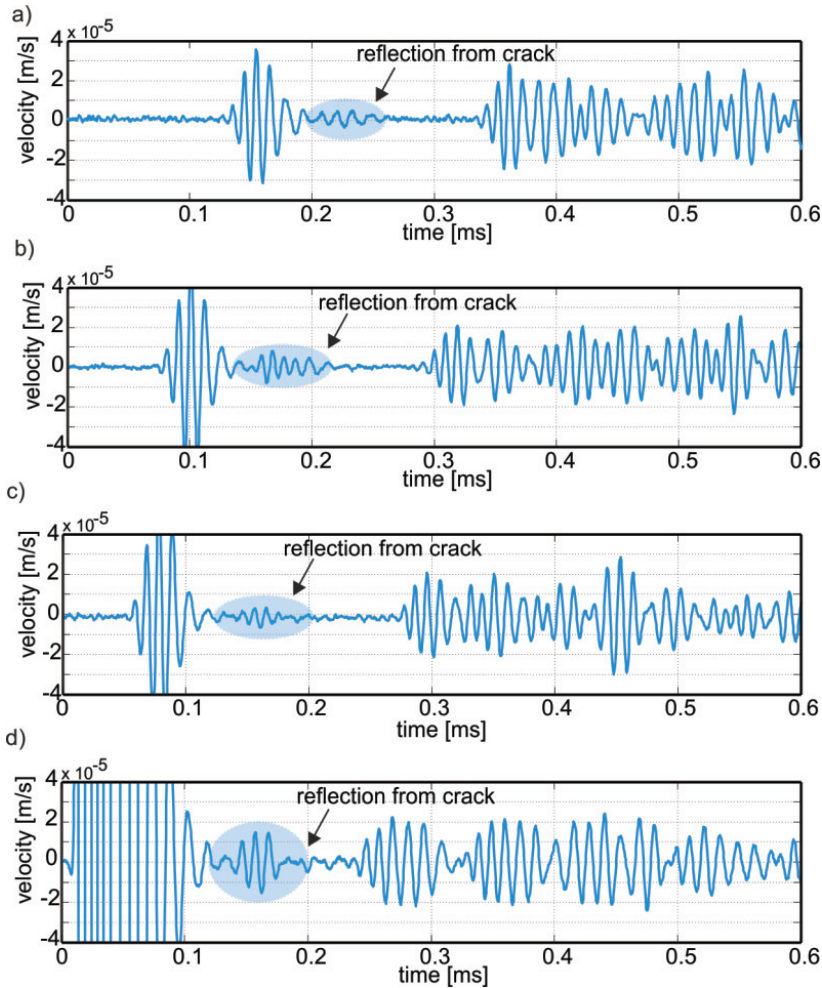
Fig. 16. Set of experimental wave propagation signals registered in steel plate: a) point no. 10; b) point no. 6; c) point no. 5; d) point no. 1

The examples of obtained time signals are presented in Figure 16. It is distinctly visible that reflection from damage can be detected unambiguously. On the basis of all registered signals and occurred reflections, the damage map was created (Figure 17). The obtained map is symmetrical but one shifted registration point (point no. 10) let to assess of which side of the plate the notch lies. The ellipses intersect near the one end of damage. However, for such configuration of measurement points it is very difficult to assess the exact size of the crack.

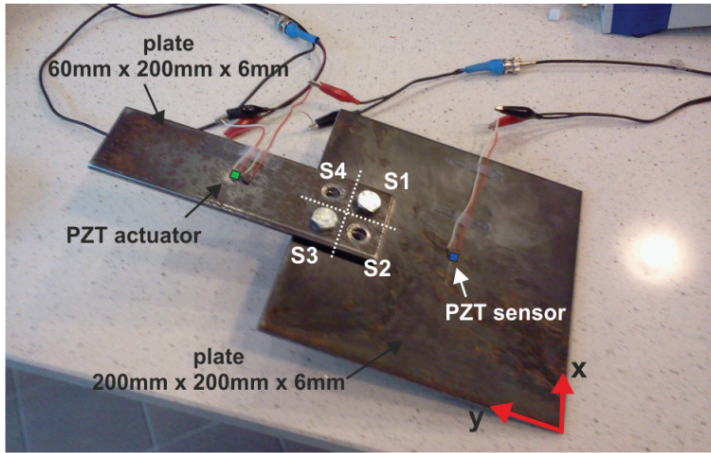
x [mm]	y [mm]
S1	113	157
S2	87	157
S3	87	183
S4	113	183

Fig. 18. Model of bolted lap joint and configuration of sensor and actuator

The research was conducted for a single lap bolted joint. It was made of two steel plates  $6 \text{ mm} \times 60 \text{ mm} \times 200 \text{ mm}$  and  $6 \text{ mm} \times 200 \text{ mm} \times 200 \text{ mm}$ . In each plate four circular holes of 11 mm diameter were cut to assemble with the use of bolts (S1 to S4, as shown in Figure 18). Bolts of 10 mm diameter and 80 mm length were made with steel of class 8.8. The value of bolt torque moment applied to bolts with the use of a torque wrench was equal to 10 Nm. Guided waves were excited and registered in the transverse direction by PZT actuators Noliac CMAP11 of dimensions  $5 \text{ mm} \times 5 \text{ mm} \times 2 \text{ mm}$  bonded at two side of the connection (Figure 18). The arbitrary waveform generator Tektronix AFG 3022 with the high voltage amplifier EC Electronics PPA 2000 generated the excitation voltage signal which was converted into a mechanical force by the PTZ actuator. The digital oscilloscope ScopeDAQ was used to register signals with a sampling frequency of 2 MHz.

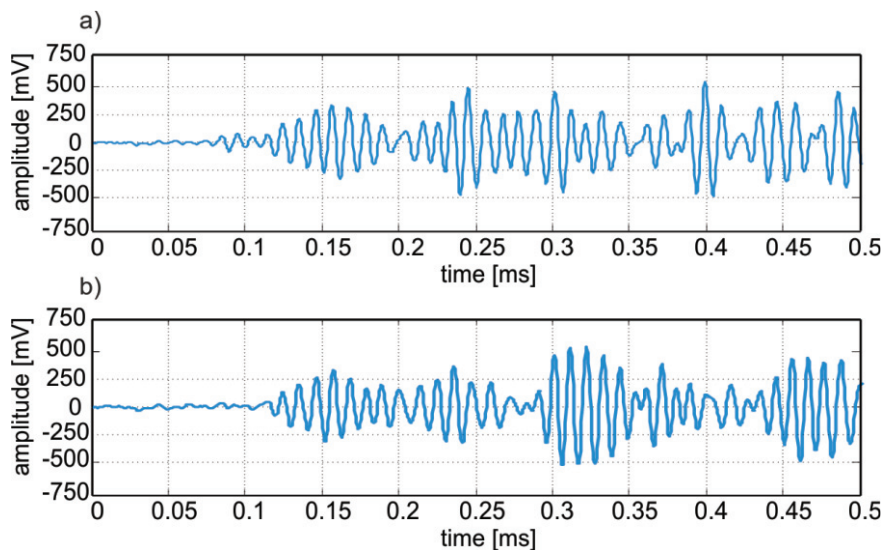
Fig. 19. Set of experimental wave propagation signals registered in bolted connection: a) damage scenario #1; b) damage scenario #2

Four damage scenarios of bolt loosening were considered (Table 3). Damage scenario #1 was a pristine joint with four bolts. In next scenarios (#2, #3, #4) one bolt (S2), two bolts (S3, S3) and three bolts (S2, S3, S4) were removed from the joint, respectively. The experimental results in the form of time signals of propagating waves for damage scenarios #1 and #2 are shown in Figure 19. The variation of these two signals is similar, but some qualitative changes can be observed. After removing one bolt (S2) the maximum amplitude of the signal in the time interval 0–0.3 ms decreased by 2%. For the pristine joint the separation of the wave packet in the time interval 0.1–0.2 ms can be observed. However, in damage scenario #2 this separation is not visible due to the interference of waves.

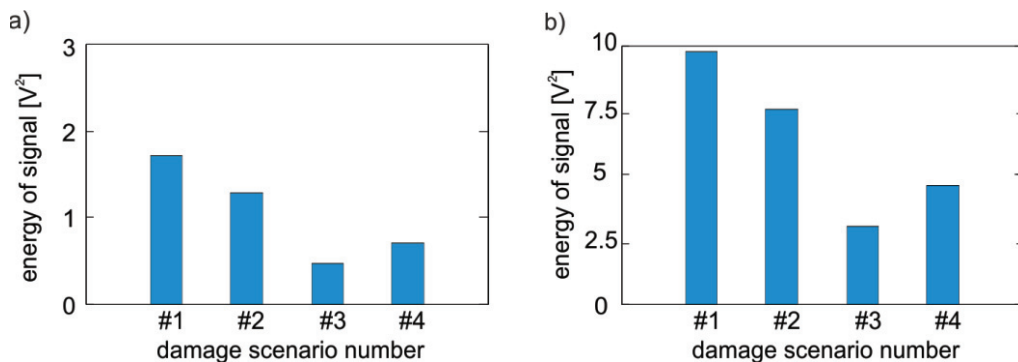
Fig. 20. Energy of experimental signals registered in bolted connection for different damage scenarios: a) in time interval 0–0.2 ms; b) in time interval 0–0.25 ms

The quantitative characteristics of the output signals for different damage scenarios were determined by the calculation of signal energies (Figure 20). Comparing energies of signals in time intervals 0–0.2 ms and 0–0.25 ms for all realised damage scenarios

a decrease in the signal energy can be observed with reference to the pristine joint. The scale of decrease was dependent on the position of the removed bolt. The results indicated that the damage index based on the energy of registered wave propagation signals gives a possibility for the state monitoring of the connection. However, it is worth noting that subsequent removing of fasteners does not always lead to a decrease in the signal energy values. It can be seen by comparing the signal energy for damage scenarios #3 and #4.
