M. Landowski, K. Imielińska

Gdańsk University of Technology, Faculty of Mechanical Engineering, Narutowicza 11/12,
80-233 Gdańsk, Poland
mlandowski@gmail.com

IMPACT BEHAVIOUR OF GLASS FIBRE /EPOXY COMPOSITES WITH NANO-ENHANCED RESIN AFTER WATER EXPOSURE

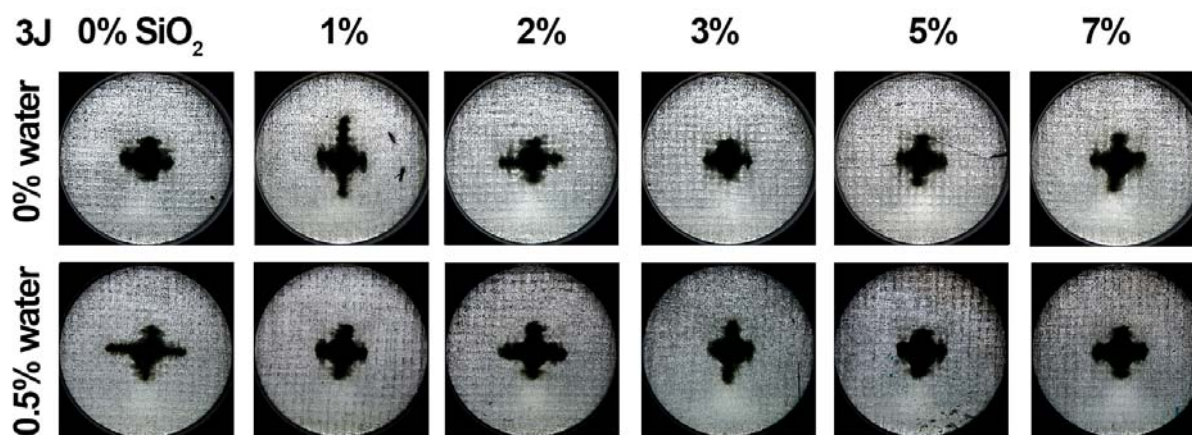
Fig. 3. Impact damage in laminates modified with 1-7% nanoparticles in dry (upper row) and wet (0,5% water absorbed)

Fig. 3 illustrates impact damage in laminates modified with 1-7% nanoparticles in dry (upper row) and wet (0.5% water absorbed). The shape of impacted zone differs slightly due to different failure modes, however impact damage area (Fig. 4) is 10-15% lower for unmodified specimens. The improvement in the behaviour of 3% SiO₂ modified specimens is observed in terms of impact damage area for “wet” (1-2% water absorbed) specimens.
