Influence of laser processing of the low alloy medium carbon structural steel on the development of the fatigue crack

Marek Szkodo¹, Anna Bień²,

¹ Mechanical Engineering Faculty, Gdansk University of Technology, Narutowicza 11/12, 80-233 Gdańsk, Poland, mszkodo@pg.gda.pl

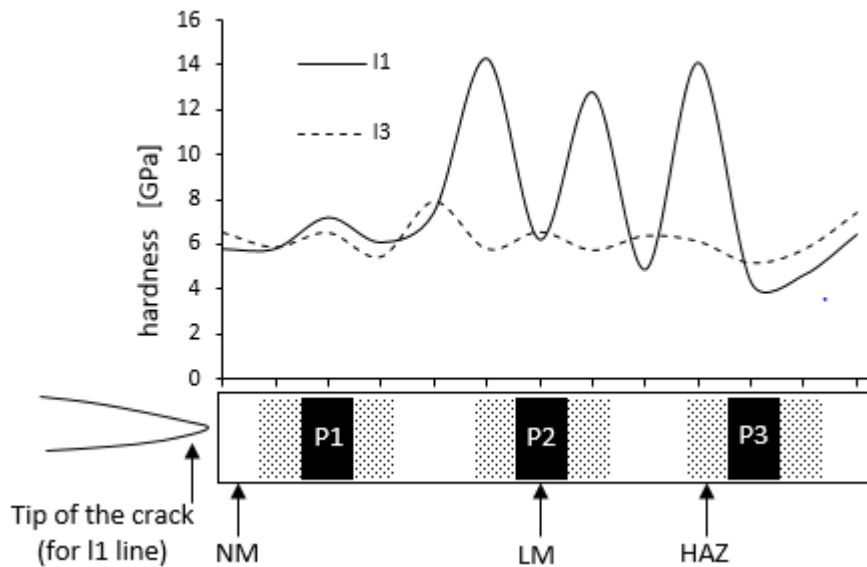
Fig. 8. The hardness at a distance of 1 mm (I1) and 10 mm (I3) from the edge of the fracture measured at a constant depth of 5 μm (NM – native material, LM – laser melted, HAZ – heat affected zone). The measurement points are shown in Fig. 2

treatment cannot explain the stopping crack propagation during fatigue test. In fact, stopping the development of crack occurred in the material area outside of the melted path and HAZ. The fatigue crack was blocked in areas of the unchanged microstructure and therefore the effect of microstructure on crack growth was not analyzed. Analysis of the microstructure obtained by the laser treatment was performed in order to find a correlation between the depth of melted material and the value of the stress generated in the base material just before the fatigue crack. In order to explain the reason for the crack stopping, micro-hardness tests along two lines (I1 and I3) were performed (see Fig. 2). Fig. 8 presents the results of micro-hardness test. As is apparent from Fig. 8, the measured hardness along I1 and I3 line is similar. However, the hardness in the HAZ is much higher for P2 and P3 paths at a distance of 1 mm from the edge of the fracture than the hardness in the same areas at a distance of 10 mm from the fracture edge. For the P1 path that was the closest to the front of the crack, hardness of the native material (NM), HAZ and laser melted (LM) steel were similar and lie

within 6 - 8 GPa. For this path, described dependency occurred for both I1 and I3 lines. During the hardness test, plastic and elastic work of deformation of the tested material were also measured (Fig. 9). The portion of elastic work W_{el} (defined as in Fig. 10) relative to the total work of deformation can be a qualitative indicator of the residual stress. Fig. 9 shows the change in the elastic deformation
