# Types of Surface Impurities versus the Quality of Brazed Joints

**Abstract:** Brazing is one of the primary joining processes increasingly often applied in industry. Because of their mechanical properties, overlap joints are particularly popular when making brazed structures. The use of brazed joints in structures of critical importance requires that particular attention be paid to joint quality, e.g. by the appropriate cleaning of surfaces to be joined. The article presents results of non-destructive tests of brazed joints made in steel S235JRG2. Surfaces used in the tests were deliberately contaminated to simulate the presence of welding imperfections. Afterwards, the test specimens were subjected to non-destructive (visual and radiographic) tests aimed to determine the effect of surface impurities on the quality of brazed joints.

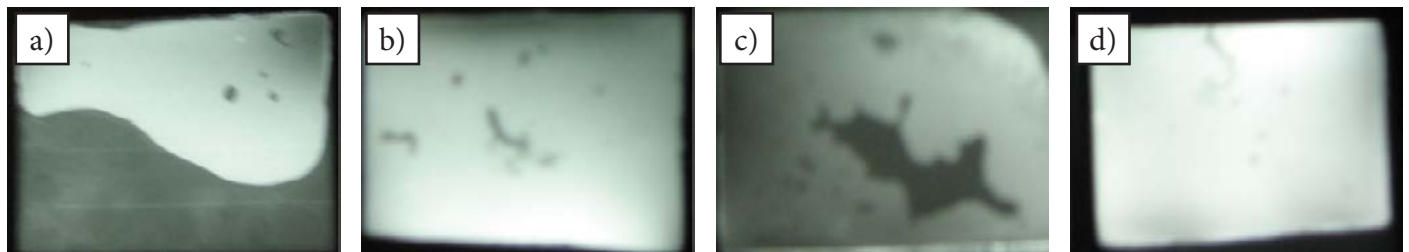
Fig. 3. Radiographic test results; a) specimen 1 – lack of the flux, a complete joint covering approximately 50% of the surface subjected to brazing, inclusions, oval gas cavities, b) specimen 3 – improperly cleaned surface, a longitudinal gas cavity having a length of 5 mm in its central part and oval gas cavities, c) specimen 8 – immersed in water, a gas cavity having a length of 20 mm and a width of up to 7 mm, oval gas cavities, d) specimen 10 – made properly, a longitudinal gas cavity having a length of 3 mm, small inclusions

Pb foil (0.05 mm) made by Kodak. The tests were performed using the following parameters: FFD = 700 mm, U = 130 kV, I = 4,5 mA and an exposure time of 3 minutes. The radiographic tests revealed that the most numerous imperfections were present in the specimens, the surfaces of which were intentionally contaminated with pieces of copper foil. The above-named inclusions precluded the formation of a complete joint and led to the formation of smaller inclusions located nearby. A similar result was observed in relation to specimen no. 9 provided with the flux used in the SAW method. The above-presented results confirmed the

results of the previous tests concerning the effect of impurities during joining processes [15]. Figure 3 presents examples of radiographic test results. Table 3 presents the test results in relation to all of the specimens.
