Non-Destructive Assessment of Masonry Pillars using Ultrasonic Tomography

Abstract: In this paper, a condition assessment of masonry pillars is presented. Non-destructive tests were performed on an intact pillar as well as three pillars with internal inclusions in the form of a hole, a steel bar grouted by gypsum mortar, and a steel bar grouted by cement mortar. The inspection utilized ultrasonic stress waves and the reconstruction of the velocity distribution was performed by means of computed tomography. The results showed the possibilities of tomographic imaging in characterizing the internal structure of pillars. Particular attention was paid to the assessment of the adhesive connection between a steel reinforcing bar, embedded inside pillars, and the surrounding pillar body.

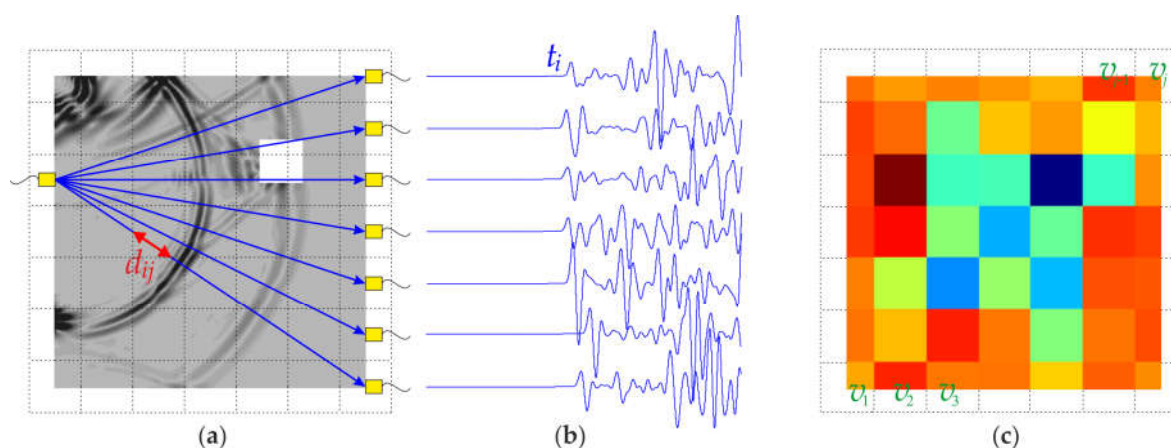
Figure 1. Schematic diagram of ultrasound tomography: (a) cross-section divided into pixels, with an indicated transmission point, receivers and a simulated wave field; (b) wave propagation signals; (c) tomographic image.

Ultrasonic tomography imaging allows the internal structure of an investigated object to be reconstructed by a set of projections through the sample in many different directions. A schematic diagram of ultrasound tomography is shown in Figure 1. At first, the tested specimen must be divided into small, geometrical cells, called pixels (marked with dotted lines in Figure 1a). Each pixel in the image represents a discrete area in the sample, and it is associated with an intensity value. The conducted calculations enable a quantitative description of each pixel, based on its physical characteristics, such as the wave propagation velocity. The number of pixels can be changed, enabling the study of the effect of spatial resolution on the quality of the obtained image.

In this study, through-transmission tomography was applied (cf.[29,32,33,34,27]). The tomographic procedure is based on elastic waves passing through the tested specimen, from the transmitter (T) to receivers (R) (Figure 1b). The image reconstruction is performed based on the information obtained from the received pulses. Typically, this information is the time-of-flight (TOF), measured along many ray paths. Based on the known geometry of the specimen, the average velocity of wave propagation can be determined. This velocity depends on the mass density, modulus of elasticity and Poisson's ratio, characterizing the material inside the tested specimen. Any obstacle present in the path of the travelling wave results in a change of the propagation time. Defects, in the form of air voids or cracks on the wave path, cause a delay in the ray reaching the receiver. On the other hand, inclusions made of materials characterized by higher propagation velocities than the neighboring medium lead to an increase of the total velocity along all the rays passing through this inclusion.

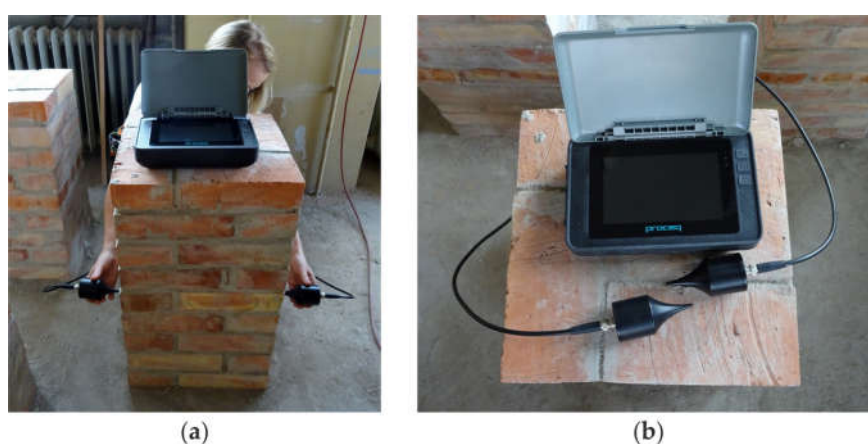
Figure 4. Experimental setup: (a) testing in through transmission mode; (b) registration unit and exponential transducers.

After 28 days, the masonry pillars were subjected to ultrasonic tests. The velocity of the stress waves was measured using the ultrasonic pulse velocity method. The PUNDIT PL-200 instrument (Proceq SA, Schwerzenbach, Switzerland) was utilized for measurements of the ultrasonic pulse velocity. Two exponential transducers of 54 kHz were used in the through transmission mode, and dry coupling was applied. The experimental setup is shown in Figure 4.

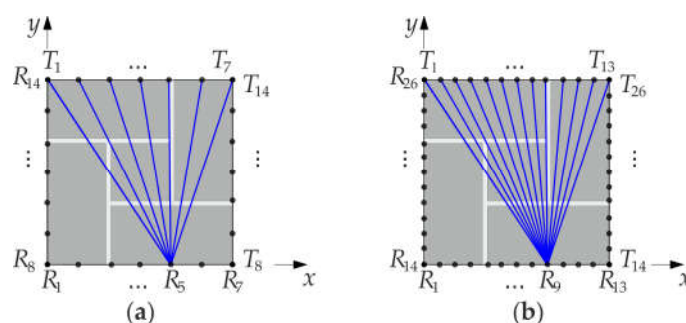
Figure 5. Configuration of the measurement points: (a) configuration #A (transmission of waves at points T_1 - T_{14} and sensing of waves at points R_1 - R_{14}), (b) configuration #B (transmission of waves at points T_1 - T_{26} and sensing of waves at points R_1 - R_{26}).

Measurements were carried out on the middle (i.e. 5th) layer of bricks. Two experiments were conducted. In the first test (configuration #A), 7 measurement points were distributed at each pillar edge, while in the second test (configuration #B), measurements were taken at 13 points. The configurations of the measurement points are given in Figure 5. Transmitting points are denoted by T, and receiving points by R. The receiving transducer was set at a given point, and then the transmitting transducer was moved from the first to the last point on the opposite wall. There were 14 transmitting/receiving points for configuration #A and 23 transmitting/receiving points for configuration #B.

Numerical analyses of the stress wave propagation were carried out using the finite element method (FEM) in the Abaqus/Explicit. A two-dimensional model of the fifth layer of the pillar was developed using four-node plane strain elements, with reduced integration (CPE4R). The size of all elements in the model was $1 \text{ mm} \times 1 \text{ mm}$. The material of the pillar was assumed to have linear elastic behavior. The material properties of the bricks and mortar were determined experimentally (Table 1), and for the steel, the following parameters were adopted: $E = 200 \text{ GPa}$, $\rho = 7850 \text{ kg/m}^3$, $\nu = 0.3$. The connections between the bricks and mortar as well as between the mortar and steel were modelled as a tie constraint. The boundary conditions were assumed to be free on all edges. The excitation signal was a one-cycle sine wave of 54 kHz frequency, modulated by the Hann window. The size of the integration step was 10^{-7} s . The output acceleration signals were recorded at the same points as in the experimental investigations (Figure 5).

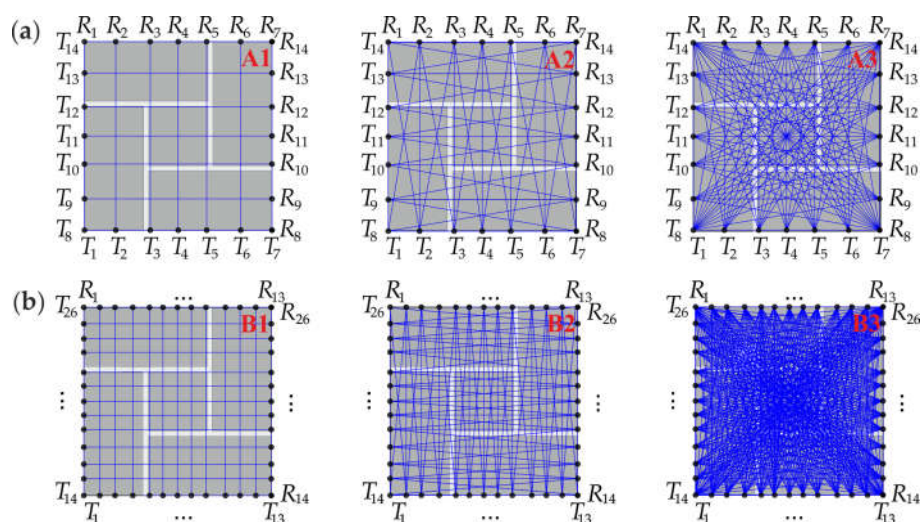
Figure 6. Configuration of paths: (a) configuration #A (#A1, #A2 and #A3); (b) configuration #B (#B1, #B2 and #B3).

3.4. Configuration of Pixels and Paths

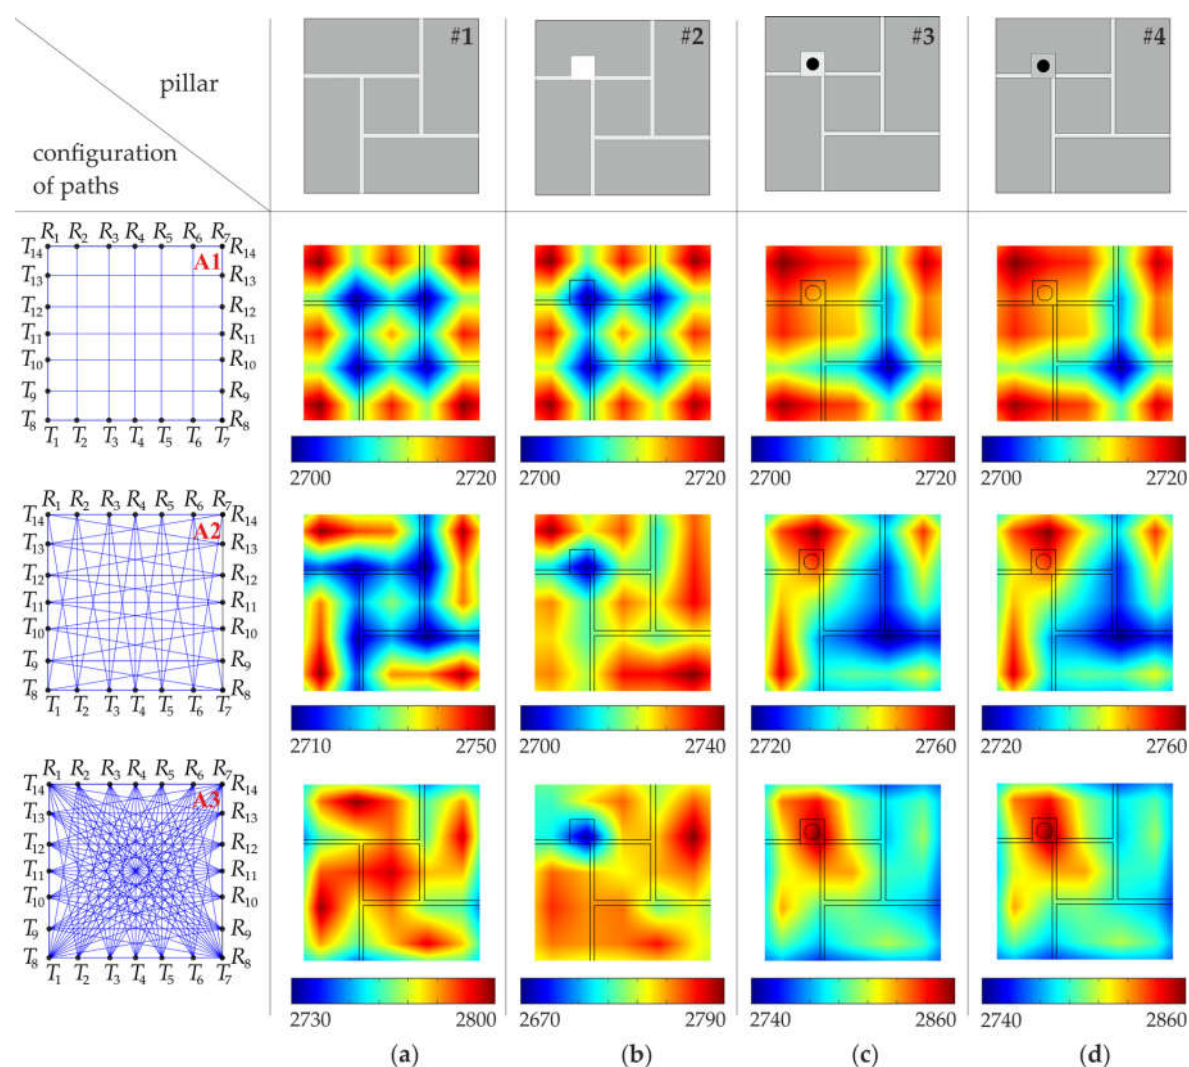
Figure 7. Tomographic velocity images (values in (m/s)), with a division into 49 pixels (configuration #A), obtained from FEM signals: (a) intact pillar; (b) pillar with the square hole; (c) pillar with the steel bar grouted by means of gypsum mortar; (d) pillar with the steel bar grouted by means of cement mortar.

Ultrasound tomography images, determined based on numerical FEM signals, are shown in Figures 7 and 8, with a division into 49 and 169 pixels, respectively (see Section 3.4). In general, the increase in the number of transmitters, as well as the increase in the number of paths, improved the resolution of the velocity maps and provided a more precise image of the internal structure of the pillars.

Tomograms for the intact pillar (#1) enabled the identification of the arrangement of joints (Figures 7a and 8a). Joints made of cement-lime mortar were characterized by a lower wave propagation velocity than the brick itself. The impact of the existence of joints on the tomographic images was visible, regardless of the number of transmitters used and the number of measurement

paths. However, maps created based on the simplest configurations of paths (#A.1, #B.1) did not give satisfactory results regarding precise joint localization. The use of vertical and horizontal wave paths enabled only the identification of the directions of the mortar joints. More accurate tomographic images were obtained when a larger amount of measurement data was collected. Increasing the number of paths (configurations #A.2-A.3 and #B.2-B.3) allowed the position of joints in the considered cross-section and the exact brick arrangement pattern to be determined.

Tests conducted for the pillar with the hole (pillar #2) allowed its position to be estimated, but only when a sufficiently large number of ray paths was used (Figures 7b and 8b). In the case of configurations of vertical and horizontal paths (configurations #A.1 and #B.1), the obtained tomographic images were very similar to those obtained for the intact pillar. To obtain the precise localization of the hole, the configuration, including all paths between the transmitting point and receiving points, were required. For such configurations (#A.3 and #B.3), a clear area, with a lower value of the velocity, can be observed. It was also possible to identify the arrangement of mortar joints, especially in the case of the image divided into 169 pixels.

The results for the pillars with the steel bar grouted by means of gypsum cement mortar are shown in Figures 7c and 7d (49 pixels) and Figures 8c and 8d (169 pixels). Tomographic velocity images of the simplest paths differed considerably between configuration #A.1 and #B.1. In the case

of configuration #A.1, no path crossed the steel bar, therefore, it was not possible to localize the bar. However, since two paths passed directly along the joints, two straight lines with lower velocities appeared in the map, indicating the direction of the mortar joints. When 26 instead of 14 horizontal and vertical paths were used, two perpendicular paths crossed the steel bar. Therefore, for configuration #B.1, two longitudinal areas with a higher velocity appeared on the maps. These lines were the effect of blurring, which occurs in linear tomography. They indicated the presence of the bar but did not allow for its exact localization. The precise localization was achieved after considering more paths crossing the bar (configurations #A.3 and B.3). As a result, a distinct area with higher velocity values can be observed around the bar position. It should also be noted that the maps for pillars #3 and #4 are almost the same. This means that the main influence on the velocity distribution was the presence of the bar, and therefore, it was not possible to determine the type of mortar (gypsum or cement) used.

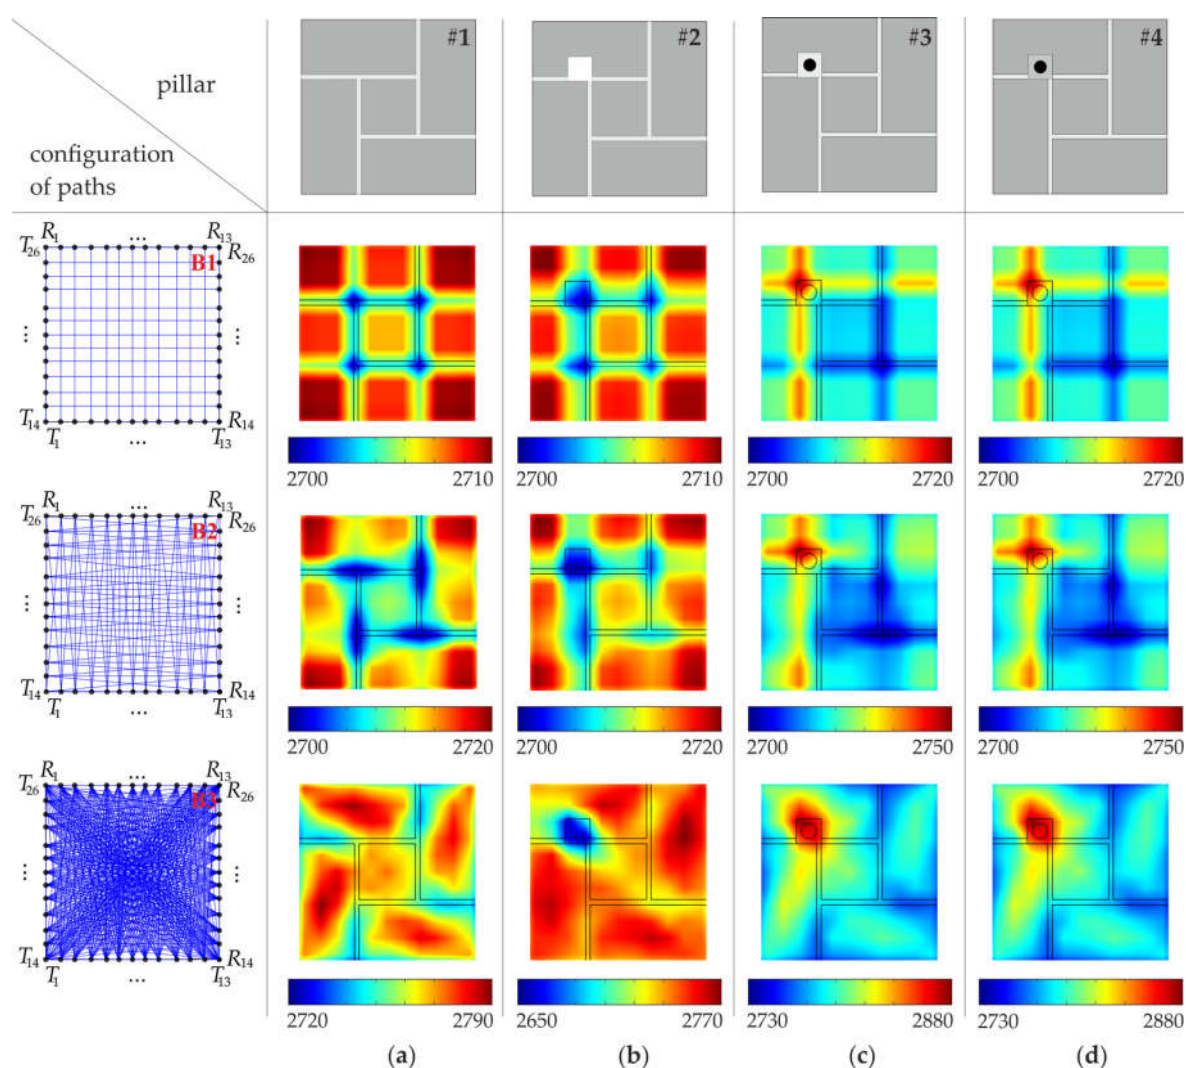
Figure 8. Tomographic velocity images (values in (m/s)), with a division into 169 pixels (configuration #B), obtained from FEM signals: (a) intact pillar; (b) pillar with the square hole; (c) pillar with the steel bar grouted by means of gypsum mortar; (d) pillar with the steel bar grouted by means of cement mortar.

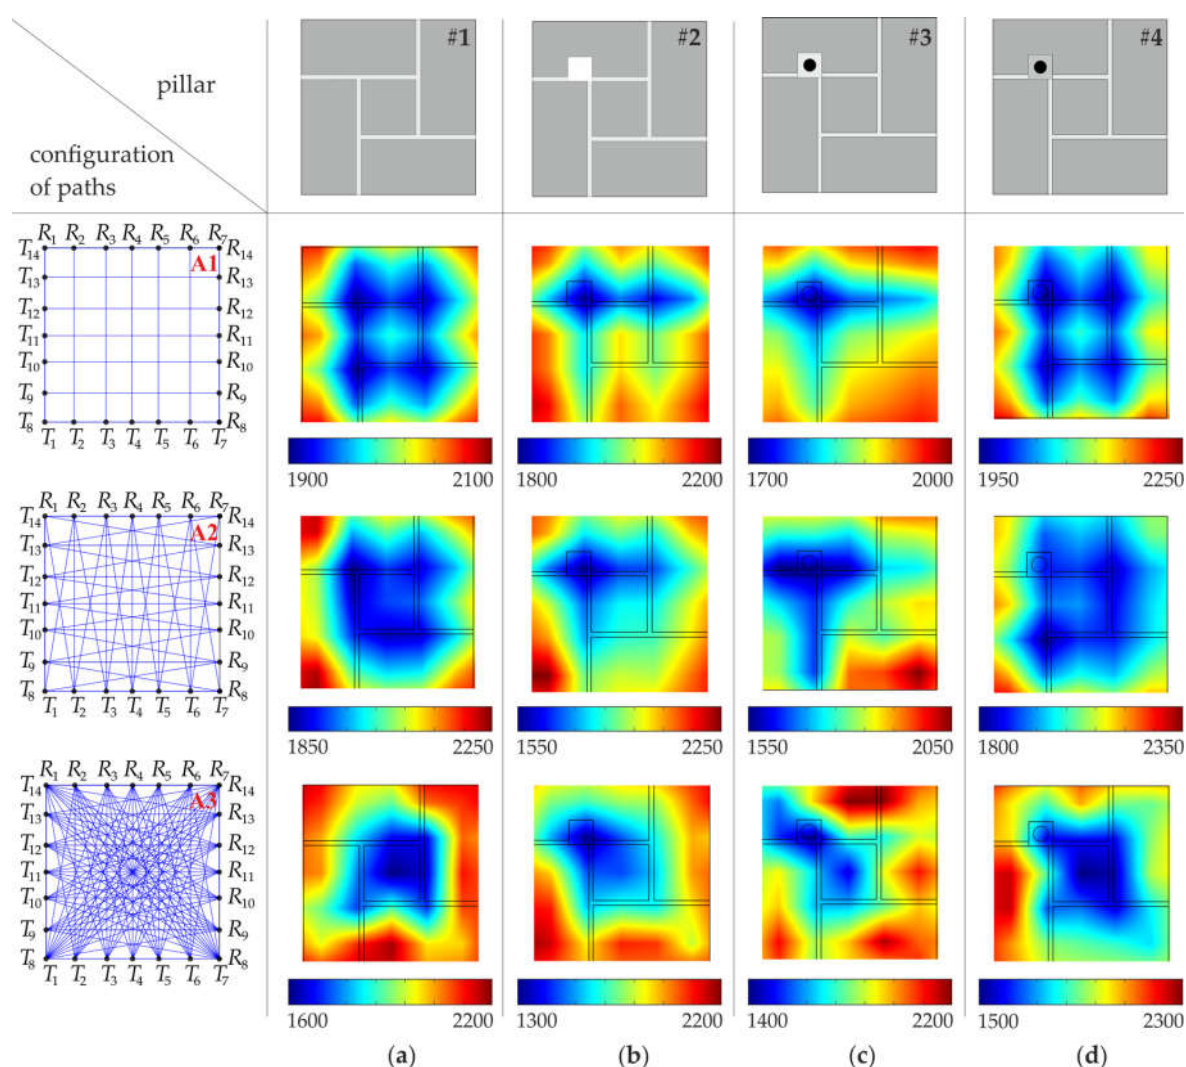
Figure 9. Tomographic velocity images (values in (m/s)), with a division into 49 pixels (configuration #A), obtained from experimental signals: (a) intact pillar; (b) pillar with the square hole; (c) pillar with the steel bar grouted by means of gypsum mortar; (d) pillar with the steel bar grouted by means of cement mortar.

The experimental tomographic images are shown in Figures 9 and 10, with a division into 49 and 169 pixels, respectively (see Section 3.4). Contrary to numerical maps, the quality of experimental images did not increase with the increase of the number of pixels or paths used. In real masonry elements, connections between mortar and bricks are not ideal. Air voids, pores and a lack of adhesion between a brick and mortar may occur. The heterogeneous nature of the tested specimens as well as the imperfections of the connections between bricks and mortar caused a strong dissipation of the energy of propagating waves and consequently affected the quality of the obtained tomography images.

Measurements made for the intact pillar (# 1) using only vertical and horizontal paths revealed lower propagation velocities at joint intersections (Figures 9a and 10a). With the increase of the number of paths, for configurations #A.3 and #B.3 a zone with lower velocity values appeared in the central part of the pillar due to the accumulation of joints and paths crossing them.

Maps of the pillar with the hole are shown in Figures 9b and 10b. The hole unambiguously disturbed the wave transition. The location of the hole can be indicated as the area with lower velocity values. The identification of the position of the hole was clearest in the case of vertical and horizontal rays (#A.1 and #B.1), however, it was affected by the blurring effect. As in the case of the intact pillar, the accumulation of lower velocities can be seen for configurations #A.2, #A.3 and #B.2, #B.3.

The maps obtained for the pillar with the bar grouted by gypsum mortar (#3) revealed similar patterns as those for the pillar with the hole (Figures 9c and 10c). This may indicate poor adhesion between the bar and the gypsum mortar. On the other hand, the tomographic velocity images for the pillar with the bar grouted by cement mortar (#4) were very similar to those obtained for the intact pillar (Figures 9c and 10c). This means that the connection between the bar and gypsum mortar was of a good quality, and strong adhesion occurred.

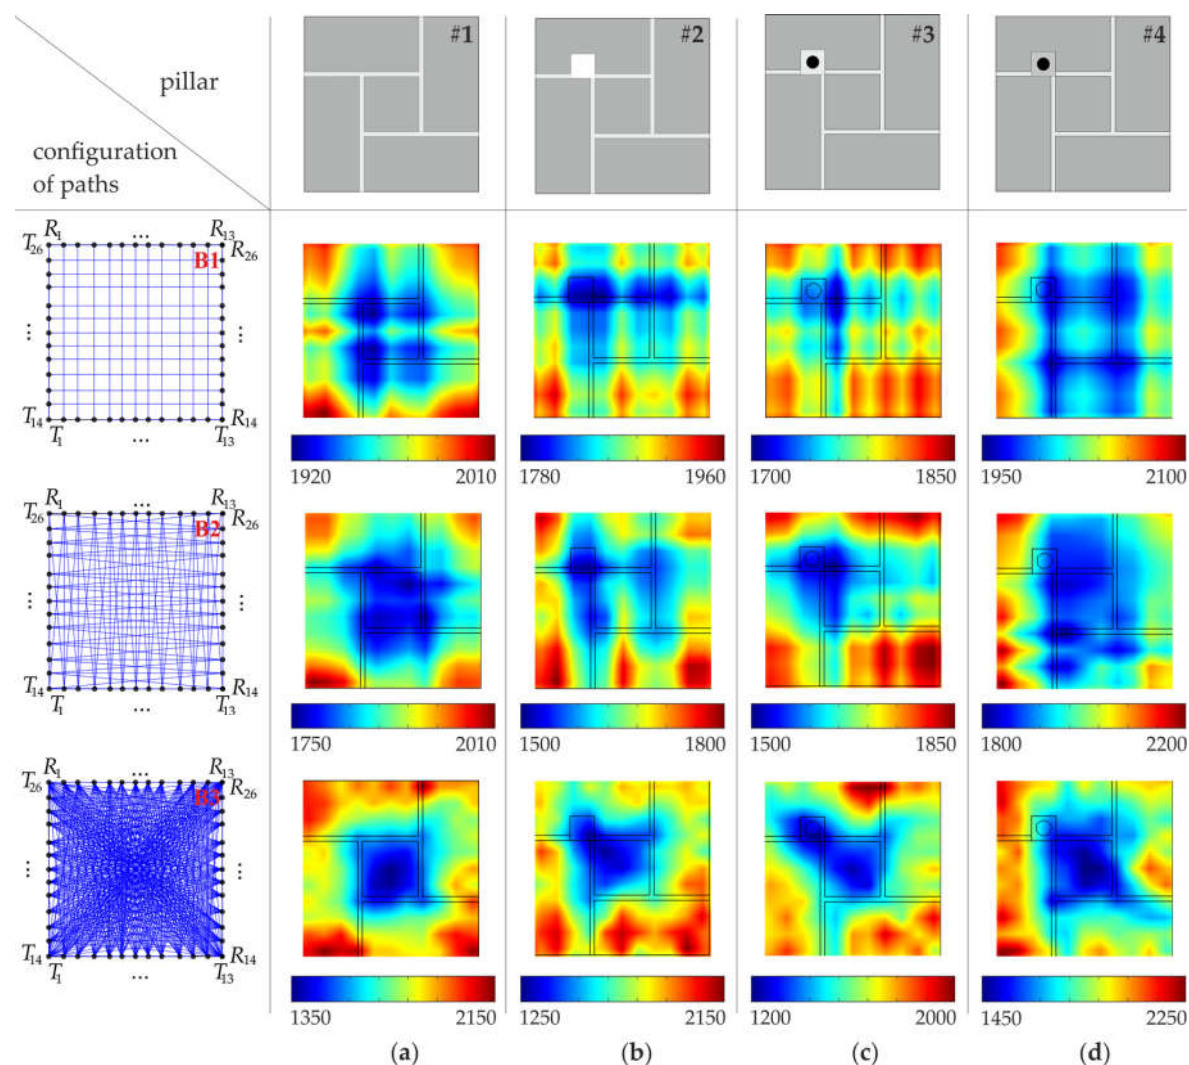
Figure 10. Tomographic velocity images (values in (m/s)), with a division into 169 pixels (configuration #B), obtained from experimental signals: (a) intact pillar; (b) pillar with the square hole; (c) pillar with the steel bar grouted by means of gypsum mortar; (d) pillar with the steel bar grouted by means of cement mortar.
