# INFLUENCE OF PROCESS OF STRAIGHTENING SHIP HULL STRUCTURE MADE OF 316L STAINLESS STEEL ON CORROSION RESISTANCE AND MECHANICAL PROPERTIES

**Keywords:** 316L steel, flame straightening, corrosion resistance, mechanical properties

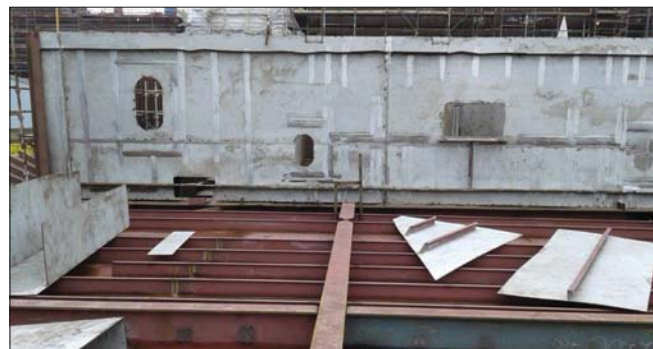
Fig. 1. RSW cargo tank under construction in shipyard

Tests were carried out on 316 L steel plates after the flame heating process. The steel plates were austenitic steel, which, due to its corrosion resistance and high plasticity properties, has a wide spectrum of uses. It is commonly used even under cryogenic conditions. In shipbuilding industry it is used to make, among others, LNG gas tanks in a liquid state (operating temperature of about -155°C), piping and to lay RSW (refrigerated seawater) holds (for transporting fish in water at a temperature close to 0°C) of fishing vessels (see Fig. 1).

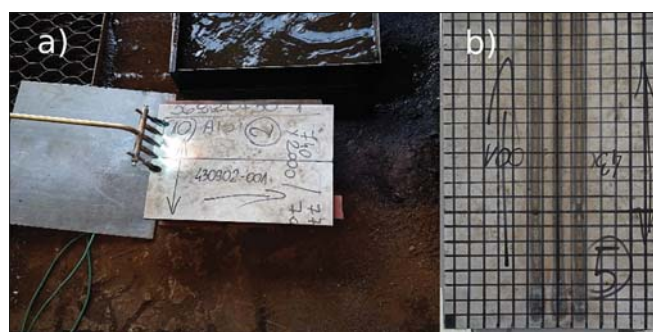
Fig. 2. Test plate during straightening process (a) and surface after process (b)

Eight test plates were provided for testing: two reference ones made of material not subjected to flame straightening (reference material), three straightened and naturally cooled ones, and three straightened and water-cooled ones (All panels had dimensions of 300×450 mm and a thickness of 10 mm. Straightening was carried out using triple flame burners. Figure 2 shows the plate during straightening. The straightening direction was perpendicular to the rolling direction.
