Damage Development on the Surface of Nickel Coating in the Initial Period of Erosion

Keywords: cavitation erosion; nickel coating; corrosion

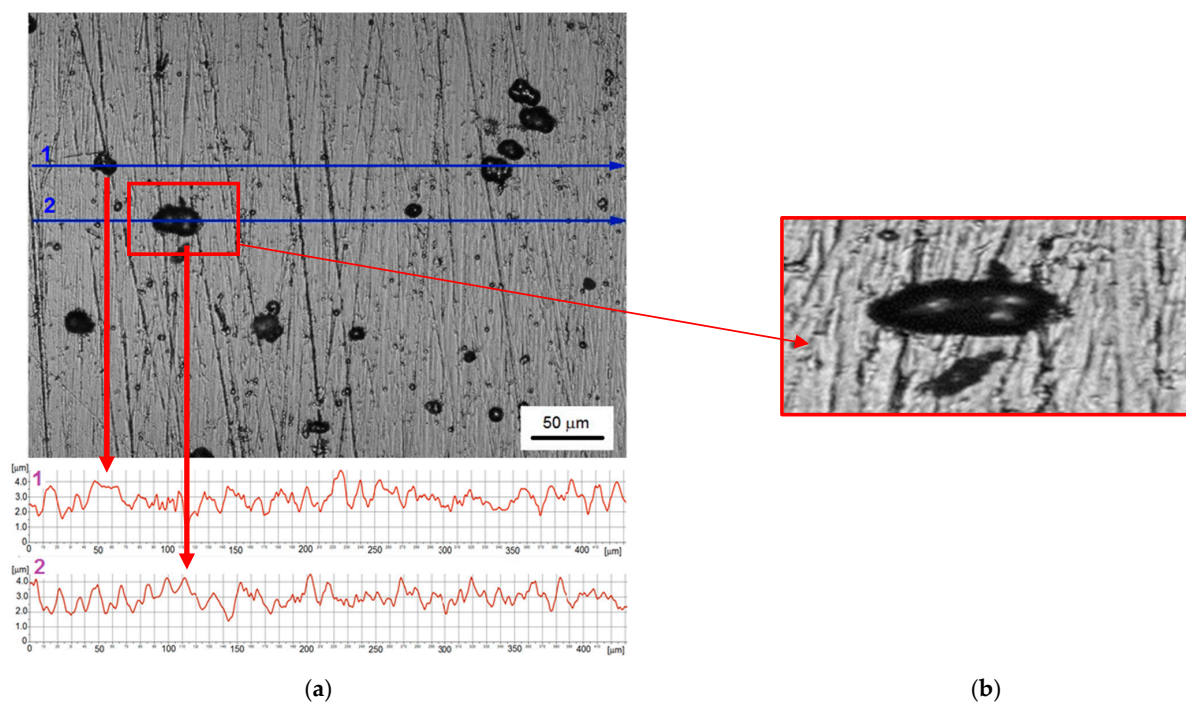
Figure 2. Nickel coating before cavitation erosion tests: (a) surface morphology with roughness profiles along the selected measurement lines; (b) 3D profile of a surface defect.

The Ni coating investigated in the presented studies is shown in Figure 2. The microscopic observation revealed the coating reflected the substrate very well and numerous defects with diameters ranging from 2 μm to even 46 μm were formed. The median size of defects was 9.6 μm the standard deviation was 8.7 μm . In addition, the roughness measurements showed that the surface unevenness had a height up to 2.5 μm and the defects were convex. Nevertheless, the coating was applied evenly to the substrate, and the observed unevenness was due to the unevenness of the substrate surface due to the low thickness of the nickel coating (about 10 μm).

The microscopic observations of the coating before cavitation tests showed that the surface irregularities were reflected by the coating due to its small thickness. However, the height of surface unevenness decreased by about 0.8 μm : from $2.63 \pm 0.29 \mu\text{m}$ to about 2 μm . In addition, defects with a wide range of diameters were formed during coating deposition. According to [49], defects in electroless Ni coatings are related to the phosphorus content and coating thickness. Thus, the cause of the numerous and large defects was likely the high content of phosphorus.

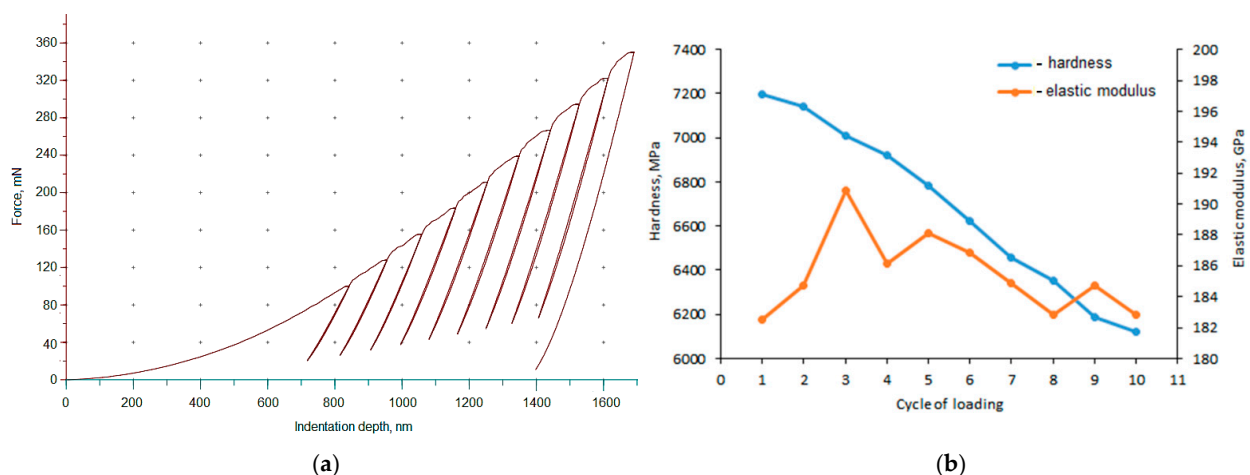
Figure 3. Force versus indentation depth curves for a Ni–P coating: (a) hardness and elastic modulus change with loading cycle (b).

The results of cycling loading are shown in Figure 3. The first load caused an indentation depth of about 0.8 μm , so it was less than 1/10 of coating thickness. With increasing cycles of load, the indentation depth increased as well. The maximum indentation depth during the third cycle was approx. 1.05 μm . Thus, starting from the third cycle, the indentation depth was higher than 1/10 of the coating thickness and the substrate began to have an influence on the results obtained. After all cycles, the maximum indentation depth was approx. 1.7 μm and the permanent indentation depth was 1.4 μm . With the increasing number of cycles, hardness decreased. After 10 cycles, hardness decreased over 1000 MPa. Thus, the softening effect occurred. In addition, the bigger drop of hardness arisen at the third cycle, which is related to the depth of indentation. However, the subsequent cycles resulted in a steady drop in hardness at a rate of 150 MPa per cycle. The modulus of elasticity increased during the first three cycles but then decreased. This study shows that the cyclic load significantly influenced the hardness and modulus of elasticity of the tested Ni–P coating and steel substrate, especially after the 3rd cycle, when the depth of the indentation is so deep that the substrate influences the deformation process of the entire coating-substrate system. Changes in hardness and modulus of elasticity made the coating more susceptible to plastic deformation.

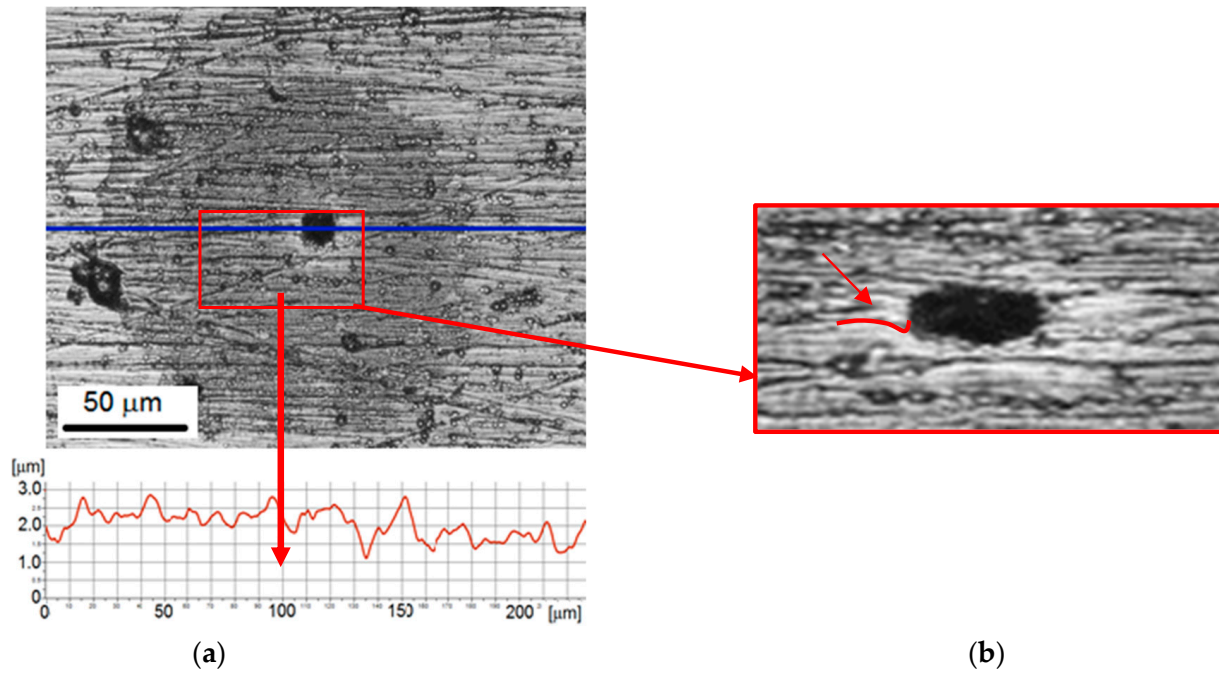
Figure 7. Nickel coating after 10 min of the cavitation erosion tests: (a) surface morphology with roughness profile along the selected measurement line; (b) 3D surface profile.

Microscopic observations of the surface after 10 min of the cavitation test revealed circular shadings around the formed cavities on the observed surface (Figure 7). The round shading has become darker and more pronounced. The diameter of shaded circles around the pits was in a range from $200\ \mu\text{m}$ to $400\ \mu\text{m}$, while the diameter of the pit from $20\ \mu\text{m}$ to about $30\ \mu\text{m}$. Thus, the pit diameter was comparable to 5 min of testing. However, the edge of the pit was no longer concave but became convex (denoted by a red line and an arrow). The appearance of shading may be related to the oxidation of nickel (corrosion of nickel). According to research by Suslicek et al. [43], in the last stage of cavitation bubbles collapsing, the temperature inside the bubble exceeds $1000\ \text{K}$, and can even reach $5000\ \text{K}$. The high temperature and water environment in which cavitation tests are carried out meet the conditions necessary for the nickel oxidation process. The product of nickel oxidation is nickel oxide (NiO), which in the form of a thin film covers the eroded surface [44]. The performed observations showed that the appearance of shadows did not affect the 3D profile and surface roughness profile. The round shape of the shadows, in line with the shape of the imploding cavitation bubble, is also consistent with the assumption of nickel oxidation made. Thus, the observed shadows may be a thin layer of nickel oxide. On the other hand, it is known that the generated temperature inside the bubble drops sharply as a result of flowing cold water. It follows that only those cavitation bubbles that are in direct contact with the coating contribute to the oxidation of nickel and the formation of the observed dark shadows.

Extending the test duration to 10 min did not affect the pit diameter, but increased the shading diameter almost 3 times. Such a large increase in the diameter of the shading may be caused by the softening of the coating, as shown by the research on the influence of cyclic loading. Because of the decrease in the hardness of the coating, the coating deformed more due to the collapse of the bubble, which increased the contact surface with the coating. The effect of high temperature described before could likely lead to an acceleration of the oxidation process and the increase of the shading diameter.

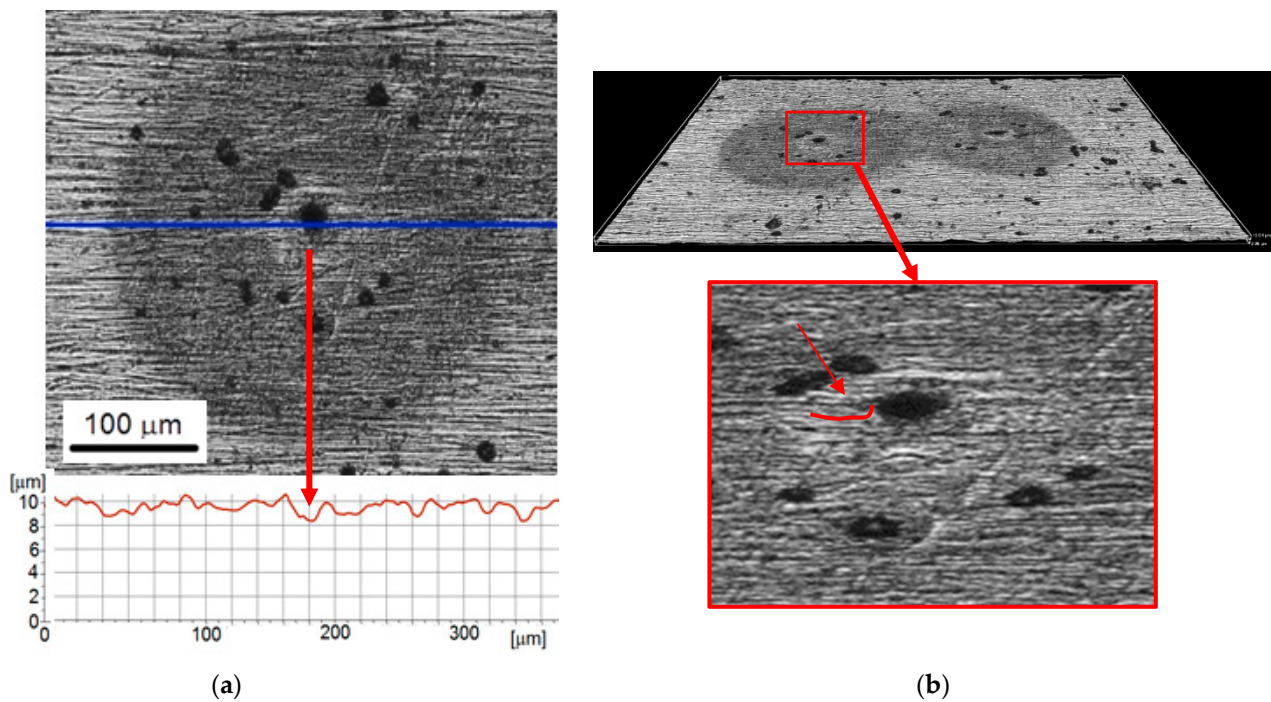
Figure 8. Nickel coating after 30 min of the cavitation erosion tests: (a) surface morphology with roughness profile along the selected measurement line; (b) 3D surface profile.

Extending the test duration to 30 min slightly affected the diameter of the shadows but had a significant effect on the change in the diameter of the pits (Figure 8). The diameter of shadows was about 300–400 μm , while the diameter of the pits was in the range from 20 to 40 μm . Thus, the diameter of the pits increased. In addition, Figure 8b shows that pits had a characteristic shape: the surface just around the pit was slightly convex, and next to it was concave. The roughness profile (Figure 8a) shows the pit depth of about 2 μm . As the possibilities of surface analysis with an optical profilometer are limited, the formation of a microcrack at the bottom of this pit cannot be excluded. This damage shape was likely the reason for corrosion development. Corrosion tests (c.f. Section 3.2) have shown lower corrosion resistance of the steel substrate in comparison to the Ni coating. The other factor influencing the development of corrosion was an increase in stress level in the coating. Elongation of the test duration means an increase in the number of impacting cavitation pulses. Although some of them are too weak to cause a pit in the hard nickel coating, they are able to supply some of the impact energy and stresses to the surface layer. The increase in stresses promotes the acceleration of corrosion processes.
