Aleksander Piwek*

Chapel at St. Joseph's Church in Gdańsk

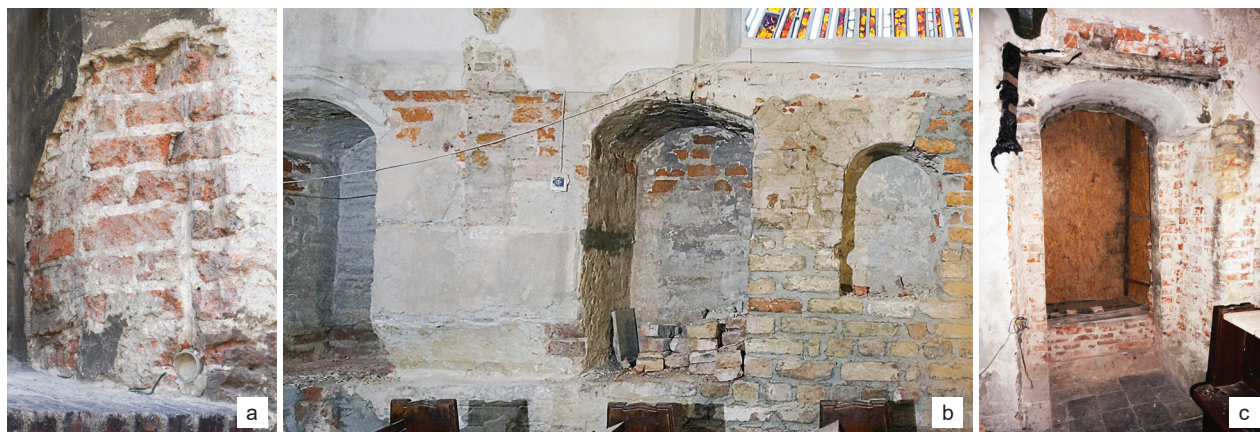
Fig. 4. Discoveries in the northern wall of the chapel at St. Joseph's Church in Gdańsk:

- a) a fragment of the first window from the west, b) three recesses; between two of them (on the left) there is a quarter circular indentation in the wall, c) a recess in the south wall, in the 2nd half of the 17th century, which was a passage to the chancel (photo by A. Piwek)

Only the third window from the east on the west side provided some information about the architecture of the Gothic windows. The bricks exposed above the sill contain fragmentary surviving Gothic moulding (Fig. 4a). A small fault with traces of thin plaster ran deep into the wall from the face of the wall. The inner parts of the fault were hacked off, so it is not known whether it still contained additional decoration. From an analysis of the better-preserved window decoration of the nearby older sacred refectory [7], it can be assumed that there was a shaft in the fault. The glyphs present behind this fault were created by hacking off the corners of the plain wall to give them neo-Gothic forms, considered more appropriate for medieval chapel architecture in the early 20th century than the plain wall.

Further traces on the wall are spatially related to the interior of the chapel. These include the quarter circular niche found (Fig. 4b) between the bricked up recesses of the second and third (from the west wall). It runs horizontally through their bases and is 30 cm high. It penetrates into the wall from 9.5 cm (on the eastern side) to 14.5 cm (on the western side). As it is close to the trapdoor covering the exit to the underground, it is most likely associated with it. Further traces include two rectangular niches filled with bricks probably dating from the 1st quarter of the 17th century. They are 20 cm wide, 59 cm high, and start at 885 cm and 1,340 cm from the present eastern wall at a height of 146 cm above the floor. They were created in the Middle Ages and are only associated with the north wall³. The last traces include two vertical strips 20 cm wide of machine-made bricks, narrowing the second and seventh recesses to the west. These covered the vertical channels forged in the wall (to a depth of about 20 cm). Soot marks were found on their surfaces. They are therefore associated with the addition of furnaces to the wall in the early 20th century.

On its surface, three pairs of vertical grouts were found, connected by segmental arches (Fig. 4c). In terms of shape, they were similar to those recesses in the north wall, which were classified as type one. There were not very large differences between them in terms of dimensions: spacing, base height (167–176 cm), cap height (here 167–176 cm) and depth (70 cm). One reason for this state of affairs may be the priority of the commencement of the construction (perhaps the completion) of the large chapel (the present chancel) in the Middle Ages. The masonry of the recesses varied. The first to the east contained uniform brick material throughout its depth, probably dating from the 17th century. The interior of the second to the east, along a length of 29 cm, had an early 20th century solid brick infill. It was created to vent smoke through a vertical channel (40 × 90 cm) forged in the wall. The bricks obscuring its section from above contained traces of soot. The third recess, near the west wall, was walled up with a thin wall of machine-made bricks after 1945.

At distances of 438 and 593 cm from the east wall, a rectangular masonry reaching the floor was found, 263 cm high, composed of post-1945 machine-made bricks. When it was removed, a recess 16 cm narrower (on each side) was revealed, with a plastered segmental arch reaching 228 cm (Fig. 4c). It resembled the second type of recess from the north wall. The walls on which the arch was supported were partially hacked off (at 16 cm). The background of the recess had another masonry. It consisted of 26–26.5 × 12.5–13.5 × 6.5 cm machine-made bricks. Almost all of them were plastered. The front of the arch was obscured by a 9 cm high beam facing the wall. There was a vertical grout 40 cm from the southern edge of the recess. There was also a similar one on the opposite side. These indicate the forging of a passage into the chancel. It was created probably in the 17th century. Then, it was bricked up on the chancel side at the beginning of the 20th century. On the side of the chapel, the side walls have had their surface hacked off. The intention was to widen the resulting recess to make room for a wide rectangular cupboard with a wooden frame secured from above by a thin beam. Bright horizontal stripes (less dusty than the other surfaces) were found on the fragments of the plastered transverse partitions. It is thus known that the cupboard had five shelves. Their lower surfaces were found at the following heights from the floor: 39, 84, 129, 179 (top surface) and 215 cm. The passage with the fault between the two bricked-up western recesses was the original one, connecting the small chapel with the large one (the future chancel). It must be assumed that its further fate was interchangeably linked with the previously described passage forged in the 17th century in the same wall.

The last trace on the south wall is near the third vault bracket from the east (Fig. 4b). Vertical ripped grouts were found at 797 and 893 cm from the east wall. They started at a height of 236 cm from the floor. From above, they ended with a horizontally placed beam 8 cm high. Traces of its setting were found 390 cm from the floor. The re-building thus delineated contained 6.5–7 cm bricks on mortar containing clay. It was associated with the entrance to the level of the pulpit set on the chancel side. The stairs leading up to it had to be adjacent to the wall in order to cause as little disturbance as possible to the faithful gathered inside the chapel. The opening must have been forged before 1678, when the associated pulpit was destroyed.

At a distance of 200 cm from the floor, the base of a segmental arch was exposed, which “blended” into the north wall (Fig. 4c). Based on its curvature (the highest point was 150 cm from the north wall), it appears that the arch was 300 cm long. Below it, the wall contains bricks measuring: 29.5–29.9 × 13.5–14–15.5 × 7–7.5–8–8.5, 10c = 89 cm. The arch should be associated with a medieval recess. It is highly likely that its background had a passage. The bricked up recesses are associated with the removal of the medieval matroneum, which presumably took place in the 1st quarter of the 17th century. Above the described arch, two vertical grouts were found. They were found at 123 and 244 cm from the north wall⁵. They started at 325 cm from the floor level and ended at 508 cm to connect with the segmental arch. Within the area thus delineated were machine-made bricks measuring 25 × 12.2–12.2 × 6.7–6.8 cm, 10c = 81 cm. These form the masonry of the Gothic entrance made in the 20th century. Further analysis revealed that from this entrance (floor level), it was possible to access the now collapsed, one-flight stairs (Fig. 5). These were adjacent to the west wall. They were covered by a brick arch with a hacked-off corner, descending towards the south. An examination of the passage in the west wall to the adjoining room revealed a fragment of the Gothic arch on the north side. It therefore belonged to the original layout of the chapel. Its present irregular coping is the result of 17th–18th century alterations.

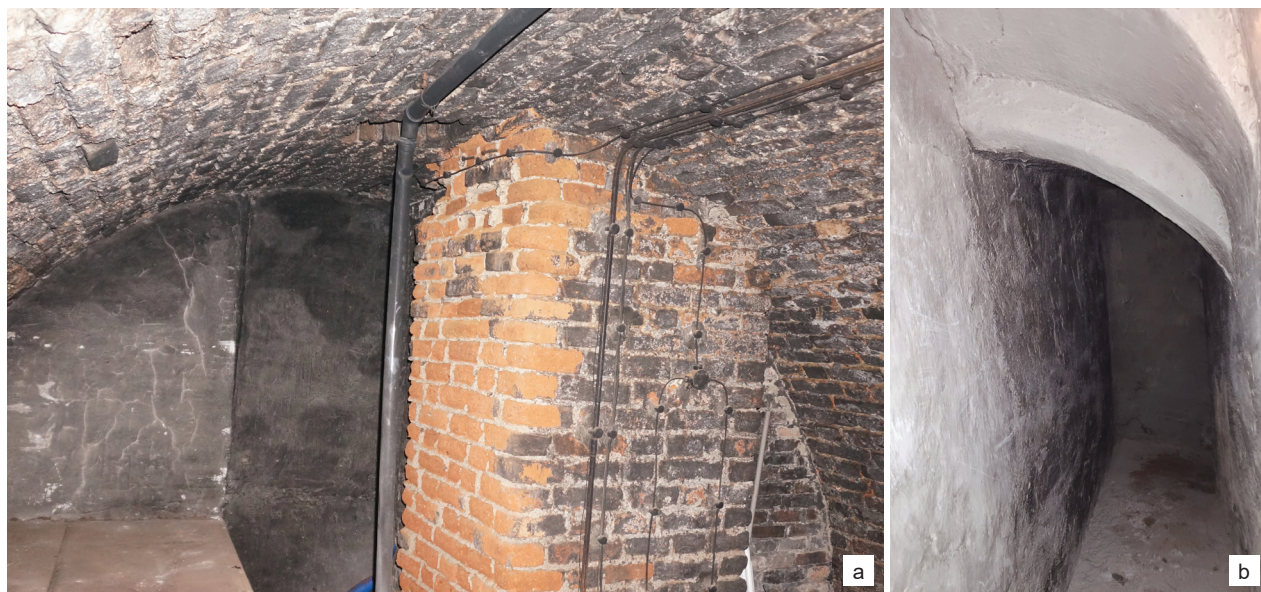
Fig. 6. Underground parts connected with the chapel at St. Joseph's Church in Gdańsk:
 a) a view of the interior of the crypt under the eastern part of the chapel towards the south,
 b) a fragment of the present corridor connecting the former crypt with the chancel (photo by A. Piwek)

of the brick covering were half covered by a bricked-up wall narrowing the passageway to 48–60 cm (Fig. 6b). It was probably made in the 20th century.
