Aleksander Piwek*

Chapel at St. Joseph's Church in Gdańsk

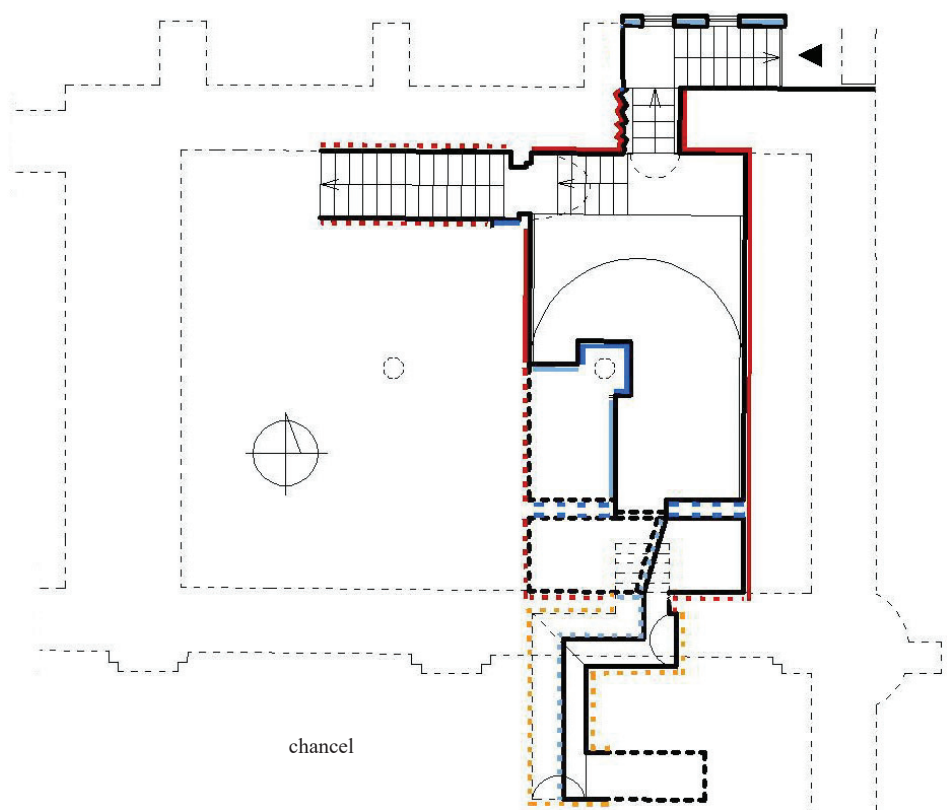
II. 2. Rozwarstwienie ścian kaplicy przy kościele św. Józefa w Gdańsku na parterze (poniżej okien) i w piwnicy. Literą „d” oznaczono odmienny od kamiennej posadzki kaplicy zasięg drewnianej kłapy.

Oznaczenia: 1 – koniec XV w.,
2 – XVII w.,
3 – XVIII w.,
4 – po 1840 r.,
5 – lata 1901–1920,
6 – 1945–2019
(oprac. A. Piwek)

The architectural analysis of the external surfaces of the walls brought some information about the history of the building, but much more was obtained by carrying out work in the interior of the chapel (Figs. 2, 3). The scope of the research undertaken was limited mainly to areas where the original plaster had not survived. In addition to fragmentary modern and younger painting decorations, conservators found medieval (consecration crosses) decorations on them. The original function of the described interior was therefore sacred, located within the present chapel space.

An architectural analysis carried out on the inner side of the north wall revealed a considerable number of vertical grooves, connected to each other by segmental arches (Fig. 3a). The parts thus separated were found to be masonry of seven recesses. Three types were found among them. The first belonged to the first, second, fifth, sixth and seventh recesses (counting from the east wall) (Fig. 4a). They were 88–91 cm wide and 75–78 cm deep. The caps of the arches reached a height of 210–220 cm, while the edges of the base were 90 cm high (from the floor level). In recess five, the side walls (at the height of the fifth layer of bricks from its base) have a groove made up of two sloping walls. This is a remnant of a shelf. The recesses mentioned are original and date from the Middle Ages. They have been bricked up
