Aleksander Piwek*

Chapel at St. Joseph's Church in Gdańsk

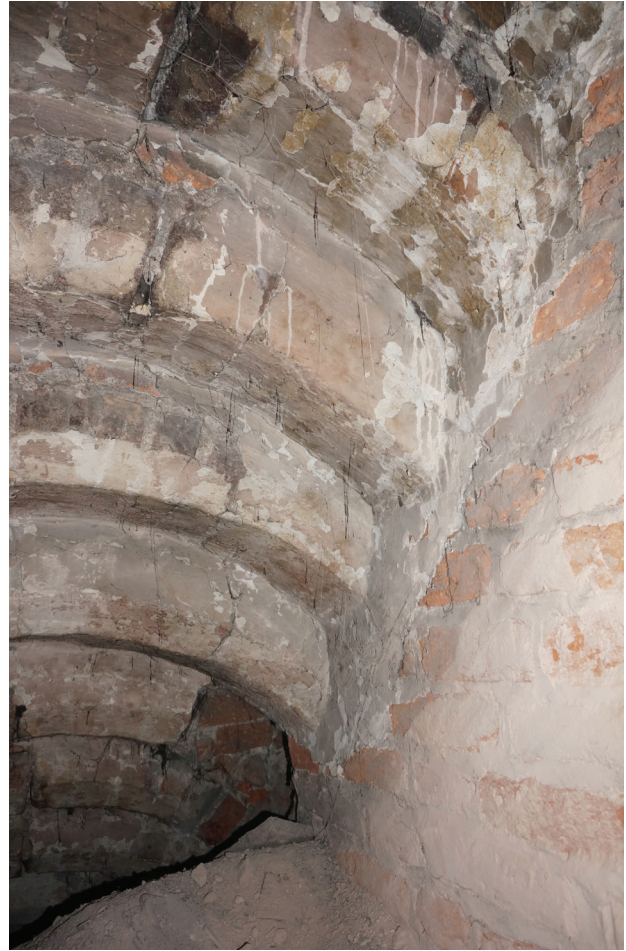
Fig. 5. A section of a partially buried descent from the level of the former matroneum to the ground floor of the chapel at St. Joseph's Church in Gdańsk (photo by A. Piwek)
