Cavitation behaviour of the SUPERSTON alloy after laser treatment

B. Majkowska*, W. Serbiński

Department of Materials Science and Engineering,
Gdansk University of Technology,
ul. Narutowicza 11/12, 80-952 Gdansk, Poland

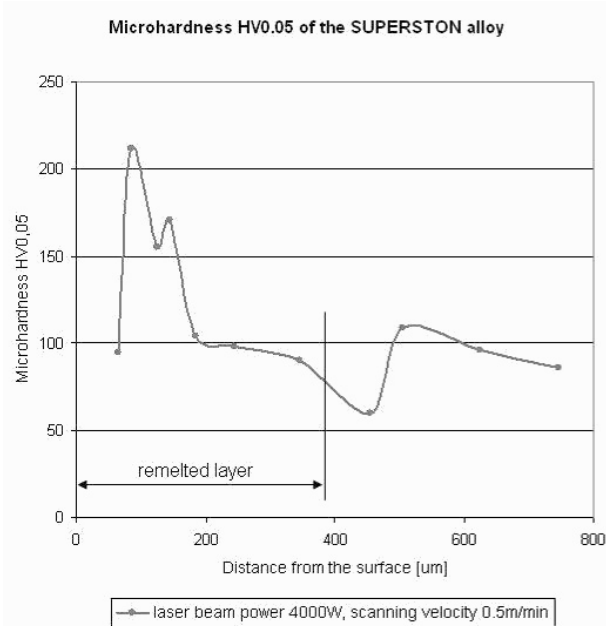
Fig. 5. Microhardness in cross-section of laser remelted layer of the SUPERSTON alloy (4000W, 0.5m/min)

Microhardness in the remelted layer of the SUPERSTON alloy made by the Vickers method under load 0.49 N.

Results of the microhardness measurements are presented in Figs 5 and 6.
