Results of acoustic emission tests of corrosion protection degree of ship steel tanks covered by means of protective coatings (Phase I)

Henryk Bugłacki
Piotr Eichert
Gdańsk University of Technology

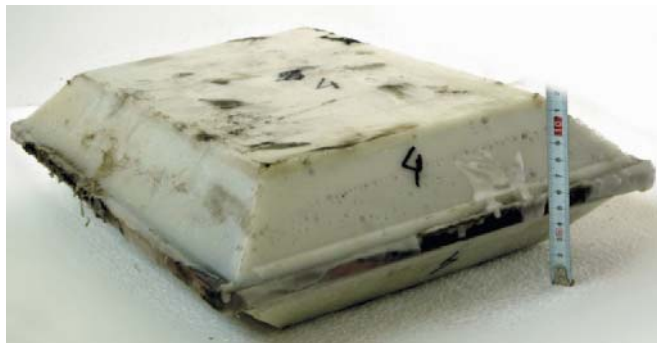
Fig. 2. The specimen covered with the polyurethane layer - concrete filler protective system

In Fig. 2 the specimen covered with the polyurethane layer - concrete filler protective system is shown.

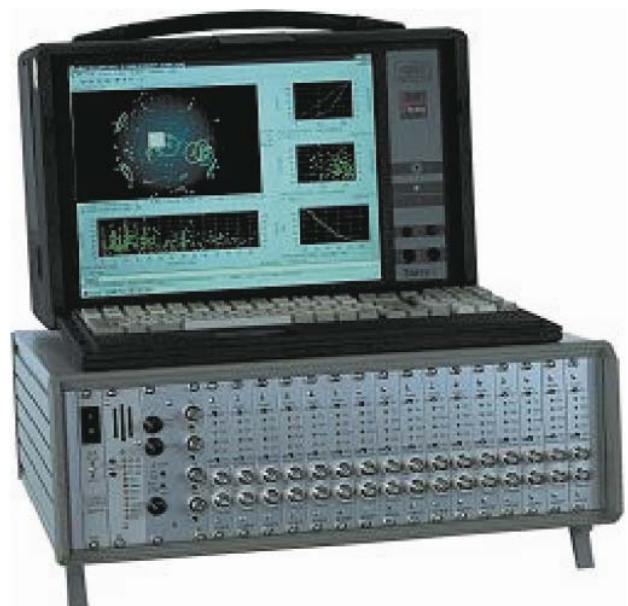
Fig. 4. AMSY5 system of the Vallen firm applicable to AE testing.

For measurements the 16-channel set of AMSY5 system and VS30-V, VS75-V sensors of the firm Vallen Systeme GmbH (Fig. 4) were used.

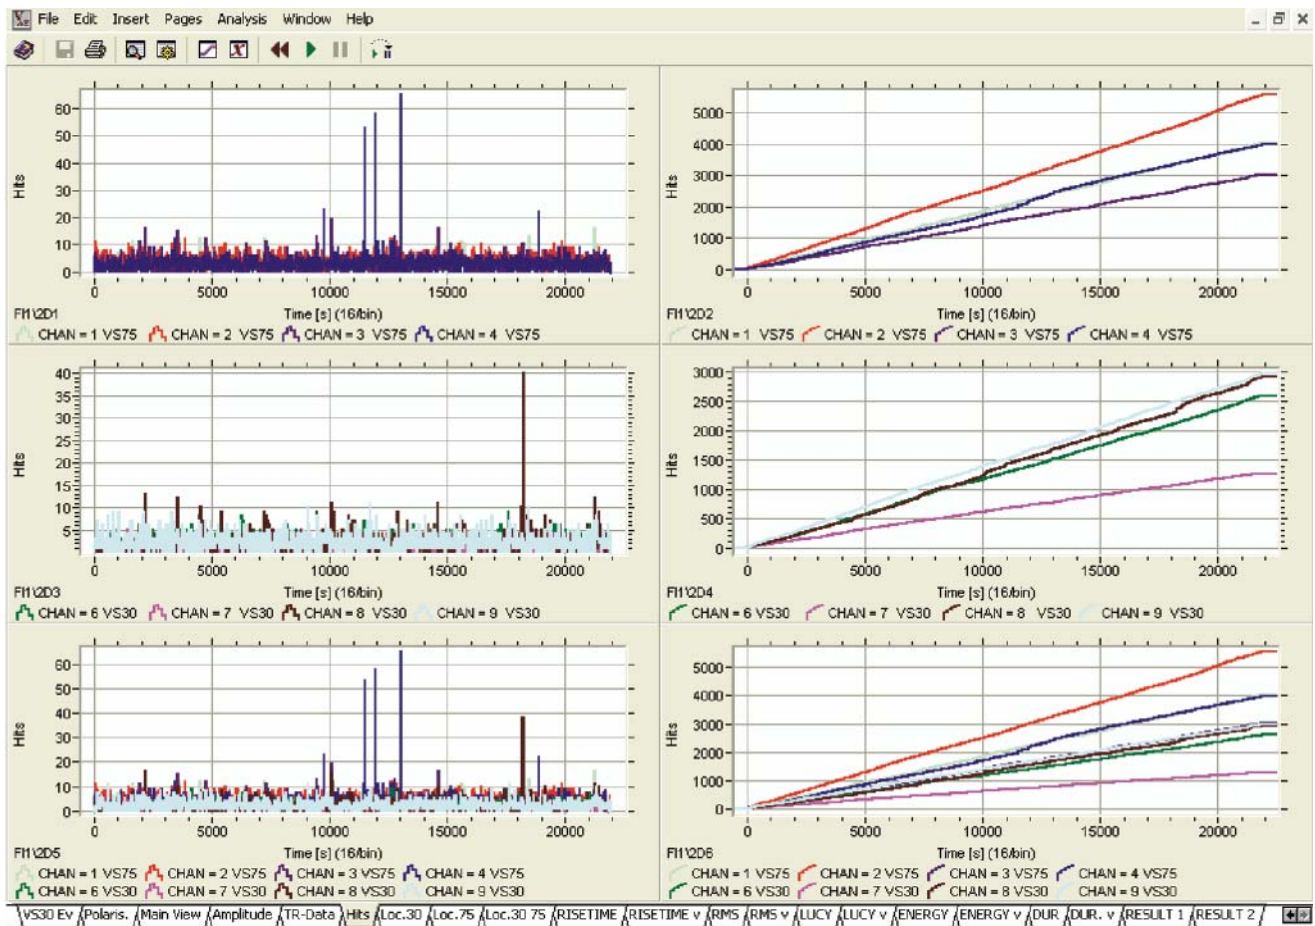
b) The response (detection of one pulse signal in the channel) - hits

Fig. 7. Example AE signals and descriptors recorded for the selected test no. 19 performed for the whole set of plate specimens

The example recorded AE signals and descriptors for the selected test no. 19 of the entire set of specimens, are presented in Fig. 7. The raw plate specimen (S) showing a significant level of AE signals has been correctly localized. The plate specimen no. 7 covered with the paint coating shows weak AE signals. Additional weak sources of AE signals, located on the plate specimen no. 6 covered with the polyurethane layer-concrete filler coating, were also found. As the AE signals localized in it are characterized by another quantity of energy and another rise time it can be deemed that the source of AE signals is of a different character than corrosive one. It can be e.g. processes which occur within internal structure of the concrete filler.

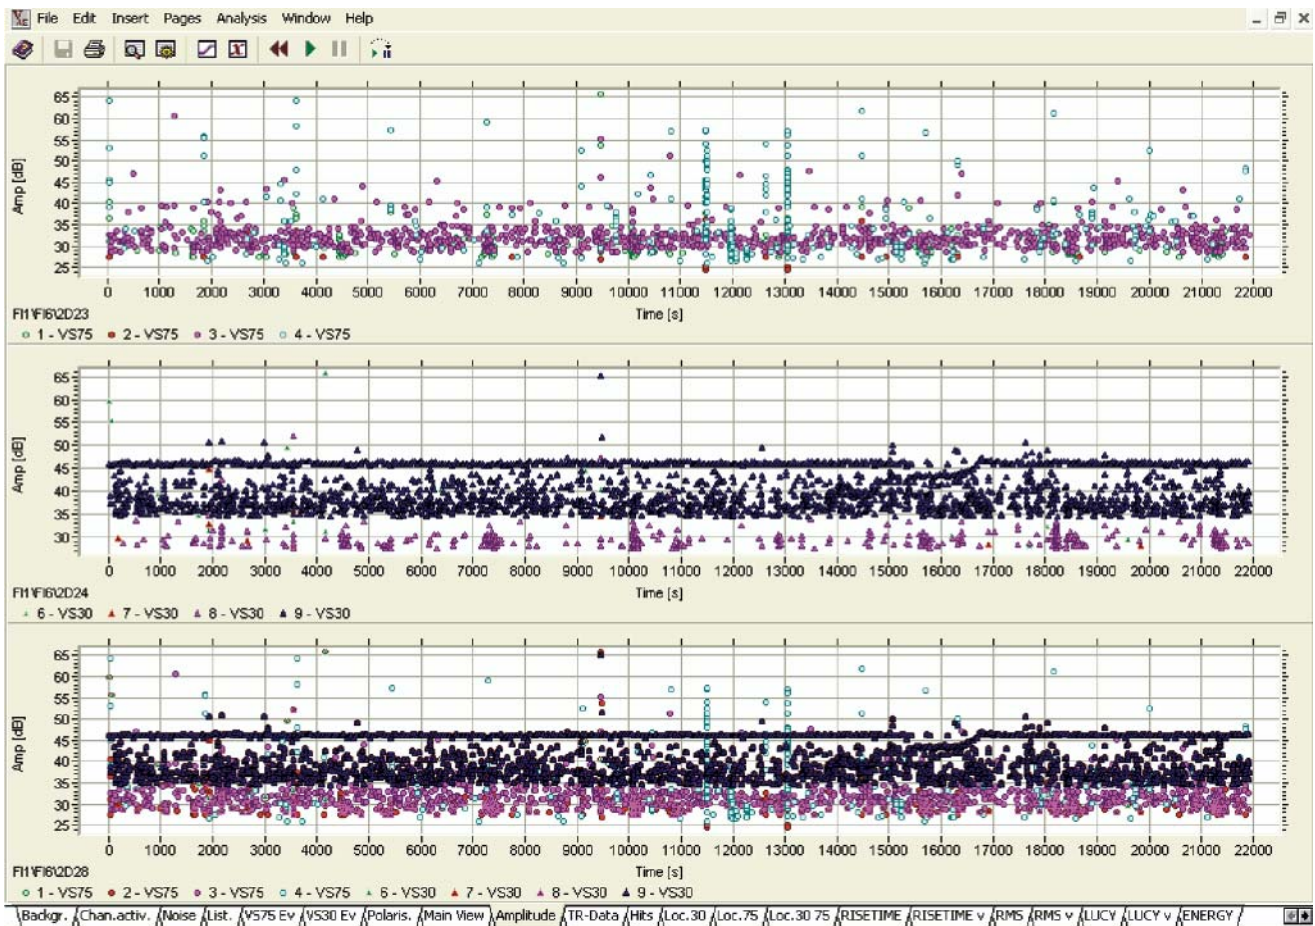
c) The peak amplitude A_m

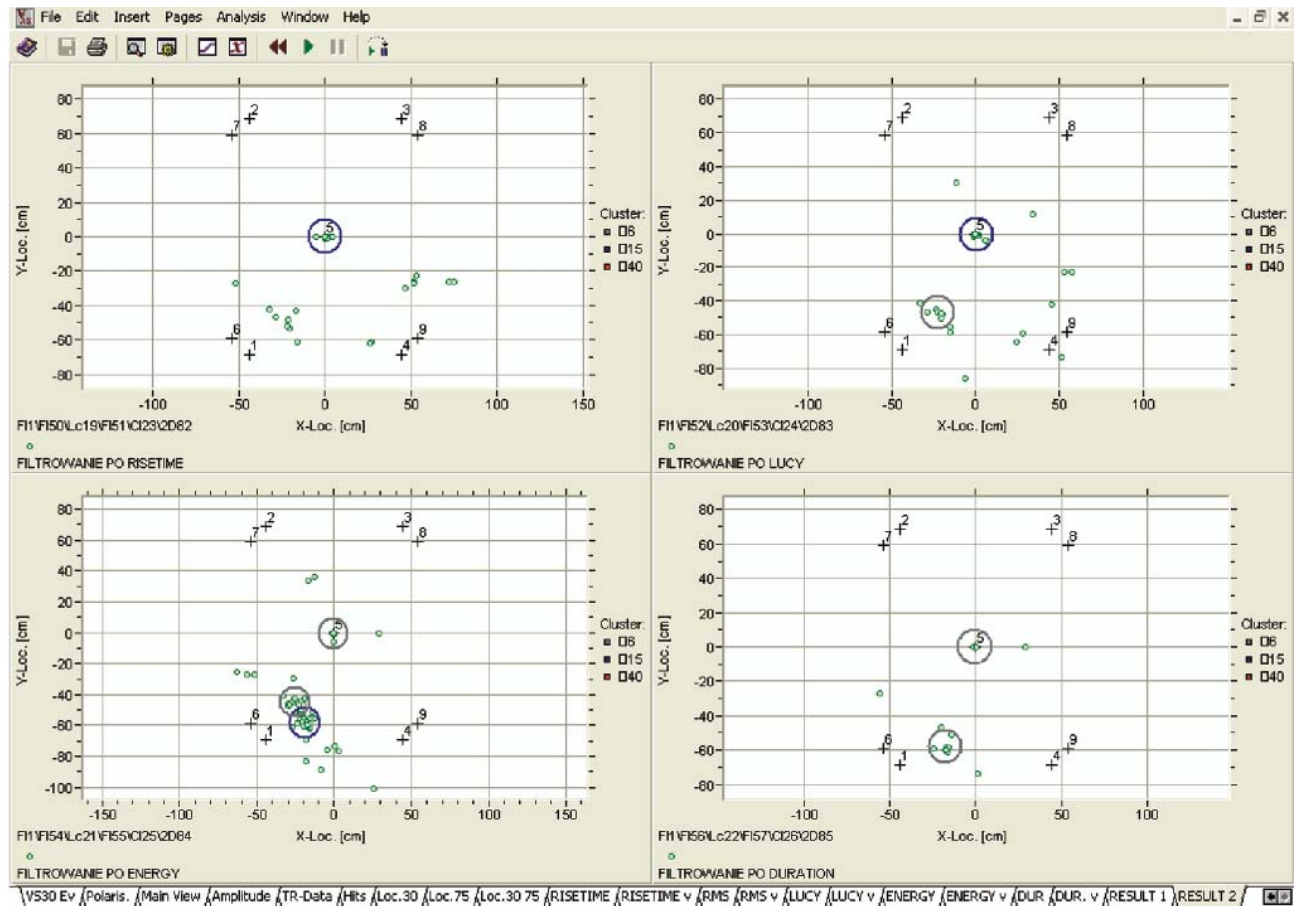
e) Localization with filtering

- Small additional acoustic emission sources localized on the plate specimen with the protective coating (no. 6) were found. The localized signals which are characterized by another energy quantity and another rise time, suggest that their origin character is different than that of corrosion processes, e.g. resulting from the cracking of internal concrete structure of coating layer.
