Results of acoustic emission tests of corrosion protection degree of ship steel tanks covered by means of protective coatings (Phase I)

Henryk Bugłacki
Piotr Eichert
Gdańsk University of Technology

This paper presents methods and results of the 1st series of tests of acoustic emission (AE) signals, aimed at assessing degree of corrosion protection of a tank made of hull structural steel, protected by means of a protective coating combined from polyurethane layer and concrete filler. The tests were carried out in compliance with a method specially elaborated for application to the work in question. In the method were used requirements of the standards in force, as well as experience gained during realization of the research project CORRSHIP, included in 5th Frame Program of European Union. The application of the AE method to detect and localize corrosion sources during exposure of specimens to corrosive mixture confirmed its high usefulness for the carried-out tests on corrosion protection effectiveness of new types of protective coatings.

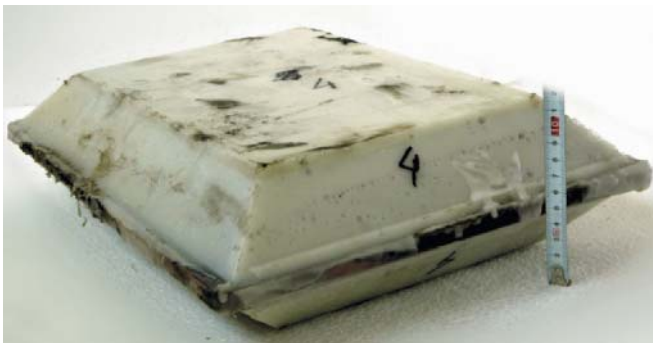
Fig. 2. The specimen covered with the polyurethane layer - concrete filler protective system

In Fig. 2 the specimen covered with the polyurethane layer - concrete filler protective system is shown.
