Simulation of damage process of containership's side structure due to collision with a rock

This paper presents methods and results of a simplified numerical simulation of collision process of containership's side structure and a rock. Analysis of results of the modeling makes it possible to draw conclusions as to a character of the event as well as to estimate area and depth of damage caused by the penetrating rock, in order to select geometry of a filler and impermeable layer of 2nd protection barrier.

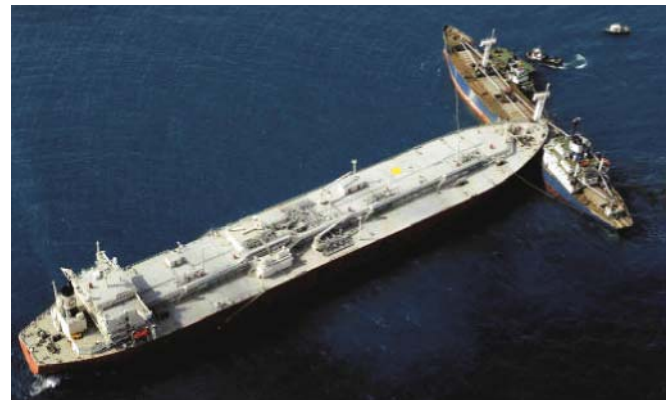
As shown below, the perpendicular hit of bow of one ship against midship part of the other is an often occurring case of collision, Fig. 1 and 2.

Fig. 1. Collision of m/t Gas Roman and m/v Springbok [2]

During such hit – if the hitting ship is fitted with a bow bulb – a damage of hit ship's plating and supporting structure in its bilge zone below waterline, is possible. In this zone fuel

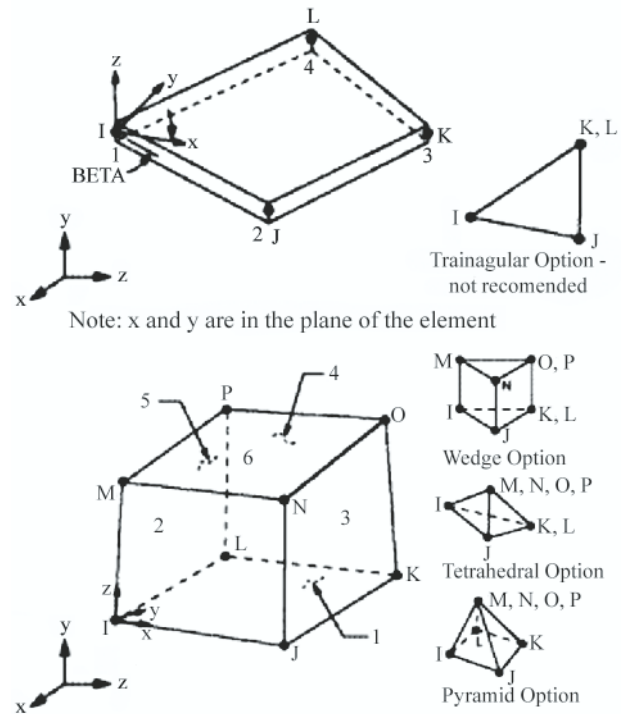
of the frames were modeled with finite shell elements, webs of the plating stiffeners in the zone between frame no. 86 and 121 – with finite shell elements, and in the remaining zones – with finite beam elements. And, flanges of the stiffeners and frames were modeled with finite beam elements within all the model, Fig. 3.

Fig. 3. Forms of finite shell and solid elements applied to the analysis
