B. Świczko-Żurek¹, A. Szumlański², J. Zorn¹

ALLERGY TO IMPLANT COMPONENTS: CHROMIUM, NICKEL, COBALT AND TITANIUM

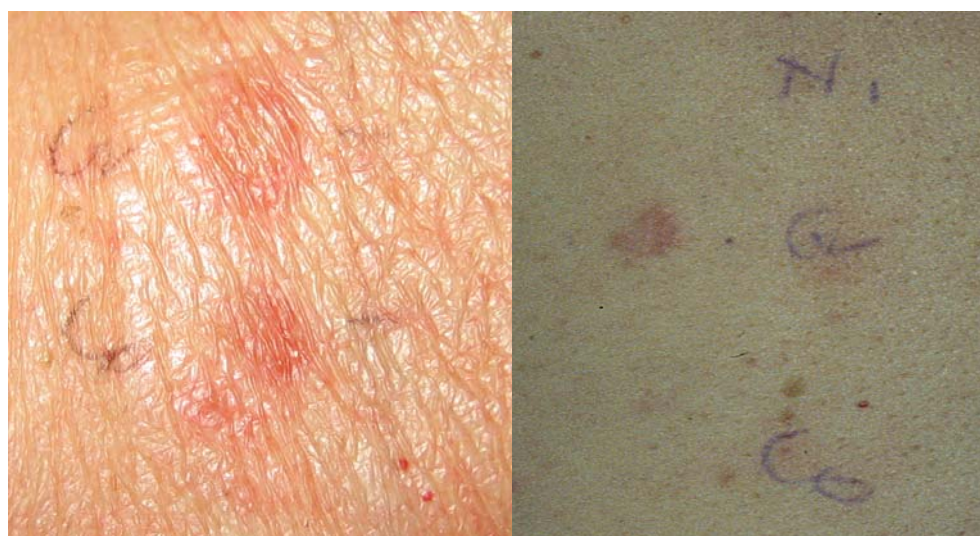
The patients (6) were subjected to the tests on the Ni, Cr, Co allergens (Fig.3).

Fig.3. Skin changes after performing the tests

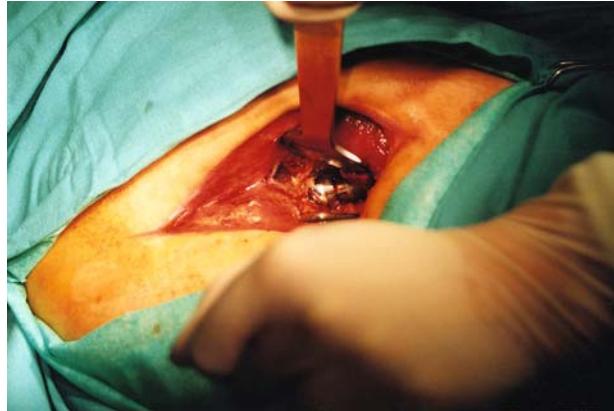
Two of them (1,2) had their implants removed due to aseptic loosening and intolerance of endoprosthesis. It resulted in pain, fistula serosa and edema. There were found to have oversensitiveness to Cr and Co. The allergic were not diminished by using antihistaminic drugs (Fig.4).

Fig.4. The hip implant removing caused by aseptic loosening

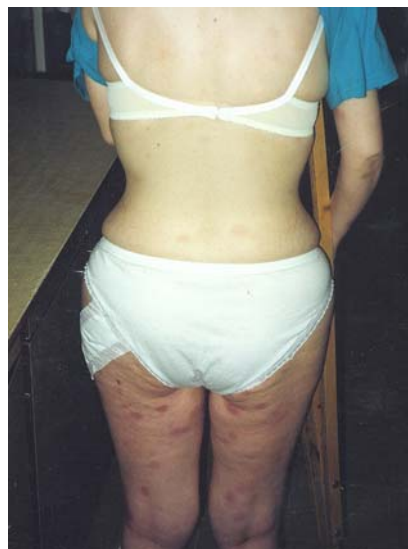
The patient (3) with Ni allergy suffered from skin imperfections after introducing hip implant (Fig.5). The symptoms decreased after applying antihistaminic drugs.

Fig.5. The patient with Ni sensitiveness after applying hip prothesis
