## PROBLEMS OF VARISTOR QUALITY ASSESSMENT DURING EXPLOITATION

### Abstract

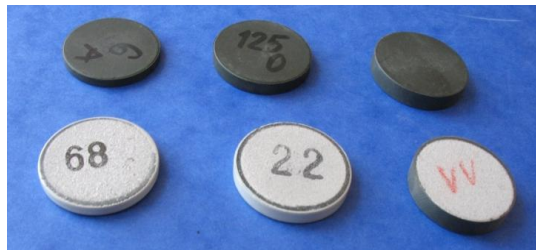
Fig. 1. Varistor samples: ZnO structures after being fired (top row) and with metalized contacts (bottom row); the thickness of the varistor structure determines the voltage value when the varistor begins to conduct current: left – 280 V, middle – 440 V, right – 660 V.

Varistors are produced on the basis of zinc oxide (ZnO) with a homogeneous distribution of various dopants – other metal oxides (e.g.: bismuth, cobalt, manganese) – in the ZnO mixed powder [1-4]. The composed material is usually cylindrically shaped in a press and fired later at high temperature (Fig. 1), to aggregate ZnO into grains. The aggregation process depends on how the used materials are mixed and squeezed. The mentioned additives play an important role during aggregation processes and are precisely selected by the varistor producer.

The voltage when varistor starts to conduct current is determined by the number of the grain junctions between the varistor electrodes. Thus, a shift in these voltage values is provided by changing the element thickness or applying a stack of the elements. The latter method is used for preparing varistors which protect high voltage power lines.

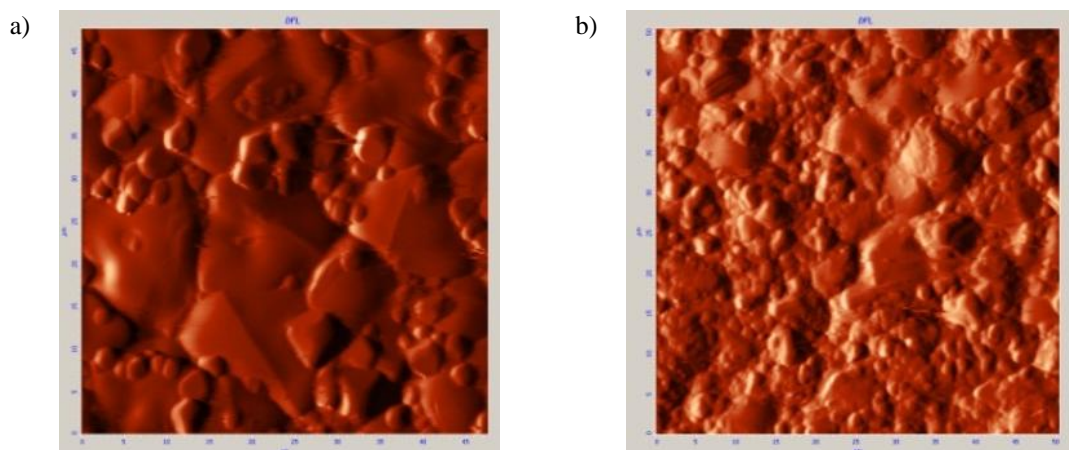
Fig. 2. Varistor structures in microscopic view (square area of size  $50\ \mu\text{m} \times 50\ \mu\text{m}$ ): (a) well-prepared with large grains; (b) poor quality with smaller grains.

The aggregated grains form a structure which determines the final current-voltage characteristics of varistors. The well-prepared elements comprise relatively big grains that have the non-linear characteristics of junctions between them (Fig. 2a). Tiny grains (having ohmic contacts) are characterized by more linear characteristics (Fig. 2b). The ultimate varistor characteristics is the sum of characteristics of the junctions between the consecutive grains.

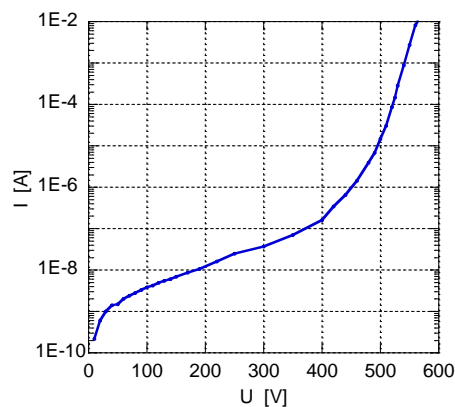
Fig. 4. Typical current-voltage characteristics of a varistor designated for working in a household power network.

Varistors are characterized by a strongly non-linear current-voltage characteristics (Fig. 4). This means that at a low voltage of a few hundred volts the leakage current of a varistor applied in a domestic power network should not exceed 1 mA (typically, such varistors can sustain the currents up to 10÷15 kA during short (~10  $\mu$ s) overvoltage pulses). When an overvoltage pulse occurred with a longer duration, e.g. ~100  $\mu$ s, then the sustained current is lower due to limited ability of heat dissipation within the ZnO structure.

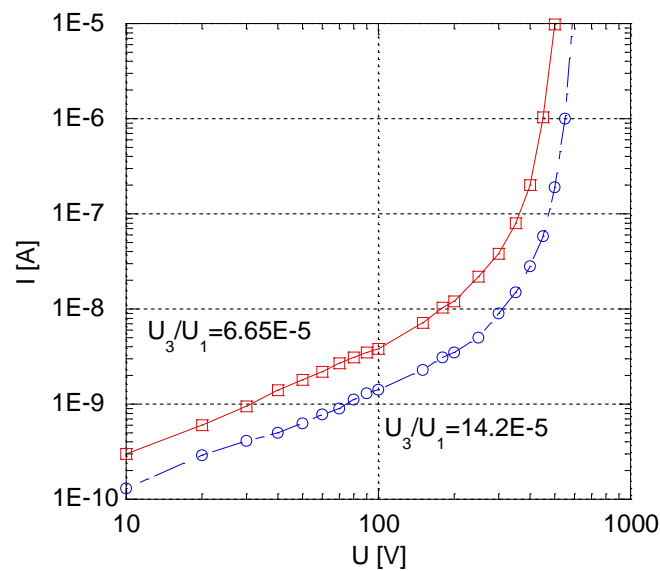
Fig. 5. Intensity of the third harmonic component  $U_3$  related to current-voltage characteristics in varistors designated to work with nominal voltage of 280 V; varistors were polarized during measurements by a sinusoidal voltage  $U_1$  having a frequency of 10 kHz.

The simplest method of varistor quality determination is to measure its leakage current or to measure its nonlinearity by the third harmonic component [1]. The leakage current can be measured by applying a magnetic current sensor (e.g. a coil having a ferromagnetic or a steel core) and a current meter. The third harmonic can be measured by a specialized nonlinearity meter but it is more complicated than the leakage current measurements because a polarizing voltage in a power network has usually nonlinear components of unknown intensity. Therefore, in this case the system has to monitor nonlinearities of the power network voltage which polarizes the investigated varistor, too. The third harmonic component is a reliable factor of varistor quality and differs among the examined elements (Fig. 5). Table 1 presents data obtained for two groups of varistors: well prepared (marked with the letter "O") and having poor quality (marked with the letter "A"). For every "O" sample the third harmonic index value was higher. This indicates more nonlinear current-voltage characteristics.

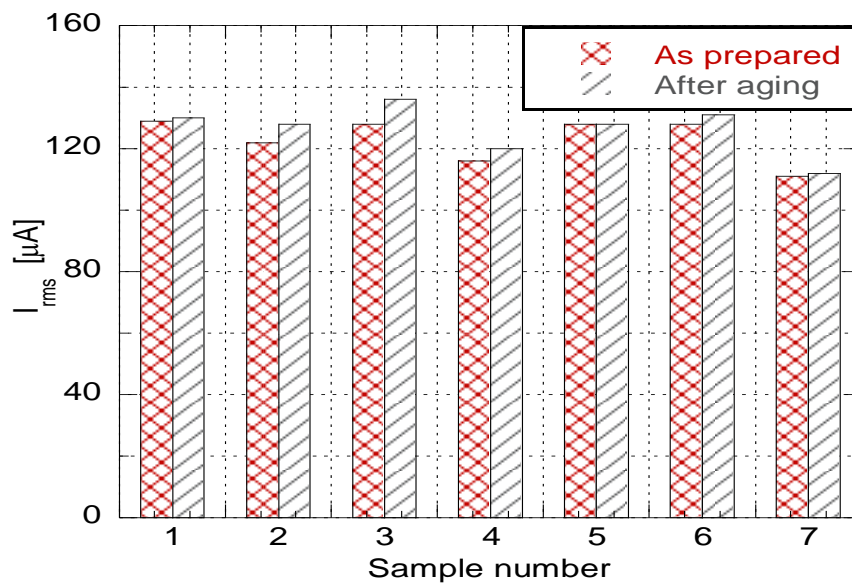
Fig. 6. Changes of the leakage current  $I_{\text{rms}}$  in an exemplary set of seven varistors at a polarizing voltage of 350 V<sub>rms</sub> before and after aging by applying 1000 current pulses of amplitude 0,5 kA and duration 8/20  $\mu\text{s}$ .

The above-mentioned problems of varistor quality monitoring in their working mode suggest that the most reliable method should base on measurements of their leakage current and temperatures at excessive overvoltage pulses. There is clear evidence that even not too intensive aging by repeated current pulses increases slowly varistor leakage currents (Fig. 6).

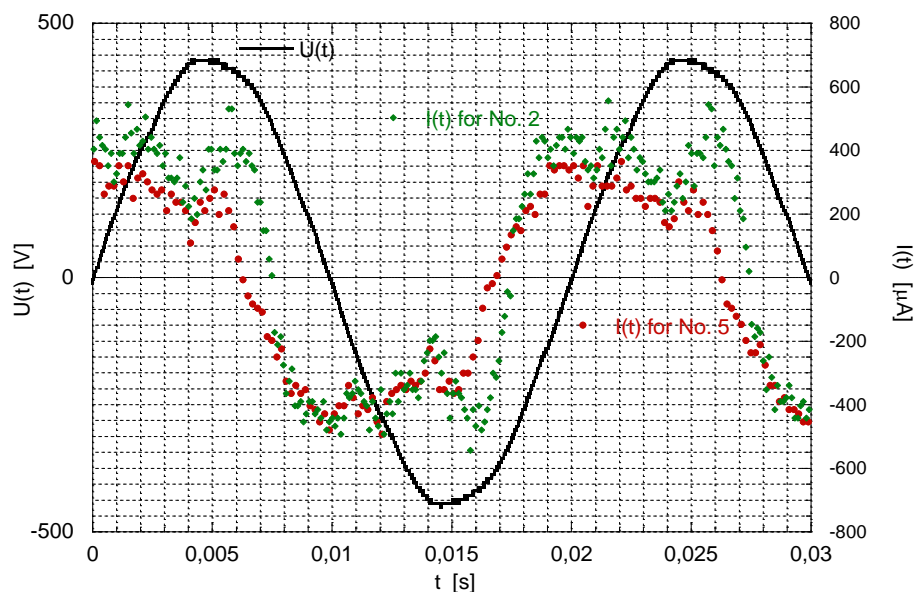
Fig. 7. Intensity of leakage current  $I(t)$  flowing through varistors of poor (No. 2) and high (No. 5) quality polarized by sinusoidal voltage  $U(t)$ ; the investigated varistor's working voltage  $U_{\text{RMS}} = 275 \text{ V}$ ; the current  $I(t)$  was measured by current transformer, model Kyoritsu KEW 2432.

The leakage current can be easily measured during overvoltage pulses by a cheap electronic unit, isolated from the power supply line circuit (Fig. 7). The more problematic are varistor temperature measurements because the temperature sensor has to be powered and placed close to the varistor structure. Otherwise, such placement increases the probability of moisture invasion into the grained structure.

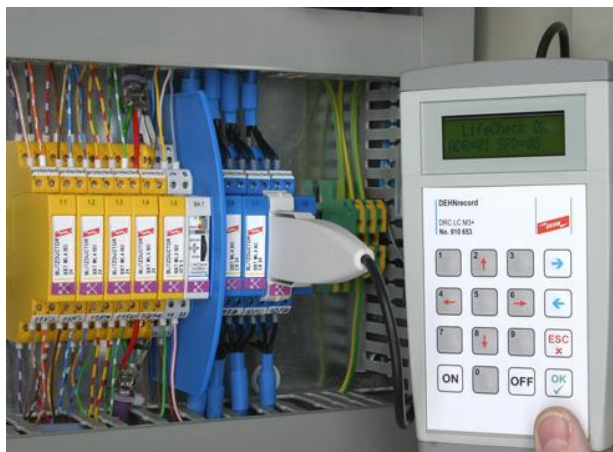
Fig. 8. Measurement system of varistor quality in a household power network proposed by DEHN [10].

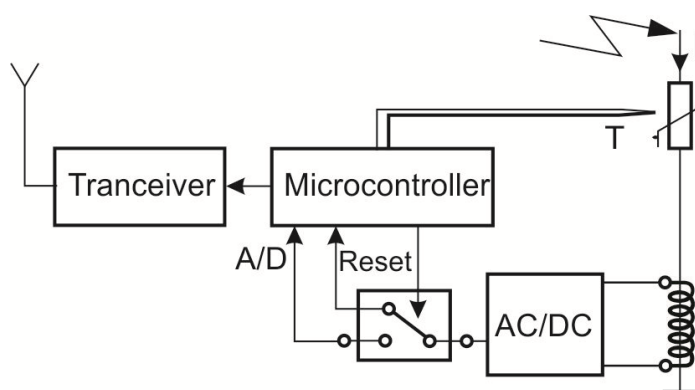
Fig. 9. Measurement system for varistor quality monitoring.

The unit requires extremely low power because it remains in the standby mode mainly. The exception is when it is waked by a reset signal induced when an overvoltage pulse occurs (Fig. 9). Then, the microcontroller measures the intensity of the occurred overvoltage pulse by counting the time when the signal at the output of the AC/DC converter is greater than the assumed threshold level. The proposed solution means that we can apply the microcontroller which needs in the standby mode a power consumption not exceeding a few  $\mu\text{W}$  and less than 1 mW when the output voltage of the AC/DC converter is measured [14]. Such a small energy can be delivered by a lithium battery which can be used in the system designed to last ten or even more years. To increase the reliability of the system, an alternative power harvesting unit (e.g., solar power, thermal energy) can be attached as well.

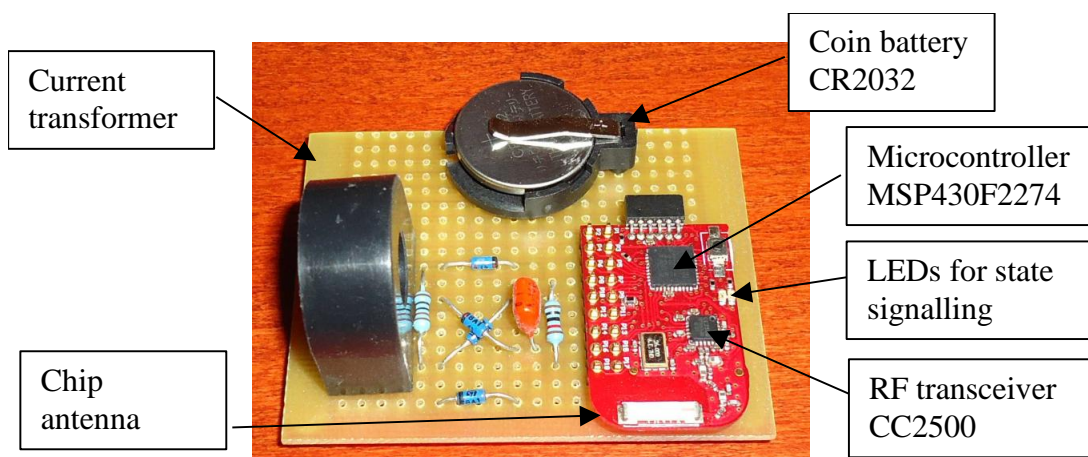
Fig. 10. The prototype version of the proposed measurement system with the RF transceiver for wireless communication.

The developed prototype version of the measurement system (Fig. 10) comprises a current transformer with a diode bridge and an RC filter which generates the reset signal to the microcontroller and integrates the overvoltage signal to measure its intensity. The current consumed by the working circuit depends on the functionality of the system. When the wireless communication module is switched off, the supply current is about 2,4 mA in the activated state (during voltage measurement by the built-in AD converter and saving data in the EEPROM on-chip memory) and drops to 1,4  $\mu$ A in the standby mode. Such current consumption is higher than the values suggested by the chip suppliers [16]. Despite the observed discrepancy, the applied battery, type CR2032 of 210÷260 mAh capacity, should maintain the system working even for ten years.
