## REDUCTION OF DERIVATIVE PIPELINE EFFORT IN WATER TURBINE

**Abstract:** The article presents an approach to evaluate and reduce the effort of the derivative pipeline in a water turbine of a hydroelectric power station in its vulnerable spots. Potential places of the biggest effort of the structure, as well as the coefficient of displacement and safety factor related to them were identified using FEM numerical method. Pipeline reinforcement was designed and made based on FEM analysis and non-destructive tests.

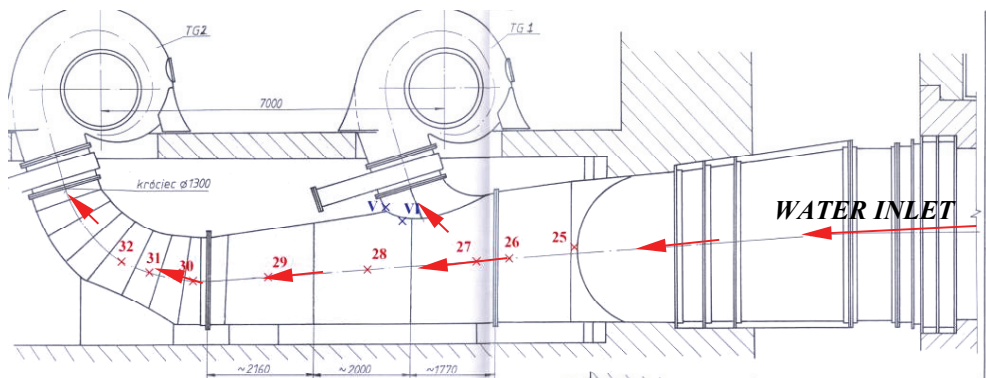
Fig. 3. Longitudinal section through the inlet pipe.

A general view of the water turbine generators of the hydroelectric station discussed is presented in Fig. 1. Figure 2 shows the view of water inlet pipelines between the turbo generators. A draft with selected dimensions is shown in Fig. 3.

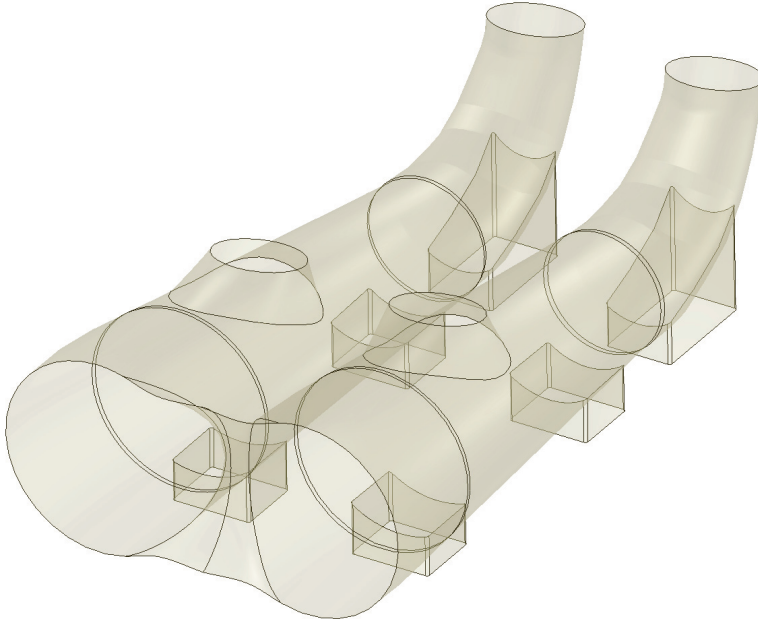
Fig. 4. Surface model of the pipeline.  
Source: prepared by the authors

A CAD computer model of the object examined was created based on available data (Fig. 4). The model was used for a numerical analysis to assess the structure's level of effort.

The thickness of the pipeline wall is 8 mm. The geometric model and calculations were made for the shells.

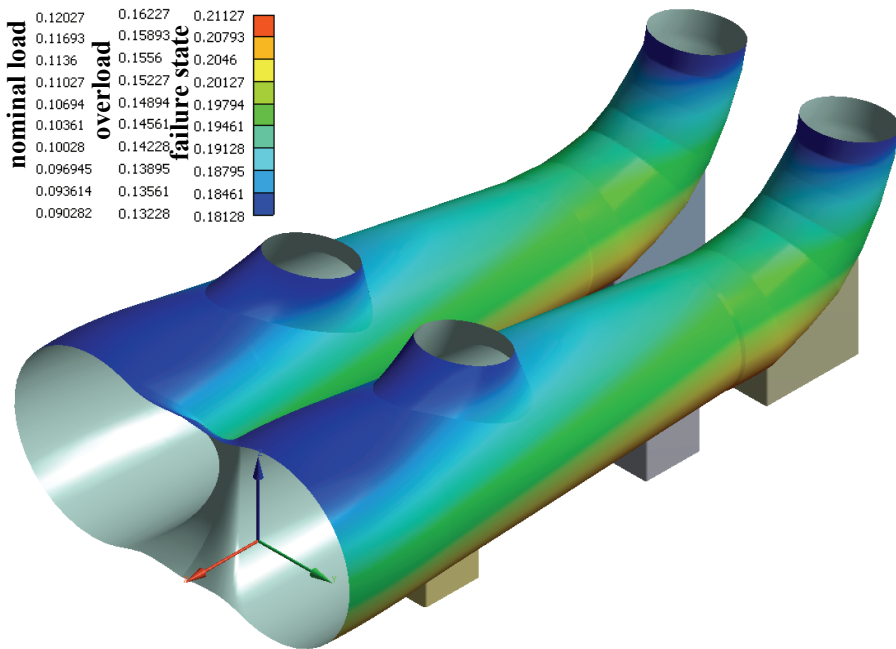
Fig. 5. Distribution of hydrostatic pressure in pipeline.

On the basis of the operating data the nominal hydrostatic load was set at 0.12 MPa, equivalent to water gauge of 10.5 m which occurs as a difference of water levels between the influent water and the bottom of the pipeline. For dynamic load states, as recommended, an overload factor of 1.4 was taken (start) – then the value of pressure loading the structure is 0.16 MPa. The value of 0.16 MPa matches the pressure that arises in reality when the turbo generator is launched [1]. The stresses have to exceed the ultimate strength of the material in failure state. A 0.21 MPa pressure meets this requirement.

Hydrostatic pressure distribution shown in Fig. 5 remains the same. Appropriate colour ranges correspond to calculated variants, which are provided with comments (nominal load, overload, failure state).

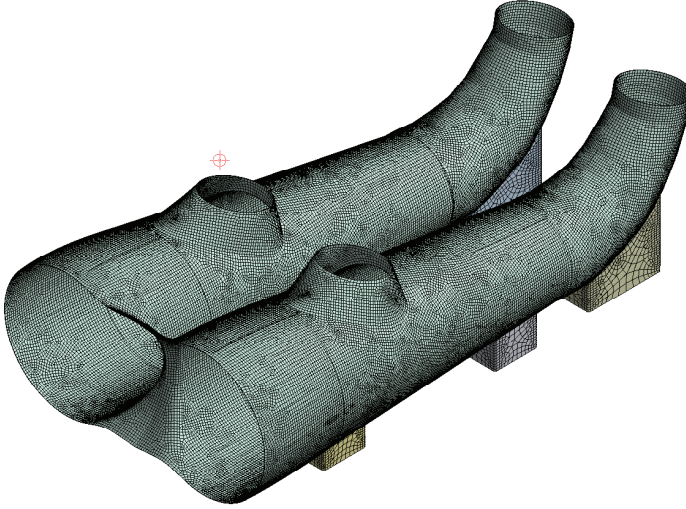
Fig. 6. Selected finite element mesh.  
Source: prepared by the authors

Finite element mesh is made out of shell finite elements with six degrees of freedom for each of the eight nodes per element (Fig. 6). The number of nodes in this range was 221231, with 73388 elements.

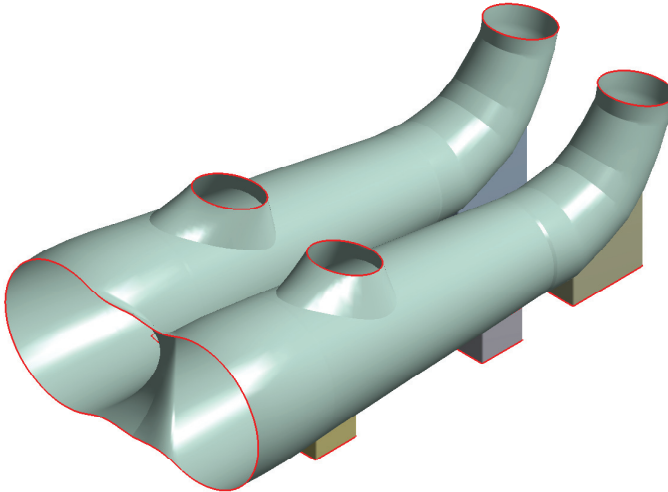
Fig. 7. Support of the model studied.  
Source: prepared by the authors

Red (Fig. 7) is used to mark the edges (nodes) whose degrees of freedom were eliminated. This way the places where the structure cannot displace were simulated. In general, these are the places where the structure is fixed to foundations, intake walls or where inlet flanges are fixed to the base of the turbine.

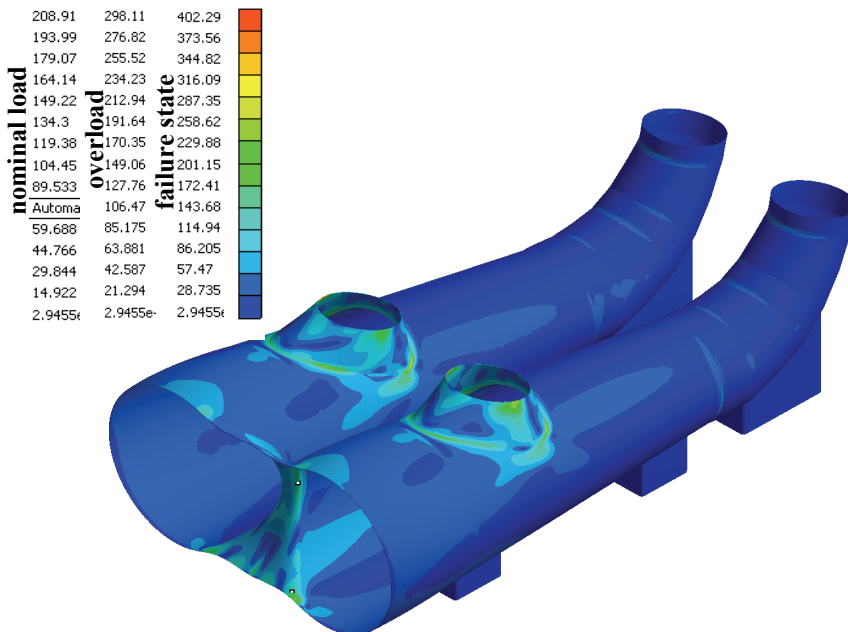
Fig. 8. Huber's reduced stress – colour range for 0.12, 0.16 and 0.21 MPa, respectively.

Figures 8 to 10 present the results of calculations as mapping of functions. Stresses reduced in accordance with Huber's hypothesis are shown in Fig. 8. The colour ranges represent, as before, nominal load, overload and failure state load, respectively. The value of reduced stress at its concentration points amounts to 80–150 MPa with nominal load. The maximum value of stress of 208 MPa (red colour in the range) may be ignored because this is the value for the point on the edge and its degrees of freedom were eliminated, thus it is the result of an approximation error of a finite element shape function. Stresses in notches under pressure of 0.16 MPa assume the value of 220 MPa and are lower than yield strength.

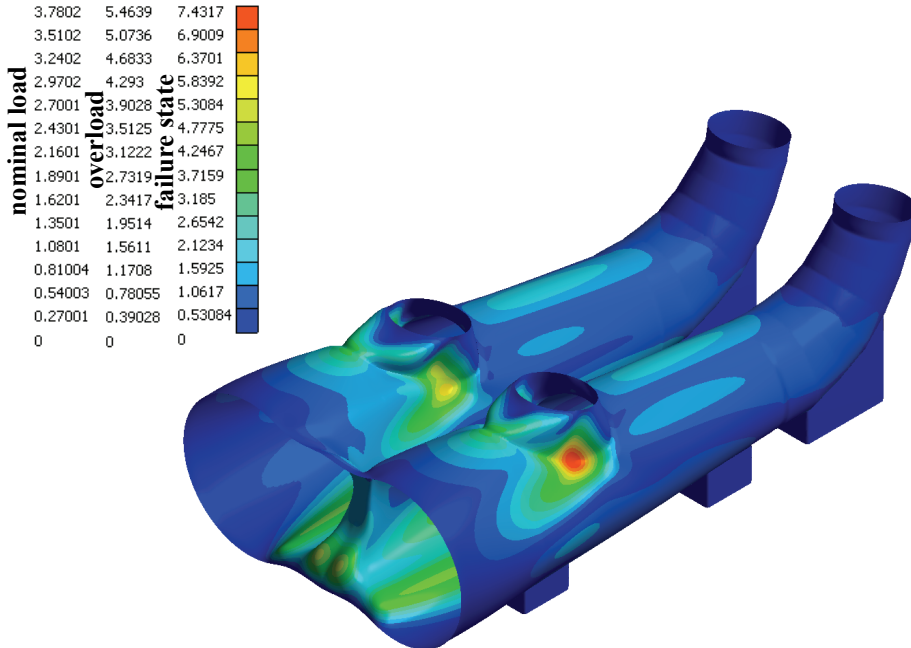
Fig. 9. Failure displacement (values in mm) – colour range for 0.12, 0.16 and 0.21 MPa, respectively.  
Source: prepared by the authors

Figure 9 illustrates resultant displacement. In nominal load state displacement value was equal to 3.7 mm; however, in overload state it was equal to 5.4 mm. The value of displacement in failure state was 7.4 mm. The last one does not make physical sense since the material exceeded its ultimate strength.

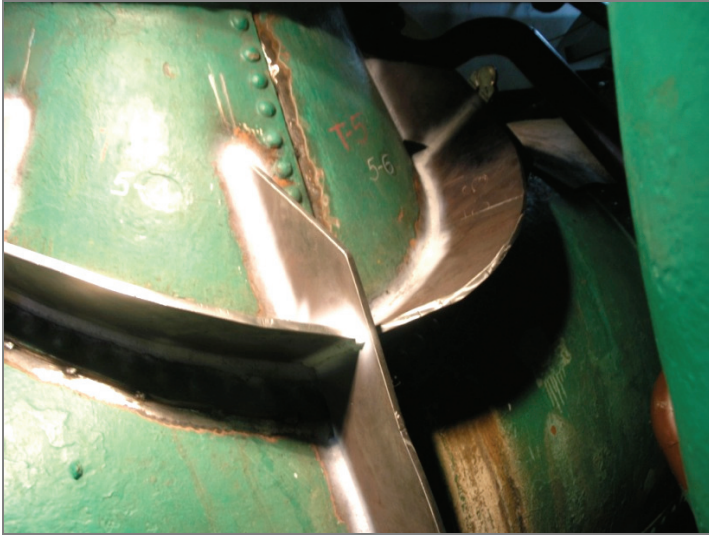
Fig. 12. Similar solutions.  
Source: prepared by the authors

Using the knowledge concerning existing solutions (Fig. 12) designed by the authors, the computer simulation was used again and multiple alternatives were examined to match an optimal way to reinforce the pipeline. The calculations were carried out for the pressure of 0.21 MPa at failure state until the achieved value of the reduced stress was below the yield strength.

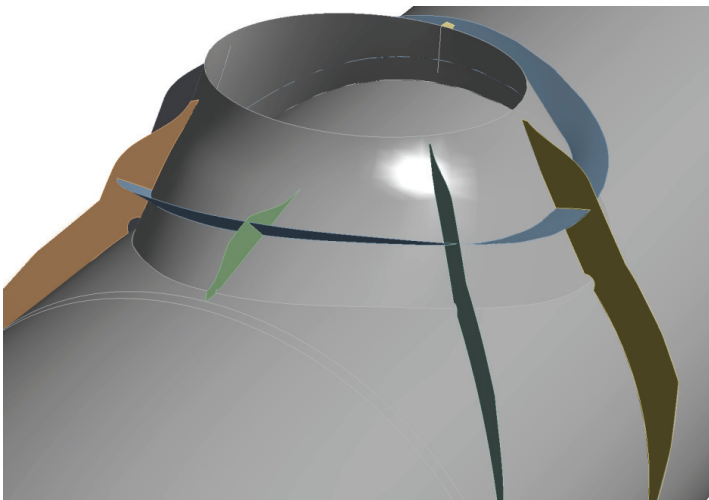
Fig. 13. Optimum location and shape of webs and bracing ring.  
Source: prepared by the authors

Finally, bracing with 6 webs and a ring was selected using 6 mm thick plates (Fig. 13). The location of the webs symmetrically to longitudinal section plane where the biggest distortion is observed was considered the most effective. Cladding with a 3 mm plate was chosen for branch reinforcement.

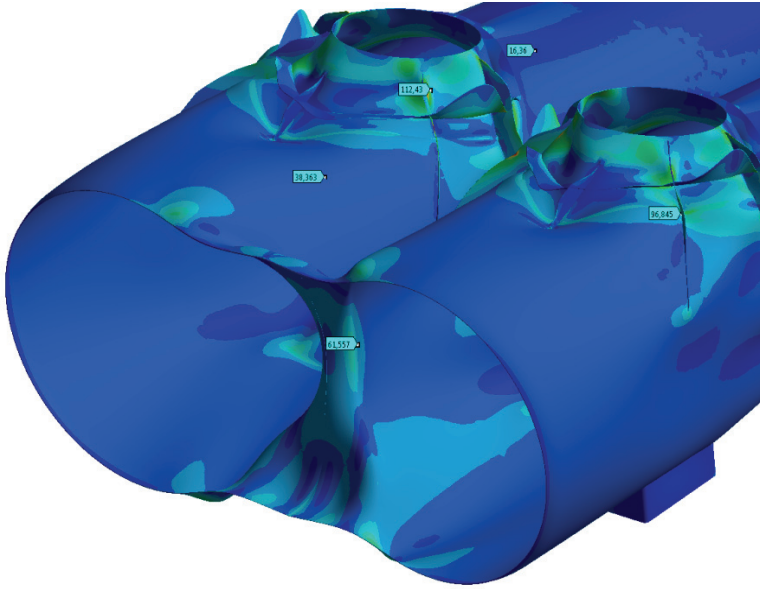
Fig. 14. Reduced stress in the pipeline with reinforcement under 0.21 MPa pressure below yield strength of the material  $R_e = 280$  MPa (rescaled view).

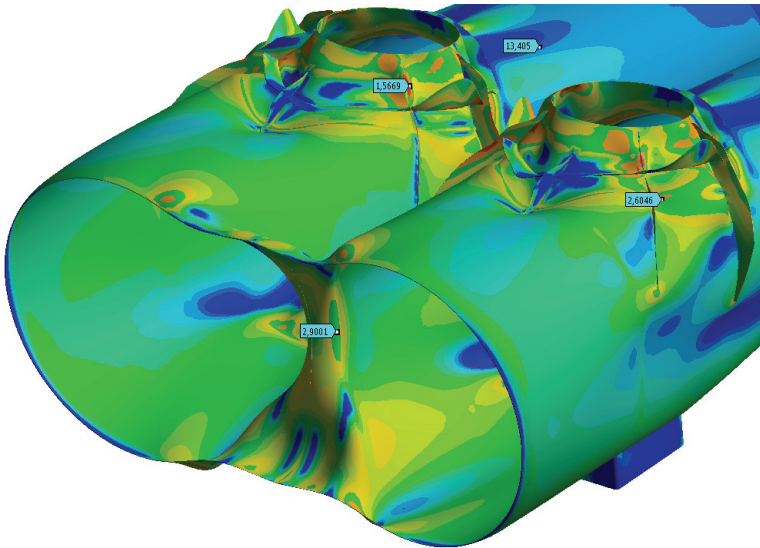
Fig. 15. Safety factor in the pipeline with reinforcement under 0.21 MPa pressure in the range above 1.5 (rescaled view).

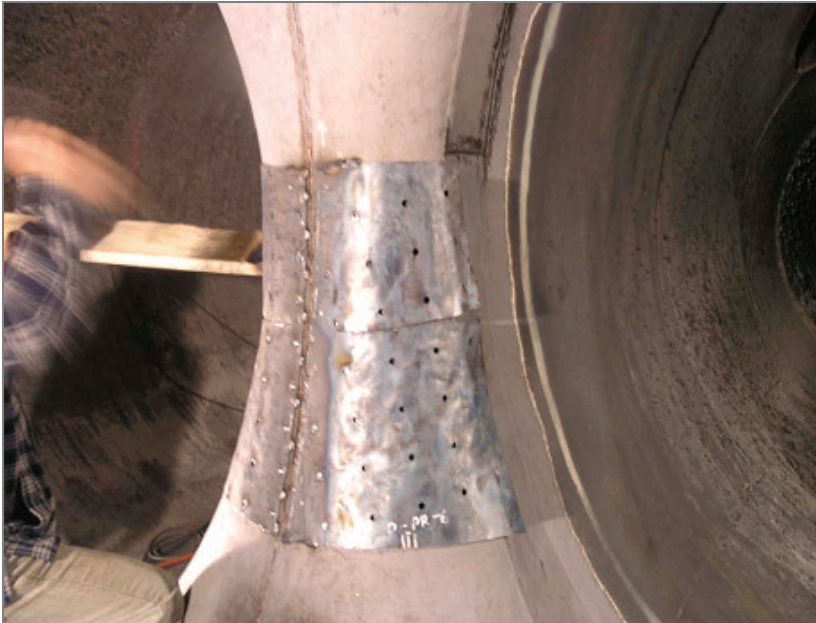
Fig. 16. Quadrangular components of the reinforcement in the process of tacking along centerline of the branch.

The assembly of the reinforcement components began from the central part (Figs. 16, 17). The reinforcement of the branch structure was divided into stages. First, the plating of the central part of the branch was laid, next the reinforcement plates of the bottom surface were laid symmetrically to the division plane. The last stage was creating the reinforced areas on the top surface of the branch. After careful fitting into the pipeline surface, each component was joined with tack welds along its perimeter, the plug welds were also made.

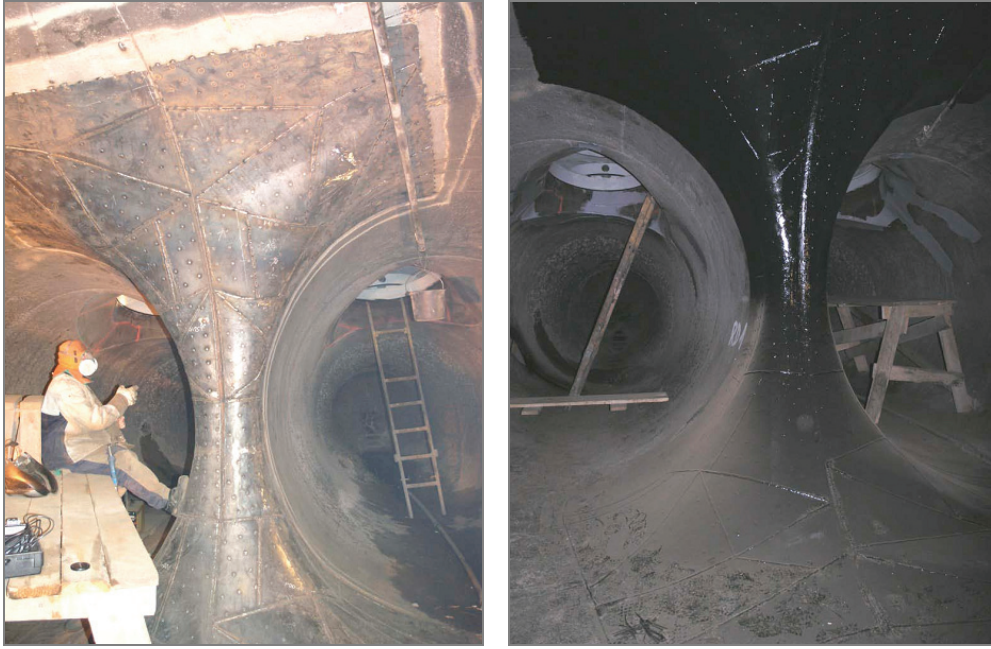
Fig. 17. Structure welding of the reinforcement components to the coating of the pipeline branch and the completed painted plating of the pipeline branch.

The next stage comprised of depositing circumferential fillet welds which joined three components simultaneously: adjoining edges of reinforcement components with pipeline coating, MAG welding process and 1.0 mm diameter solid wire with Ar + CO<sub>2</sub> gas shield were used.

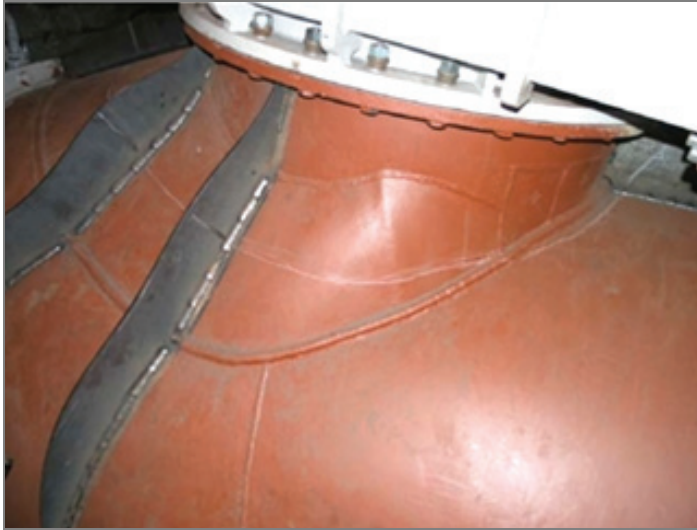
Fig. 18. Assembly of webs to the inlet pipe and the pipeline coating.  
Source: prepared by the authors

The bracing prepared was tacked to inlet pipe plates and pipeline coating as specified in the project documentation (Fig. 18). Once all webs and reinforcement rings were tacked to both inlet pipes, welding work began. The developed welding procedure stipulated weld deposition symmetrically to longitudinal centerline of the web in addition to welding of individual webs symmetrically to inlet pipe centerline. The same welding process was used as for joining the reinforcement in the pipeline branch, i.e., MAG welding process.

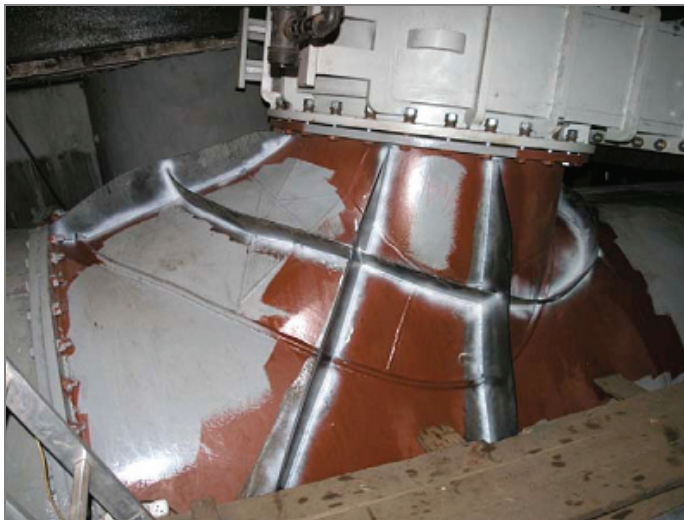
Fig. 19. Bracing webs with reinforcement ring on the inlet pipe.  
Source: prepared by the authors

In accordance with the experimental procedure visual tests (VT) and magnaflux tests (MT) were conducted to examine the fillet welds (Fig. 19). Quality level C, as defined in PN ISO 5817 standard, was presumed in the study. Test results have shown that the quality of the welds fits level B, which is higher than the presumed level.
