## REDUCTION OF DERIVATIVE PIPELINE EFFORT IN WATER TURBINE

**Abstract:** The article presents an approach to evaluate and reduce the effort of the derivative pipeline in a water turbine of a hydroelectric power station in its vulnerable spots. Potential places of the biggest effort of the structure, as well as the coefficient of displacement and safety factor related to them were identified using FEM numerical method. Pipeline reinforcement was designed and made based on FEM analysis and non-destructive tests.

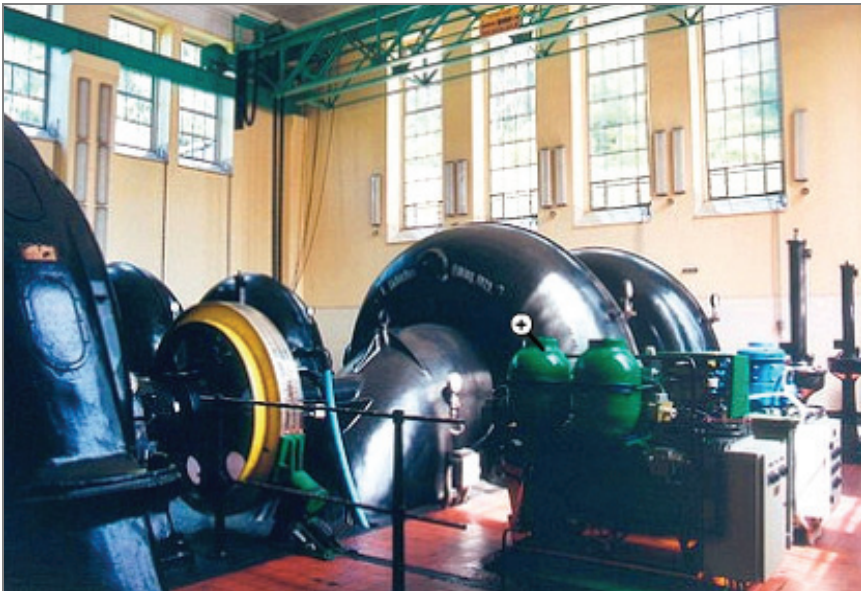
Fig. 1. View of water turbine generators in Łapino.  
Source: <http://energia-hydro.pl/2,26,0,Galeria-Lapino.html>

A general view of the water turbine generators of the hydroelectric station discussed is presented in Fig. 1. Figure 2 shows the view of water inlet pipelines between the turbo generators. A draft with selected dimensions is shown in Fig. 3.

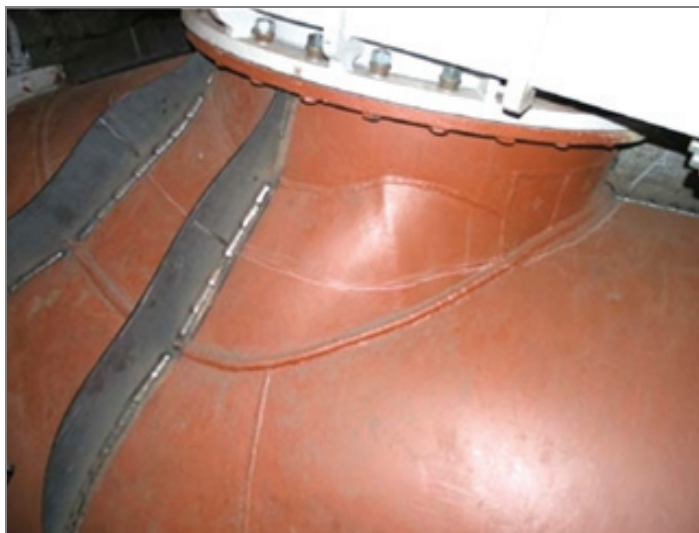
The bracing prepared was tacked to inlet pipe plates and pipeline coating as specified in the project documentation (Fig. 18). Once all webs and reinforcement rings were tacked to both inlet pipes, welding work began. The developed welding procedure stipulated weld deposition symmetrically to longitudinal centerline of the web in addition to welding of individual webs symmetrically to inlet pipe centerline. The same welding process was used as for joining the reinforcement in the pipeline branch, i.e., MAG welding process.

Fig. 18. Assembly of webs to the inlet pipe and the pipeline coating.  
Source: prepared by the authors

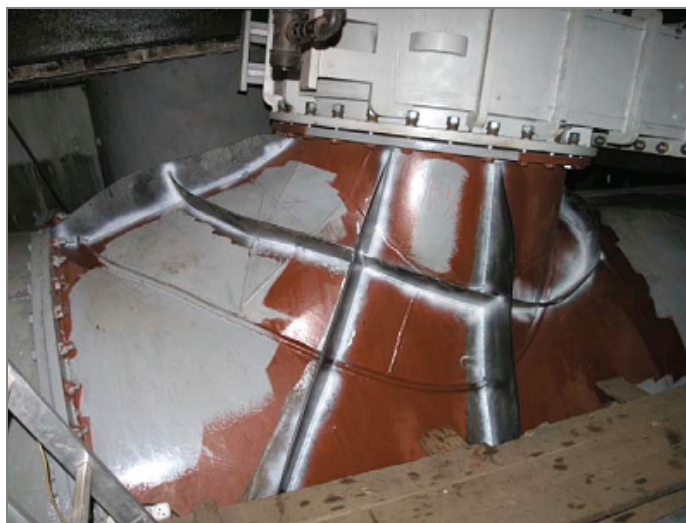
In accordance with the experimental procedure visual tests (VT) and magnaflux tests (MT) were conducted to examine the fillet welds (Fig. 19). Quality level C, as defined in PN ISO 5817 standard, was presumed in the study. Test results have shown that the quality of the welds fits level B, which is higher than the presumed level.

Fig. 19. Bracing webs with reinforcement ring on the inlet pipe.  
Source: prepared by the authors
