Karolina Prokop, Grzegorz Rogalski

# Cold Cracking Susceptibility of Joints made of Ferritic-Austenitic Duplex Steel 2205 during Underwater Wet Welding

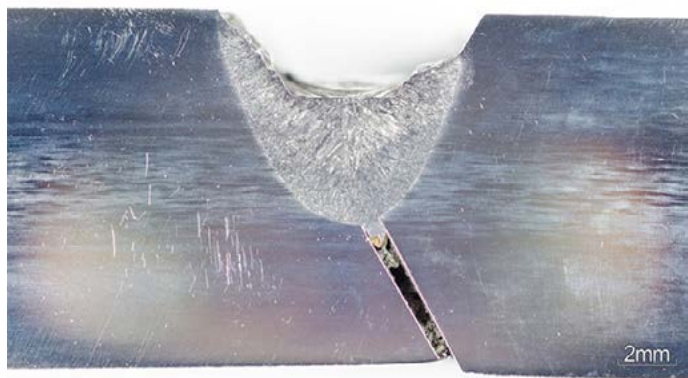
Fig. 2. Cross-section of the joint welded under water: specimen W1, non-saline water,  $q_{el} = 1.11$  kJ/mm; the lack of welding imperfections; etchant: Beraha

The macro and microscopic metallographic tests were performed following the requirements of standard PN-EN ISO 17639. The specimens were cut out using a frame saw, transversely in relation to the weld axis, so that they would include an entire welded joint. The specimen surfaces were subjected to grinding, polishing and etching using the Beraha reagent. Figures 2-6 present the microstructure of the Tekken test joints.

The results of the macroscopic tests largely confirmed the NDT results, additionally revealing internal welding imperfections such as gas pores, gas cavities and cracks initiated in the root. The HAZ was very narrow and unidentifiable up to a magnification of 50x. Both the welds made in air and under water

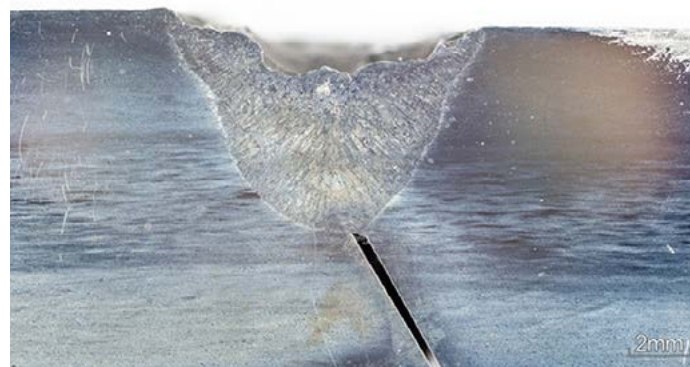
Fig. 4. Cross-section of the joint welded under water: specimen W3, non-saline water,  $q_{el} = 3.02$  kJ/mm; the lack of welding imperfections; etchant: Beraha

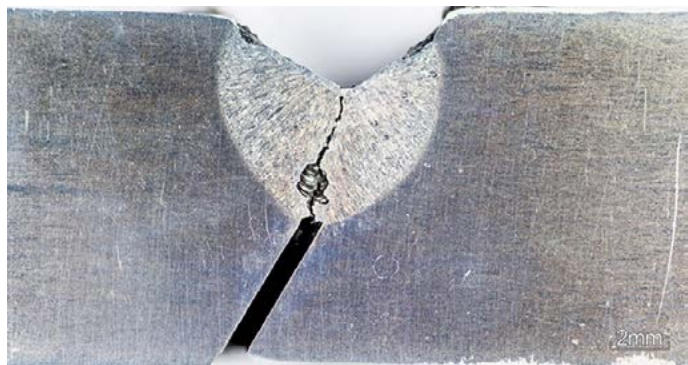
Fig. 5. Cross-section of the joint welded under water: specimen W4, non-saline water,  $q_{el} = 3.02$  kJ/mm; the crack visible in the weld (initiated in the root); gas pore; etchant: Beraha

using covered electrodes caused numerous difficulties maintaining stable welding parameters, “gentle” electrode melting and obtaining welded joints free from welding imperfections. The Tekken specimens made in air were free from cracks or other welding imperfections. The underwater welding performed with arc burning in an unstable manner lead to the formation of cracks in the weld axis. The wet welding

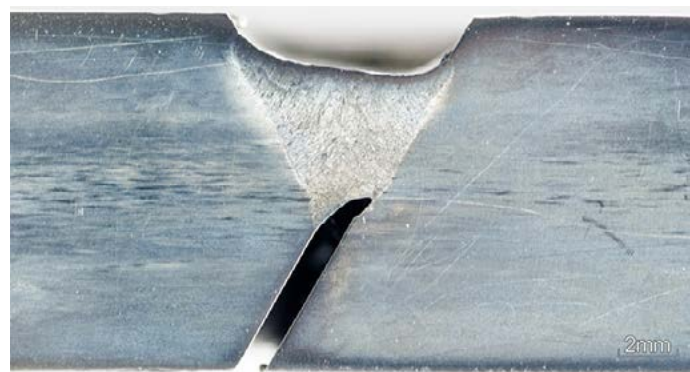
Fig. 6. Cross-section of the joint welded in air: specimen P1,  $q_{el} = 0.87$  kJ/mm; the lack of welding imperfections; etchant: Beraha

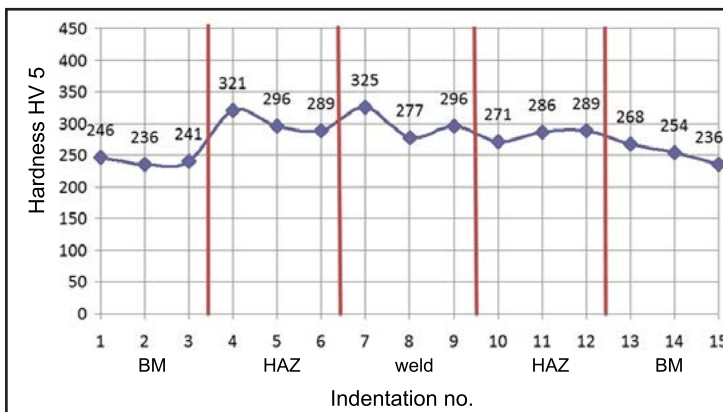
Fig. 12. Hardness distribution in the joint of Tekken W1 specimen welded under water

*arc welded joints*. However, it should be noted that in accordance with standard PN-EN ISO 15614-1:2008 *Specification and qualification of welding procedures for metallic materials. Welding procedure test. Part 1: Arc and gas welding of steels and arc welding of nickel and nickel alloys*, duplex steels are not subjected to hardness measurements. The hardness tests were performed using a VEB hardness tester. The indenter load amounted to 49.03 N (HV5). The hardness measurements were performed along the line located 2 mm below the face of the test welds. A scheme showing the location of measurement points is presented in Figure 10. Exemplary hardness distributions on cross-sections of welded joints are presented in Figures 11-15.

The cross-sectional hardness distribution in the joints along the measurement line was characteristic of duplex steels. The hardness of the base material did not exceed 270 HV5. An increase in the joint cooling rate resulting from the cooling effect of water did not significantly

affect the hardness of the specimens made under water or those made in air. The critical area of the joint, i.e. the HAZ, was not significantly hardened; therefore, it can be concluded that precipitation processes of secondary phases had not taken place during the welding thermal cycle [13-14]. It should be added that the precise measurement of hardness was impeded due to the very narrow HAZ area.
