Can Historic Interiors with Large Cubature
be Turned Acoustically Correct?Tadeusz KAMISIŃSKI⁽¹⁾, Andrzej KULOWSKI⁽²⁾, Roman KINASH⁽³⁾

Keywords: room acoustics; acoustic rehabilitation of historic interiors; Schroeder diffusers; microperforated foil.

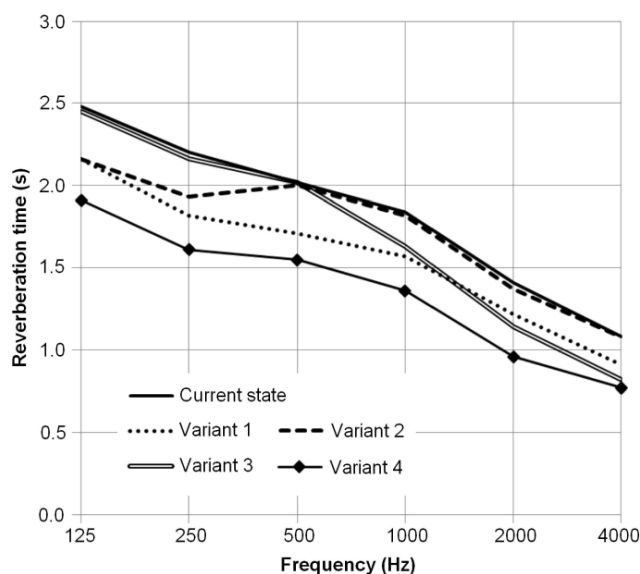
Fig. 5. Reverberation time frequency characteristics for the LUT Assembly Hall (unoccupied, computer simulation).

Simulation results closest to the design assumptions correspond to the use of all measures admissible in the hall in view of heritage conservation restrictions (cf. Table 2, Variant 4). The obtained value of $STI = 0.57$ corresponds to a good speech intelligibility (the reverberation time value for frequency 500–1000 Hz is 1.45 s). An interesting feature is the favorable behavior of the sound absorbing material used as lining under the paintings, thanks to which a significant reduction of the reverberation time in the low-frequency range has been obtained.

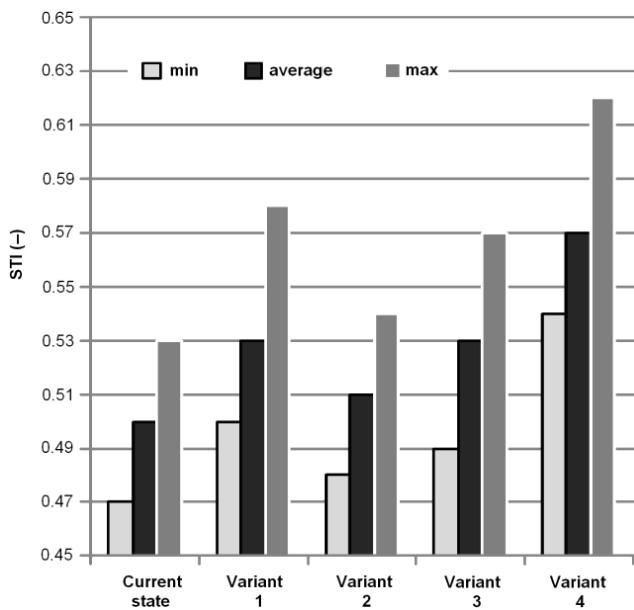
Fig. 6. The sound transmission index in the LUT Assembly Hall (unoccupied, computer simulation).

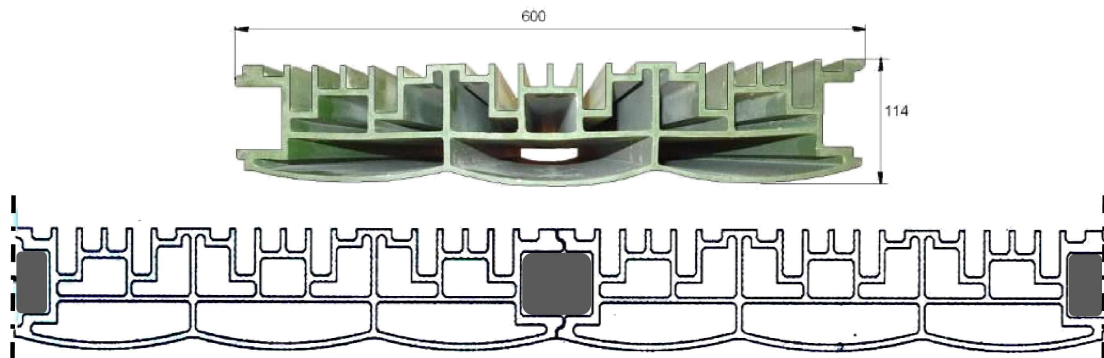
Fig. 9. A cross-section of the sound diffusers (dimensions in mm). The material and manufacturing process is protected as an industrial design (Community Designs Bulletin, 2012).

Schroeder diffusers are usually constructed by craftsmen in the course of interior finishing work or are offered in short series by specialized manufacturers. A solution concerning both the material and technological process used to fabricate the diffuser elements on an industrial scale has been patented in the European Union as an industrial design (Fig. 9). The diffuser has a form of a pressing continuously extruded out of a composite based on epoxy resin (EPD) filled with wood dust. The system is mounted on 60 mm × 60 mm posts inserted into holes provided in the diffuser’s structure.

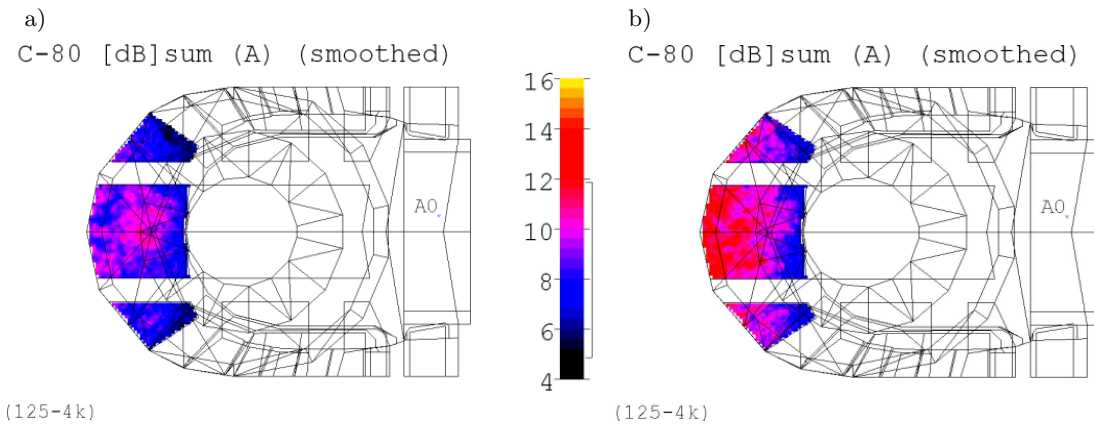
Fig. 13. The forecasted distribution of C_{80} values in the underbalcony area for the rear wall covered with:
 a) textile tapestry, b) sound diffuser.

smooth and hard rear wall with a sound scattering structure, distribution of the parameter became significantly more even (Fig. 12). The effect is particularly prominent for frequencies above 1 kHz, as in this very range, the sound absorption introduced by the diffuser is lower, while the scattering effect is stronger (Fig. 11). Even more favorable is the forecasted change in the clarity factor C_{80} (Fig. 13). This is especially

true for the last rear rows where acoustic deficiencies were most uncomfortable. In this area, C_{80} increases by as much as 5 dB, and what is more, distribution of this increased value remains even in the whole underbalcony zone. In view of the complex measurement procedure (ISO 17497-1, ISO 17497-2), sound scattering coefficients are rarely published. Graphs shown in Fig. 11 a come from the authors' own measurements (KAMIŃSKI *et al.*, 2012b), while scattering coefficients of other materials have been adopted as suggested in the instructions for the program CATT-Acoustic.

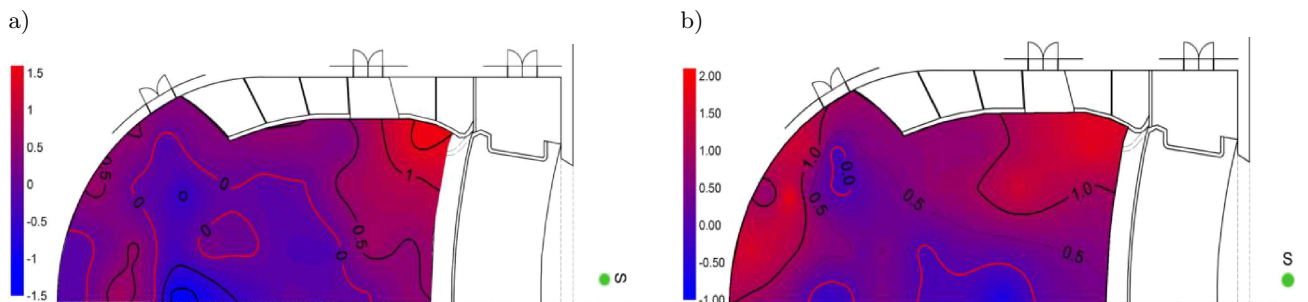
Fig. 14. The effect of mounting the diffusers on the sound strength G in octave bands: (a) 0.5–1 kHz and (b) 4 kHz.

surements covered the whole stalls. The measurements were taken in the unoccupied hall. From among all parameters that were examined, the sound strength G was the one which demonstrated the most noticeable effect related to mounting the diffuser on the rear wall. The increase was particularly high in the medium ($G_{0.5-1 \text{ kHz}}$) and high ($G_{4 \text{ kHz}}$) frequency regime in the whole area of stalls (Fig. 14). The other parameters noticeably improved in the underbalcony cavity and in the areas close to proscenium, at the expense of a slight reduction of their values in the auditorium center (Figs. 15 and 16). A view of the underbalcony cavity with the diffusers installed on the rear wall is presented in Fig. 17.

the whole impulse response decay period (cf. Fig. 15a and 14b, respectively). This means that the impression of sound strength in the auditorium and the parameter G corresponding to sensation related to this quantity is created in the initial stage of formation of the impulse response. The observation is consistent with the generally accepted regularity concerning enhanced response of the human ear to early high-energy sound reflections.

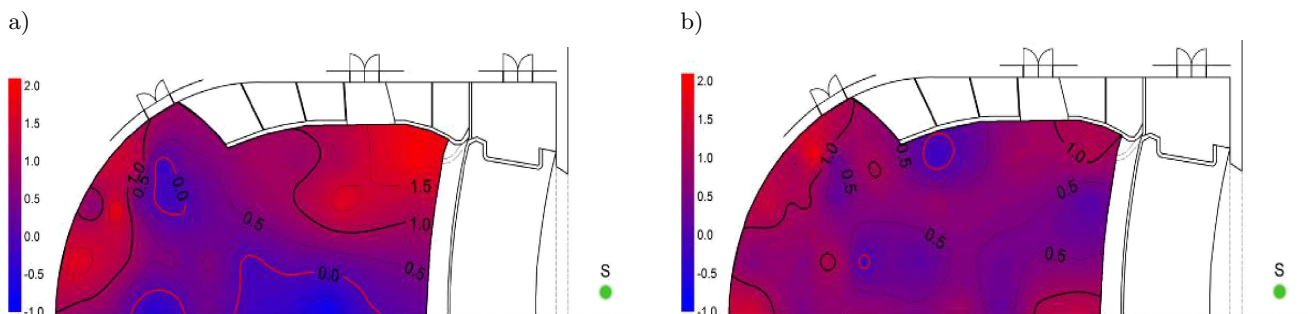
Fig. 15. The effect of mounting the diffusers on the sound strength G : a) $G_{80 \text{ ms}, 4k}$ and b) $G_{\text{Late}, 4k}$.

A characteristic feature worth noticing is a similarity of the sound strength distribution patterns in the 4 kHz octave band, observed for the first 80 ms and for

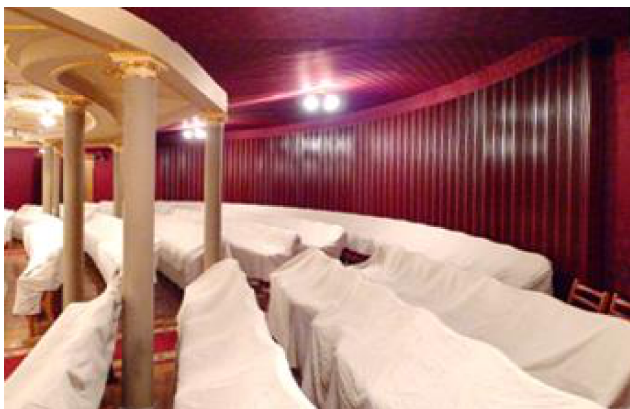
Fig. 17. The underbalcony space in the Lviv Opera House after mounting the sound diffusers.
