Review Papers

Can Historic Interiors with Large Cubature be Turned Acoustically Correct?

Tadeusz KAMISIŃSKI⁽¹⁾, Andrzej KULOWSKI⁽²⁾, Roman KINASH⁽³⁾

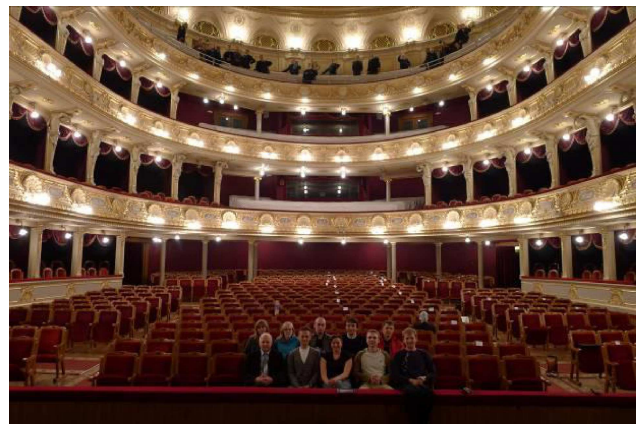
Fig. 7. A view of the Lviv Opera House hall.

The hall has a horseshoe-shaped layout typical for opera houses, with level floor in the stalls and rows of boxes situated on the semicircular wall (Fig. 7). An acoustically difficult element in rooms of this specific shape are concave underbalcony cavities situated along the rear wall in the stalls. In case of walls being finished with hard materials, such as plaster or wallpaper put up on a hard substrate, the sound reflected from the rear wall focuses in the rear part of the audience area which is considered an important acoustic flaw of any room. At some point in time, the user decided to soundproof the rear wall (Fig. 8) which was also unfortunate because of excessive sound damping in the higher frequency range observed in the last two rows of seats.

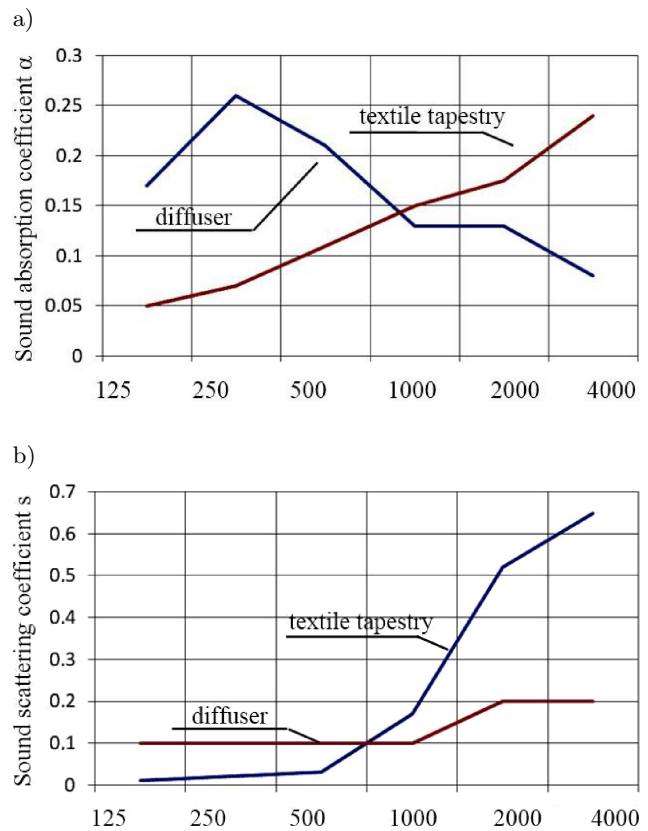
Fig. 11. Acoustic parameters of the textile tapestry and the diffuser of Fig. 9 used in computer simulation (octave resolution, frequency range 125–4000 Hz): a) sound absorption coefficient α , b) sound scattering coefficient s (KAMISIŃSKI *et al.*, 2012b).

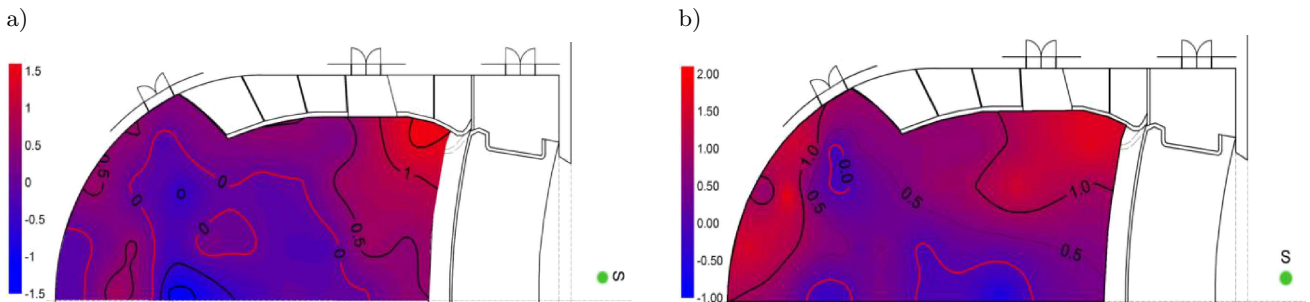
Fig. 14. The effect of mounting the diffusers on the sound strength G in octave bands: (a) 0.5–1 kHz and (b) 4 kHz.

the whole impulse response decay period (cf. Fig. 15a and 14b, respectively). This means that the impression of sound strength in the auditorium and the parameter G corresponding to sensation related to this quantity is created in the initial stage of formation of the impulse response. The observation is consistent with the generally accepted regularity concerning enhanced response of the human ear to early high-energy sound reflections.

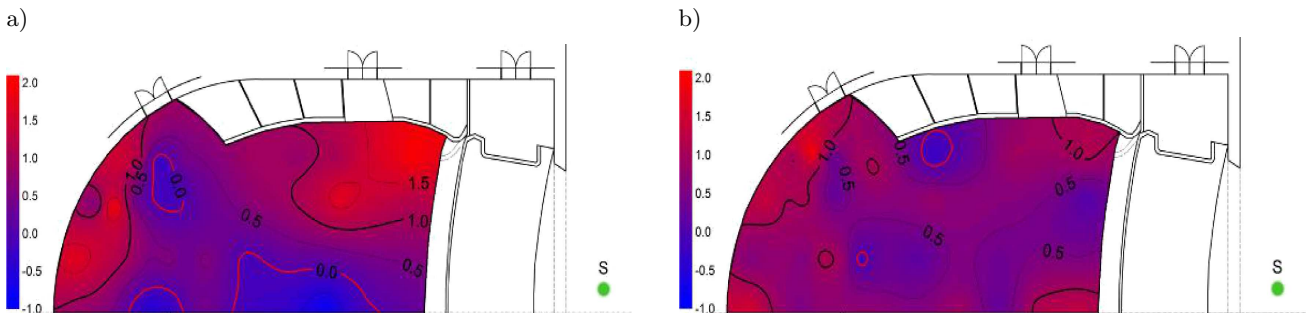
Fig. 15. The effect of mounting the diffusers on the sound strength G : a) $G_{80 \text{ ms}, 4k}$ and b) $G_{\text{Late}, 4k}$.

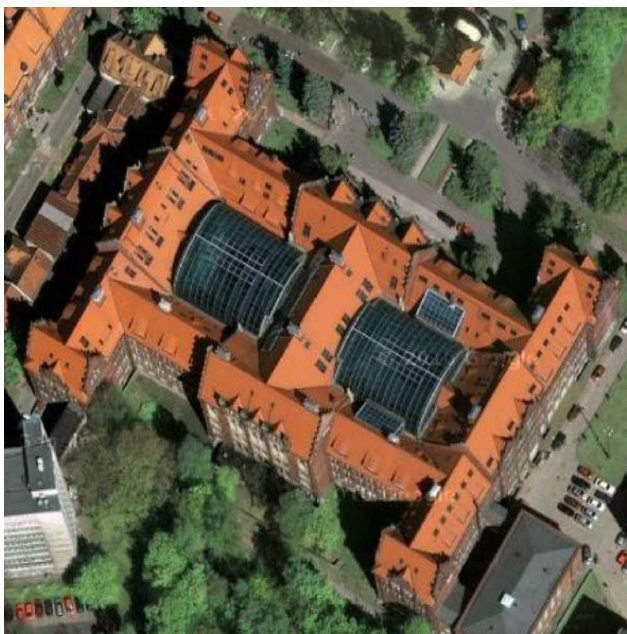
Fig. 18. Glazing roofs over Gdańsk University of Technology's main building courtyards (Google maps, 2015).

The courtyards remained open-air spaces until 2004 when glazed roofs were installed over both of them. The load-bearing structure is based on arched steel trusses with the span reaching about 22.5 m. The roof shell is made of double-pane insulation glass units with voids filled with argon. The outer panes made of tempered glass are 10-mm and 8-mm thick, while the inner pane is a 2 × 4 mm glass laminate with plastic film glued between the layers (Figs. 18–20).

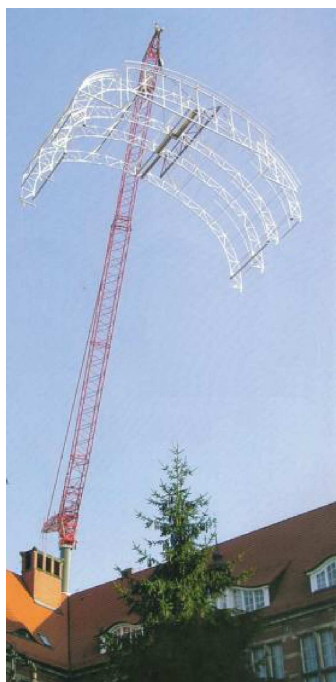
Fig. 19. Transferring glazed roof framework from the assembly site onto the Hevelius Courtyard (CYWIŃSKI, 2012).

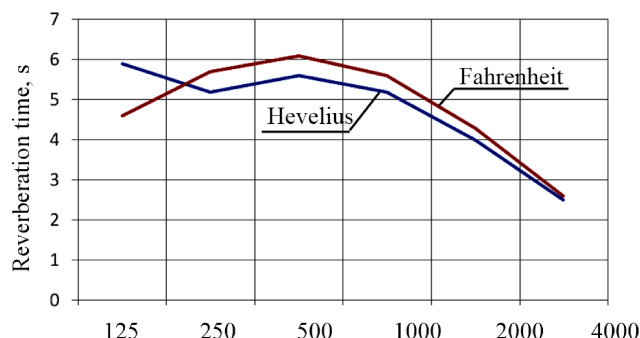
Fig. 21. Reverberation time of the courtyards after textural plaster renovation and face brick cleaning (July 2007).
