Review Papers

Can Historic Interiors with Large Cubature be Turned Acoustically Correct?

Keywords: room acoustics; acoustic rehabilitation of historic interiors; Schroeder diffusers; microperforated foil.

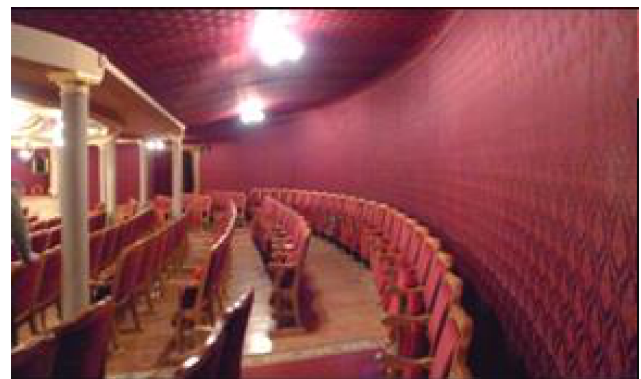
Fig. 8. The underbalcony space in the Lviv Opera House hall prior to installing the sound diffusing structures. The walls and ceiling were covered with a textile tapestry.

The hall has a horseshoe-shaped layout typical for opera houses, with level floor in the stalls and rows of boxes situated on the semicircular wall (Fig. 7). An acoustically difficult element in rooms of this specific shape are concave underbalcony cavities situated along the rear wall in the stalls. In case of walls being finished with hard materials, such as plaster or wallpaper put up on a hard substrate, the sound reflected from the rear wall focuses in the rear part of the audience area which is considered an important acoustic flaw of any room. At some point in time, the user decided to soundproof the rear wall (Fig. 8) which was also unfortunate because of excessive sound damping in the higher frequency range observed in the last two rows of seats.

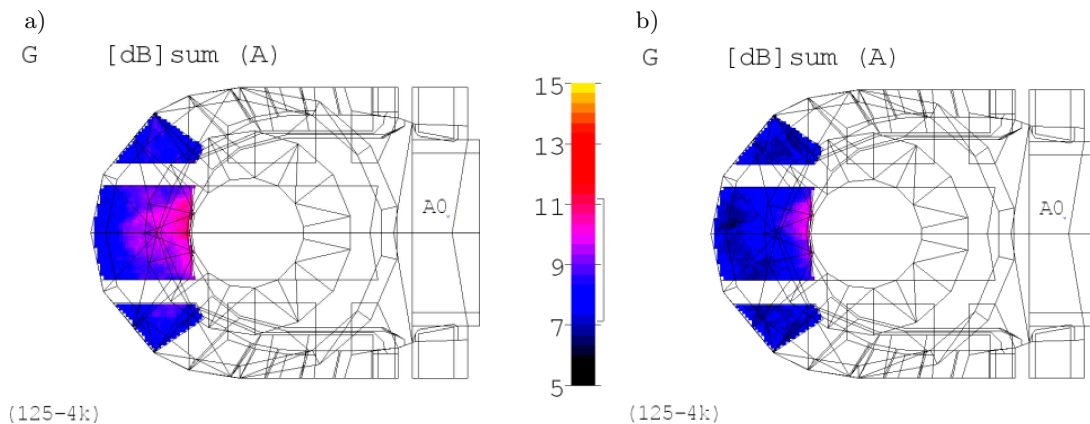
Fig. 12. The forecasted distribution of G values in the underbalcony area for the rear wall covered with: a) textile tapestry, b) sound diffuser.

The calculated distribution pattern of the sound strength G indicates that after covering the originally

smooth and hard rear wall with a sound scattering structure, distribution of the parameter became significantly more even (Fig. 12). The effect is particularly prominent for frequencies above 1 kHz, as in this very range, the sound absorption introduced by the diffuser is lower, while the scattering effect is stronger (Fig. 11). Even more favorable is the forecasted change in the clarity factor C_{80} (Fig. 13). This is especially
