ECONOMICAL METHODS FOR MEASURING ROAD SURFACE ROUGHNESS

Dariusz Grabowski, Maciej Szczodrak, Andrzej Czyżewski

Gdańsk University of Technology, Faculty of Electronics, Telecommunications and Informatics,
G. Narutowicza 11/12, 80-233 Gdańsk, Poland (✉ ksm@sound.eti.pg.edu.pl, 48 58 347 1114)

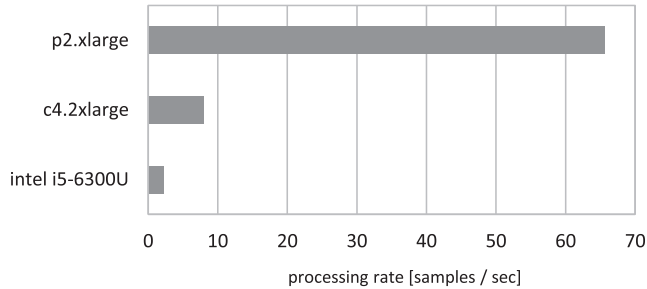
Fig. 9. The amount of processed samples during a 1 s period for different machines: **p2.xlarge** – a machine with 1 Core GPU NVIDIA K80, **c4.2xlarge** – a machine with 8 processor cores Xeon E5-2666 v3, **Intel i5-6300U** – laptop with 4 cores 2.40 GHz.

The network learning was carried out using the Amazon Web Services' cloud computing. The machine selected for the task was a p2.xlarge equipped with an NVIDIA K80 GPU with 12 GB of memory, supporting the CUDA technology. The network learning during the system development was carried out on different machines. Differences in the processing efficiency between them are presented in Fig. 9.
