BIOVAC® WASTEWATER TREATMENT PLANTS

IN THE MOUNTAIN NATIONAL PARKS

This paper presents characteristics of the Biovac® wastewater treatment plants operating in the mountain areas of the Polish national parks (NP): Tatrzański NP and Babiogórski NP as well as in the West Spitsbergen NP. On the basis of the laboratory tests performed on raw sewage and the final effluent the efficiency of the wastewater treatment plants was evaluated. It was found that high COD values and rather high COD / BODS ratios were observed in the raw sewage during an off-peak tourist season. The research has also shown that the Biovac® treatment plants (SBR technology) showed a high level of removal of pollutants from sewage discharged from mountain hostels.

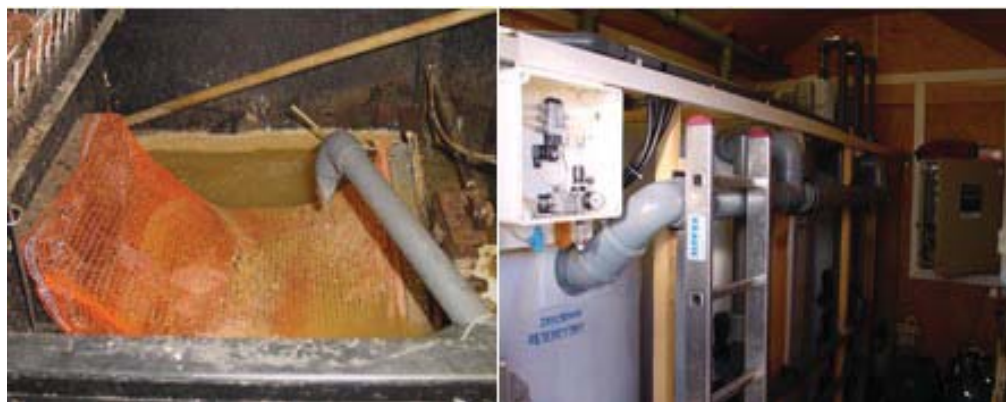
The mechanical (primary) sewage treatment is a stage where solids are removed from sewage. Biovac® plants usually employ basket screens and bag screens, although occasionally fine screens, sieves or screenings and grit separators (combined in a single unit) are used for larger wastewater treatment plants. The basket screen is a coarse screen made of stainless steel. This device is placed directly by the inlet in manholes or pumping stations to which wastewater is carried by pipe. It is guided by rails and has electric or hand hoist. Floating solids of a particular size are caught in the filtering compartment. The basket moves along the rails in vertical direction [10]. After being pulled out of the tank, the basket turns to a position that guarantees automatic unloading of screenings. The separated solids/screenings are transported to a storage tank or to a filter press via a gutter. The bag screen (Fig. 2) is mounted in front of the retention tank. The bag is made of plastic fibres and removes solids of a particular diameter. Similar bags can also be found in agriculture as a packing material for agricultural crops.

The vertical retention tank (Fig. 2) equalises the sewage flow/composition and serves as a buffer during large flow fluctuations. The tank houses submersible pumps that pump sewage to the SBRs.

Fig. 2. Biovac® wastewater treatment plant at West Spitsbergen a) bag screen , b) retention tank [10]
