Article

Wave Frequency Effects on Damage Imaging in Adhesive Joints Using Lamb Waves and RMS

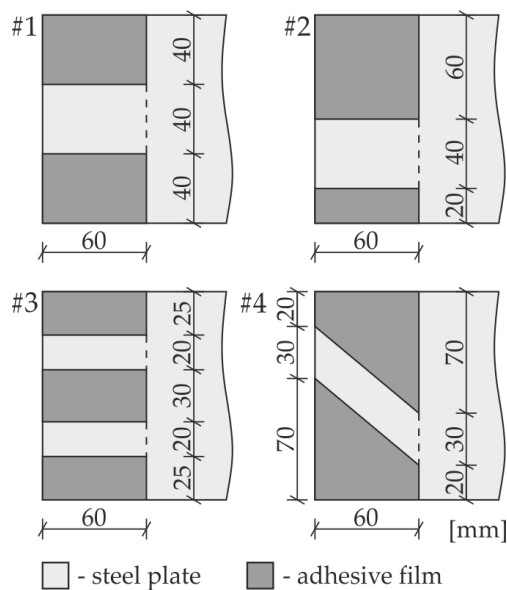
Figure 2. Variants of defects (#1 to #4).

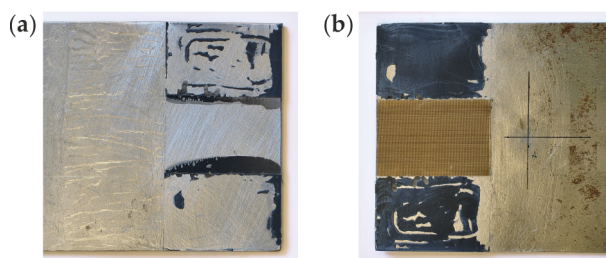
Figure 3. Photograph of experimental specimen after separation: (a) upper plate; (b) lower plate.

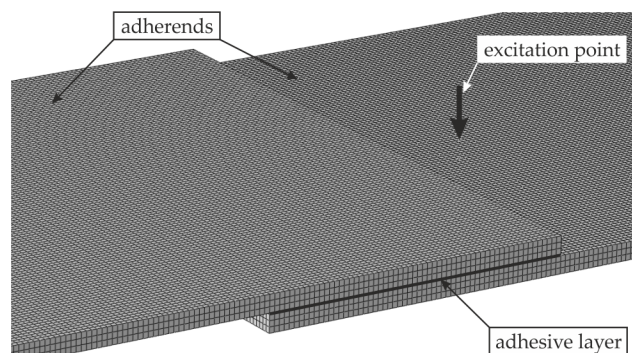
Figure 5. View of a discretized model for numerical calculations with an indicated excitation point.

The numerical modeling of elastic wave propagation in composite structures, such as adhesive joints, is a complex problem, mainly because of material inhomogeneity and an uncertainty of contact at the interfaces between different materials. An effective contribution to this issue was made by Chronopoulos [50] and Apalowo and Chronopoulos [51]. In the present paper, numerical analysis of the guided wave propagation in the considered adhesive joints (#1 to #4) was conducted using the finite element method in Abaqus/Explicit software. Some assumptions were made to simplify the modeling process and shorten the calculations. Three-dimensional FEM models were prepared for a transient dynamic analysis. Each structure was discretized by eight-node solid elements with reduced integration (C3D8R) from the explicit element library. The appropriate mapping of the wave behavior requires at least 20 nodes for the shortest wavelength of interest [52]. According to this limitation, the mesh was initially assumed to be regular and consisted of cube-shaped elements with a global size of 1 mm, which was reduced to 0.2 mm for the thickness of the adhesive layer (see Figure 5). The mesh convergence test was conducted taking into account a few refined meshes. The out-of-plane velocity values in some randomly chosen points at specific time instances were assumed as the measure of the convergence. The relative differences between results were negligible; thus, the exact calculations were conducted with the use of the above-mentioned mesh with the global element size of 1 mm. The boundary conditions were free at all the edges. The materials were adopted to meet the assumptions of a homogenous, isotropic material model. The material parameters were: for steel $E_s = 195.2$ GPa, $\nu_s = 0.30$, $\rho_s = 7741.7$ kg/m³, and for adhesive $E_a = 5$ GPa, $\nu_a = 0.35$, and $\rho_a = 1330$ kg/m³. The material damping was neglected because of its marginal influence on the RMS damage imaging. Both adherends and the adhesive film were assumed to be independent structures combined rigidly at the part of their surfaces by means of a tie connection (compatibility of translational degrees of freedom at all the contacting nodes). The excitation of guided waves was applied at the lower adherend in the form of the concentrated force surface load with the amplitude varying in time in accordance with the wave packet signal. The excitation frequency range was extended in comparison to experimental measurements (20 to 500 kHz). The dynamic analysis was conducted with the use of the central difference method with a fixed time step of 10^{-7} s. This value meets the recommendation of at least 20 points per each cycle of the wave with the higher frequency [52]. The results of the analysis were out-of-plane velocity signals collected at 3721 points spread over the area of the joint corresponding with experimental measurements.

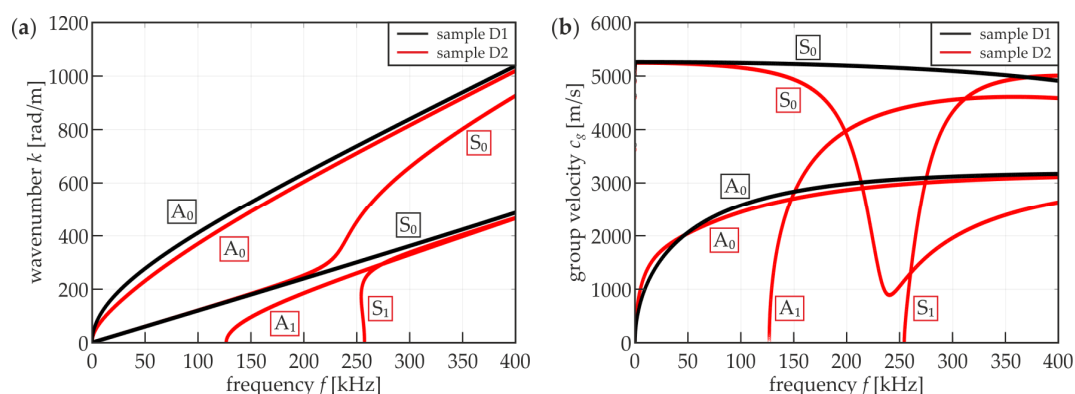
Figure 7. Theoretical dispersion curves for a steel plate (D1, black curves)–single layer medium ($d_s = 3$ mm, $E_s = 195.2$ GPa, $\nu_s = 0.3$, $\rho_s = 7741.7$ kg/m³) and adhesive joint (D2, red curves)–three-layer medium consisting of two steel plates (parameters same as above) and adhesive film ($d_a = 0.2$ mm, $E_a = 5$ GPa, $\nu_a = 0.35$, $\rho_a = 1330$ kg/m³): (a) wavenumber–frequency relations; (b) group velocity–frequency relations.

A comparison of experimental and numerical curves led to the conclusion that both approaches gave consistent results. This also proved the appropriateness of the assumption of adhesive material parameters. To track the theoretical dispersion curves of Lamb waves in the investigated media, our own code was developed in the Matlab® software (9.3.0.713597, The MathWorks, Inc., Natick, MA, USA), implementing the transfer matrix method [54,55]. Figure 7a shows wavenumber–frequency relations for both media (samples D1 and D2). The shape of the curves is approximately the same as that shown in the maps in Figure 6. However, the possibility of the effective excitation of certain modes was not the same in the results of the measurements (in both experimental and numerical curves for the single plate and the joint). In sample D1 (Figures 6a and 7, black curves), only fundamental S_0 and A_0 modes can propagate in the considered frequency range, notwithstanding that the S_0 curve is not as strongly exposed as A_0 in the maps, which may be the result of the acquisition of only out-of-plane components on the upper surface that are related mainly to antisymmetric modes. In sample D2 (Figures 6b and 7, red curves), in addition to the fundamental pair, A_1 and S_1 modes are present starting from the frequencies of about 130 and 260 kHz, respectively. Moreover, the shape of the S_0 curve changes meaningfully compared with the single-layer plate. The shape of the A_0 curve does not change significantly in comparison to sample D1. The differences between the two types of media are also clearly visible on group velocity–frequency relations (Figure 7b), which will be useful in further considerations.

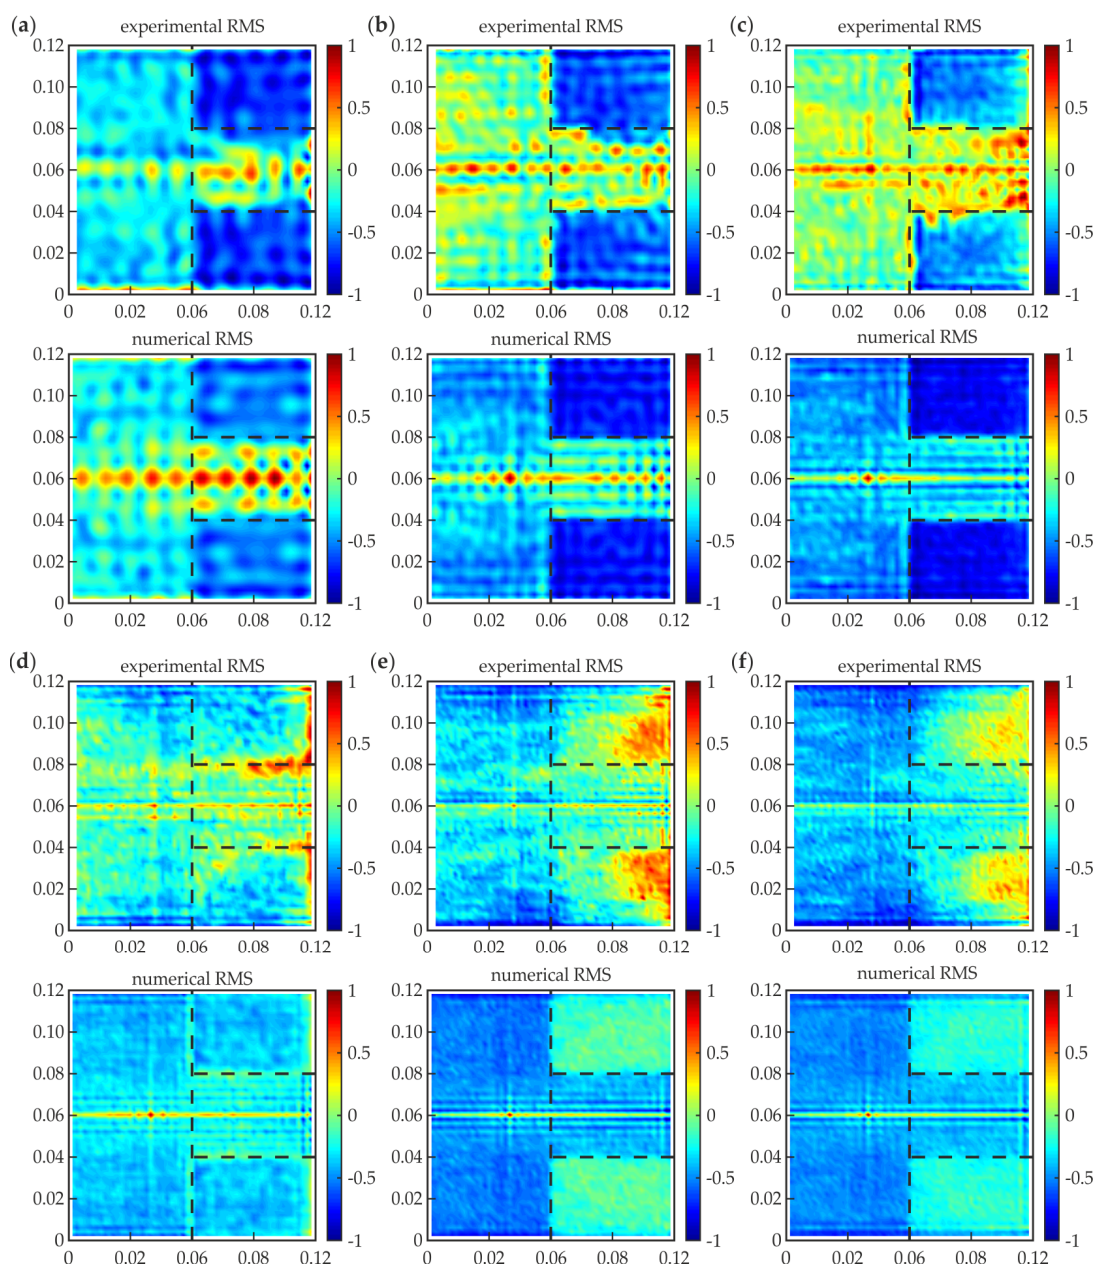
Figure 9. Experimental and numerical root mean square (RMS) maps for different excitation frequencies: (a) $f = 50$ kHz; (b) $f = 100$ kHz; (c) $f = 150$ kHz; (d) $f = 210$ kHz; (e) $f = 300$ kHz; and (f) $f = 350$ kHz.

Figure 9 shows the RMS maps normalized to unity for experimental and numerical signals collected for specimen #1. The chosen frequencies were the same as those for the SLDV maps. Each RMS value was calculated with respect to Equation (2). The time window covered the whole time of signal acquisition, i.e., $T = 3.2 \text{ ms}$. The individual characterization of a single-layer medium (steel plate, such as the damage area) and a three-layer medium (properly prepared adhesive joint) should result in the clear difference of the calculated RMS values. However, it is undeniable that excitation frequency is an essential factor affecting the effectiveness of RMS damage imaging. For the lower frequencies (50 kHz, Figure 9a; 100 kHz, Figure 9b; 150 kHz, Figure 9c), the damaged area is characterized by highest RMS values rather than an appropriately prepared joint (similar to the single plate after the joint). The difference between these two areas is clear. Some differences between experimental and numerical maps result from irregularities in defect geometry (cf. Figure 3). It is worth noticing that at the lower excitation frequency, the lower resolution can be obtained in the map and, as a result,

the larger defects can be omitted. This may be very important in the case of small defects; however, for the considered damage area, it is not essential. The frequency 210 kHz (Figure 9d) give an ineffectual result: there is almost no difference between the defect and intact joint, especially in the numerical map. In the experimental RMS, some boundary effects (intensification of the wave energy on the irregular edge) led to higher RMS values. This example shows that the invalid choice of the excitation frequency can make the measurement results useless. For the frequencies higher than 210 kHz (300 kHz, Figure 9e; 350 kHz, Figure 9f) the RMS values are lower in the damaged area than in the intact joint. The correlation between RMS values for these two areas is inverted. What is important is that the visual assessment of RMS maps shows that the distinction between the damaged and intact area of the joint is much more pronounced in the lower frequency range, especially for experimental maps, where the whole area of the adhesive layer does not have the same value. This may be the effect of the limitations of the used experimental setup. What is more, the increase in the excitation frequency is related to the increase in the wave attenuation.

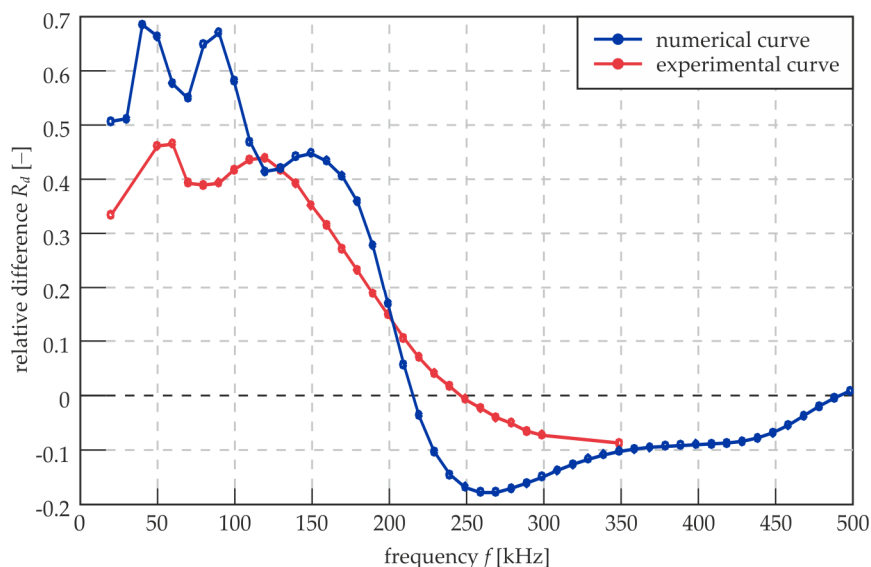
Figure 10. Relative difference between mean RMS values for damaged and intact areas of overlap for experimental (frequency range from 20 to 350 kHz) and numerical results (frequency range from 20 to 500 kHz).

Figure 10 shows the relation between R_d and excitation frequency for experimental and numerical results. The curves are slightly different, but both have some characteristic points. The first one is a local maximum for 50 kHz. For this value, the A_0 modes for single and three-layer plates are crossing on dispersion curves (cf. Figure 7b). Then, there are some fluctuations that differ between the two curves. Another peak repeating for both experimental and numerical curves is for about 120 kHz, when the A_1 mode for the three-layer plate appears. Further, the curves are falling monotonically. The numerical curve has the root equal to approximately 215 kHz, and this is the frequency value for which the damaged area and intact joint are not distinguishable (cf. Figure 9). For the experimental curve, the root is translated to approximately 250 kHz. This may be the result of the energy intensification on the edges of the defect (cf. Figure 9d). The global minimum for the numerical curve is attained for approximately 260 kHz (the appearance of the S_1 mode for the three-layer plate). This is the frequency for which the joint and the defect can be distinguished with maximal efficiency in the frequency range above 210 kHz. Further, the curve is slightly rising until obtaining another root (about 500 kHz) at the end of the frequency range. The experimental curve does not obtain the local minimum above 210 kHz; instead, it is constantly falling to the end of the assumed frequency range up to 350 kHz. Generally, the positive values of R_d are obtained when the damaged area is characterized by higher RMS values than the intact joint. Negative values indicate on the inverted relation. If R_d equals zero, there is no possibility of identifying the defects. What is important is that the absolute values of R_d are higher below the first root (about 215 kHz), which suggests that the lower frequencies allow obtaining a better differentiation of three-layer and single layer media. However, the above-mentioned decrease in map resolution cannot be neglected. To compromise both of these factors (the differentiation between defect and intact joint and the map resolution), the excitation frequency should be chosen from an approximate range of 120 to 180 kHz. The determination of an optimal frequency value requires mathematical optimization and a proposition of an objective function containing components linked with the image resolution and the R_d value.

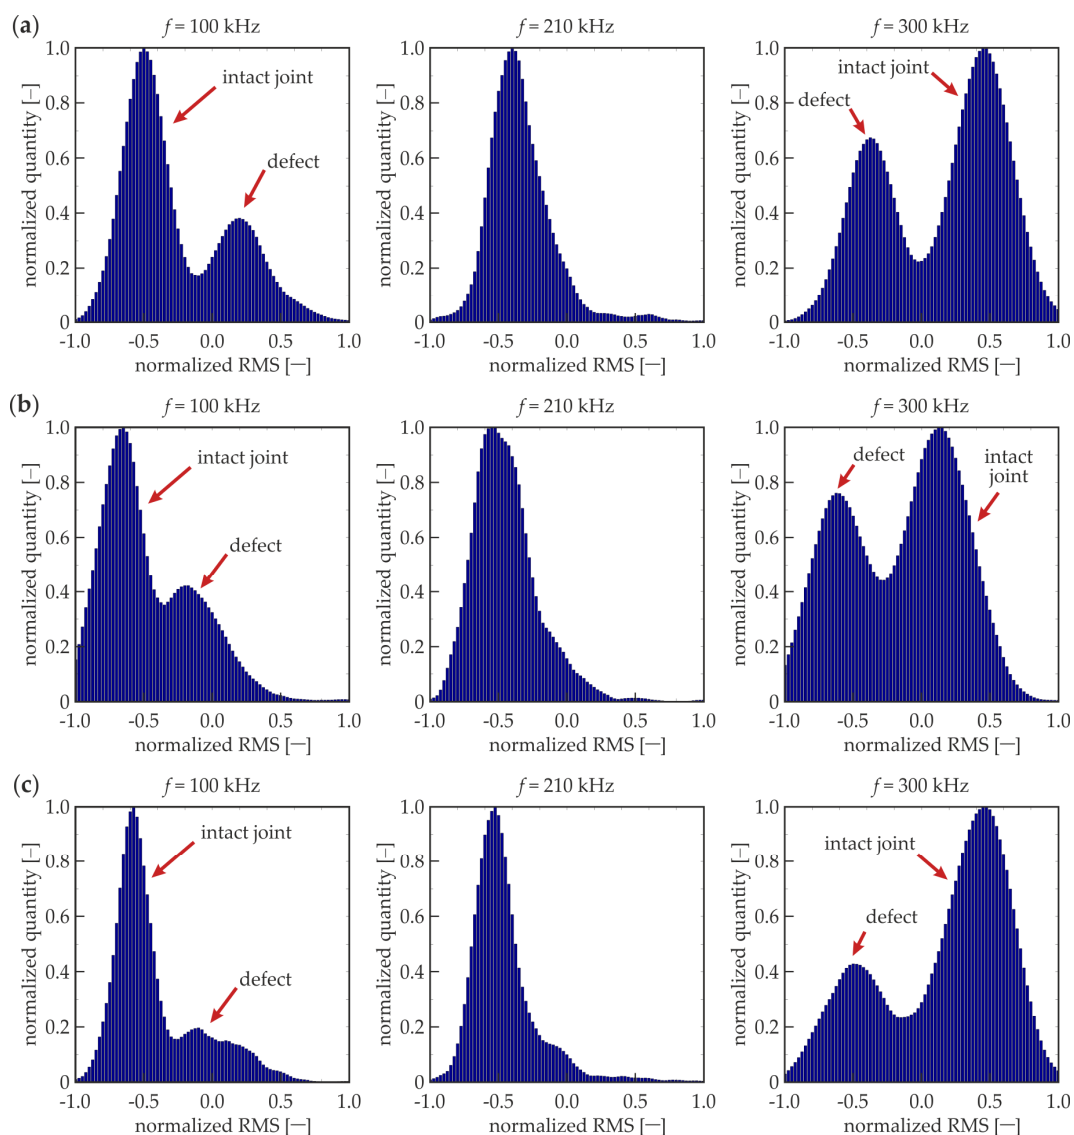
Figure 13. Numerical RMS histograms for different excitation frequencies (100, 210, and 300 kHz) and different defects: (a) #2; (b) #3; and (c) #4.

significant. The frequency of 300 kHz resulted in lower RMS values in the damaged area. Moving to the histograms (Figure 13), the frequency 210 kHz gave the unimodal distribution (no difference between the defect and intact joint). The histograms for 100 and 300 kHz gave bimodal distributions, but for lower frequencies, the defect mode was related to higher RMS values, whereas for higher frequencies, it was related to lower RMS values. The quantity for the defect mode was always smaller than that for an intact joint. The considerations for joints #2 to #4 provided the same results as for specimen #1. Summarizing, the efficiency of a measurement with a specific excitation frequency does not change with the geometry of a damaged area. It is a satisfying conclusion, because generally, the geometry of the damaged area is unknown. This means that an additional preliminary study consisting of numerical calculations can reveal the appropriate excitation frequency value and reduce the number of measurements. However, the possibility of the damage identification due to a frequency value depends strongly on the characteristics of the considered media, so they need to be determined.
