Article

Wave Frequency Effects on Damage Imaging in Adhesive Joints Using Lamb Waves and RMS

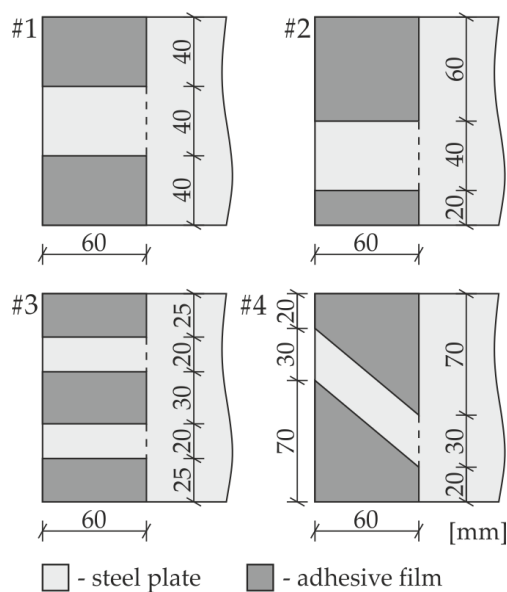
Figure 2. Variants of defects (#1 to #4).

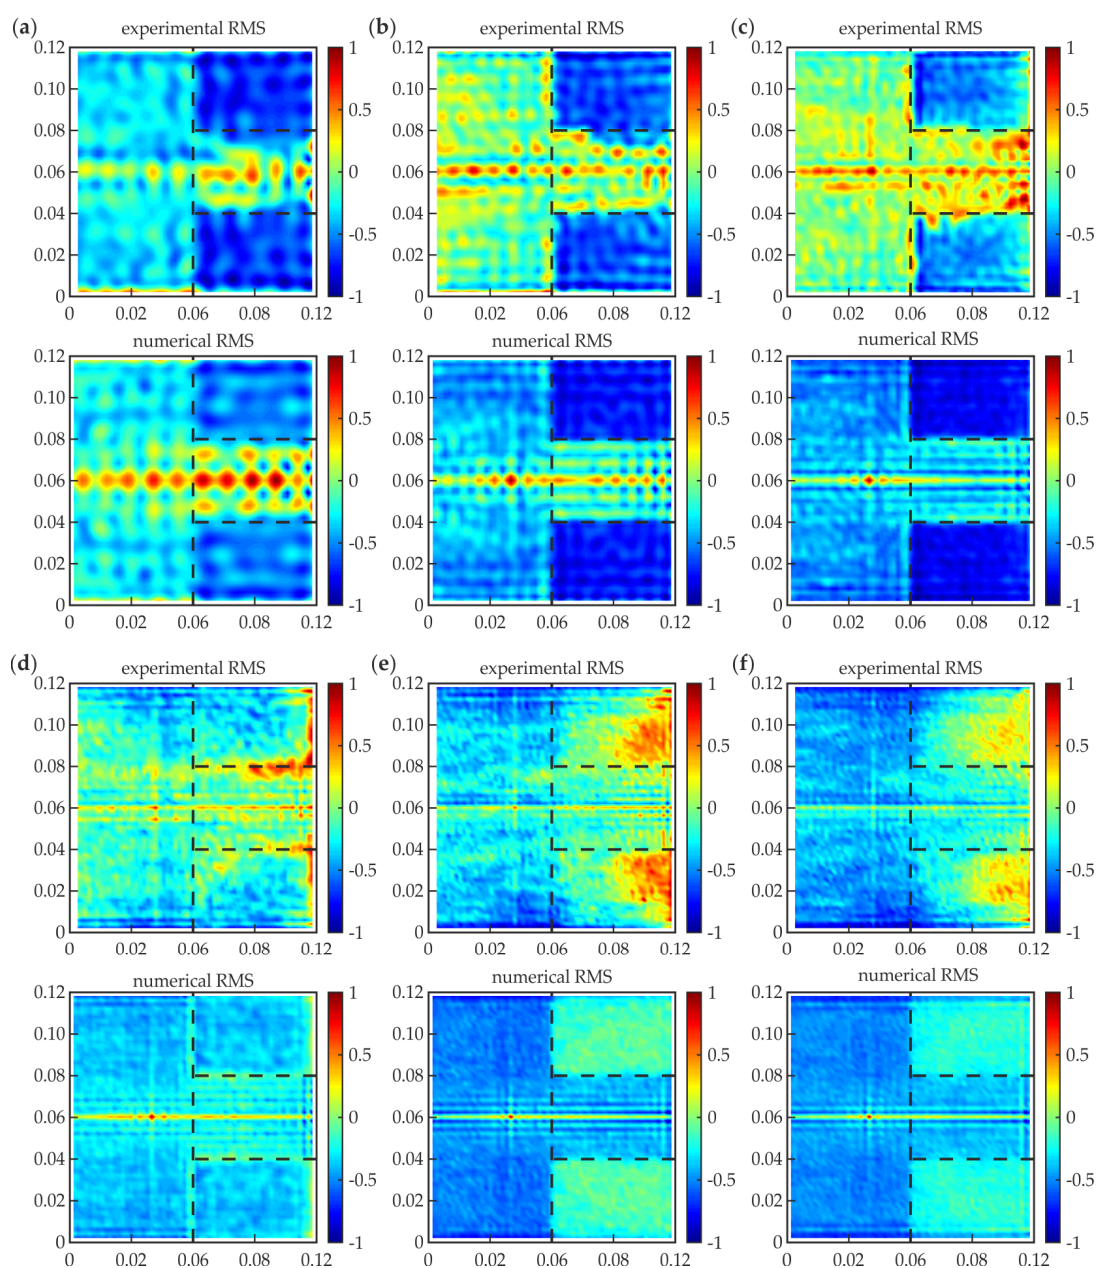
Figure 9. Experimental and numerical root mean square (RMS) maps for different excitation frequencies: (a) $f = 50$ kHz; (b) $f = 100$ kHz; (c) $f = 150$ kHz; (d) $f = 210$ kHz; (e) $f = 300$ kHz; and (f) $f = 350$ kHz.

Figure 9 shows the RMS maps normalized to unity for experimental and numerical signals collected for specimen #1. The chosen frequencies were the same as those for the SLDV maps. Each RMS value was calculated with respect to Equation (2). The time window covered the whole time of signal acquisition, i.e., $T = 3.2 \text{ ms}$. The individual characterization of a single-layer medium (steel plate, such as the damage area) and a three-layer medium (properly prepared adhesive joint) should result in the clear difference of the calculated RMS values. However, it is undeniable that excitation frequency is an essential factor affecting the effectiveness of RMS damage imaging. For the lower frequencies (50 kHz, Figure 9a; 100 kHz, Figure 9b; 150 kHz, Figure 9c), the damaged area is characterized by highest RMS values rather than an appropriately prepared joint (similar to the single plate after the joint). The difference between these two areas is clear. Some differences between experimental and numerical maps result from irregularities in defect geometry (cf. Figure 3). It is worth noticing that at the lower excitation frequency, the lower resolution can be obtained in the map and, as a result,

the larger defects can be omitted. This may be very important in the case of small defects; however, for the considered damage area, it is not essential. The frequency 210 kHz (Figure 9d) give an ineffectual result: there is almost no difference between the defect and intact joint, especially in the numerical map. In the experimental RMS, some boundary effects (intensification of the wave energy on the irregular edge) led to higher RMS values. This example shows that the invalid choice of the excitation frequency can make the measurement results useless. For the frequencies higher than 210 kHz (300 kHz, Figure 9e; 350 kHz, Figure 9f) the RMS values are lower in the damaged area than in the intact joint. The correlation between RMS values for these two areas is inverted. What is important is that the visual assessment of RMS maps shows that the distinction between the damaged and intact area of the joint is much more pronounced in the lower frequency range, especially for experimental maps, where the whole area of the adhesive layer does not have the same value. This may be the effect of the limitations of the used experimental setup. What is more, the increase in the excitation frequency is related to the increase in the wave attenuation.
