Article

# Wave Frequency Effects on Damage Imaging in Adhesive Joints Using Lamb Waves and RMS

**Abstract:** Structural adhesive joints have numerous applications in many fields of industry. The gradual deterioration of adhesive material over time causes a possibility of unexpected failure and the need for non-destructive testing of existing joints. The Lamb wave propagation method is one of the most promising techniques for the damage identification of such connections. The aim of this study was experimental and numerical research on the effects of the wave frequency on damage identification in a single-lap adhesive joint of steel plates. The ultrasonic waves were excited at one point of an analyzed specimen and then measured in a certain area of the joint. The recorded wave velocity signals were processed by the way of a root mean square (RMS) calculation, giving the actual position and geometry of defects. In addition to the visual assessment of damage maps, a statistical analysis was conducted. The influence of an excitation frequency value on the obtained visualizations was considered experimentally and numerically in the wide range for a single defect. Supplementary finite

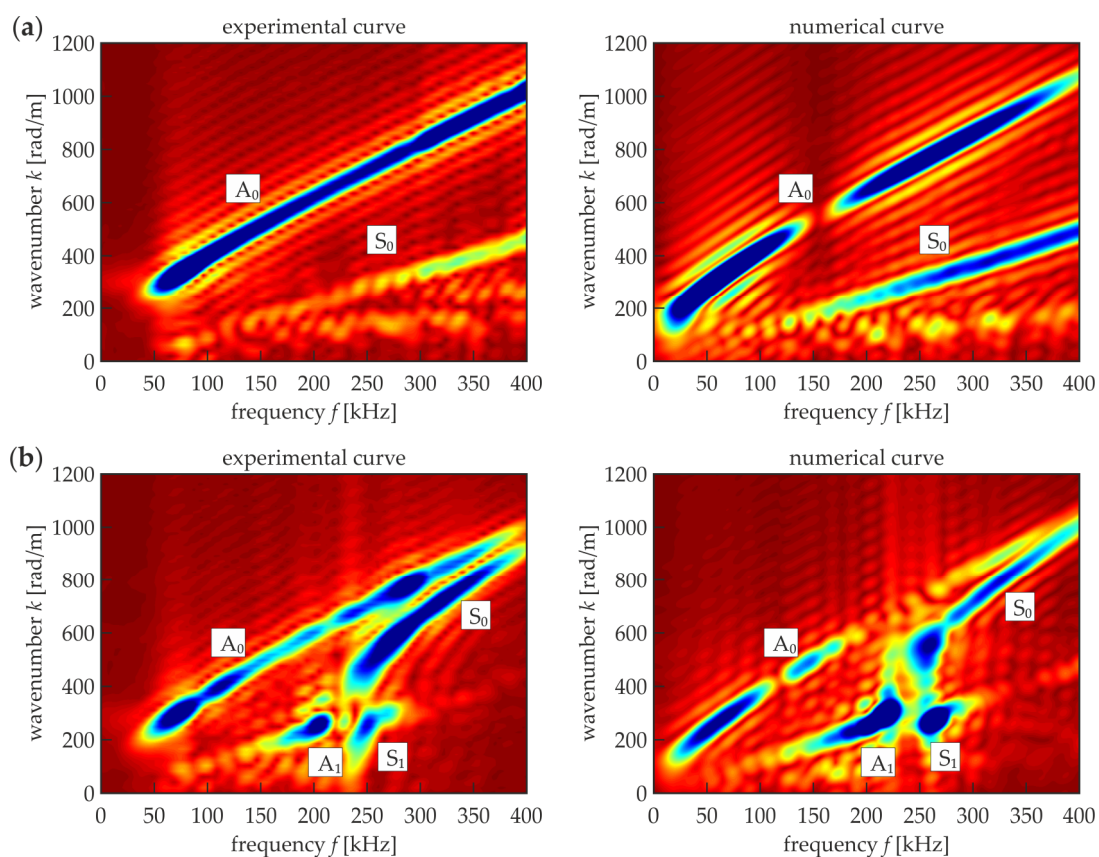
**Figure 6.** Experimental and numerical dispersion curves: (a) steel plate (sample D1)—single layer medium ( $d_s = 3$  mm,  $E_s = 195.2$  GPa,  $\nu_s = 0.3$ ,  $\rho_s = 7741.7$  kg/m<sup>3</sup>); (b) adhesive joint (sample D2)—three-layer medium consisted of two steel plates (parameters same as in (a)) and adhesive film ( $d_a = 0.2$  mm,  $E_a = 5$  GPa,  $\nu_a = 0.35$ ,  $\rho_a = 1330$  kg/m<sup>3</sup>).

The initial step in the damage detection of adhesive joints was the comparison of Lamb wave characteristics in a three-layer medium (steel–adhesive–steel, simulating a properly prepared adhesive joint) and in a single-layer medium (single steel plate or disbonded area of the adhesive joint). For this purpose, dispersion curves were prepared experimentally and numerically for a steel plate with dimensions of 240 mm × 300 mm × 3 mm (sample D1) and for two plates with an adhesive film with a thickness of 0.2 mm bonding them together (sample D2). In each specimen, a wave packet in the form of a single-cycle Hanning windowed sinusoidal function was excited. The carrier frequency was changing in the range from 50 to 300 kHz with a step of 50 kHz. Additionally, for each frequency, symmetric and antisymmetric Lamb modes were excited independently. The velocity signals (out-of-plane components) were acquired in 101 points distributed along the straight line with a total length of 100 mm. The dispersion curves in the form of the maps representing wavenumber–frequency relations were obtained in the way of 2D-FFT (two-dimensional fast Fourier transform) calculations for each of 12 measurements (cf. [6,36,53]). The final result was the superposition of all the compound maps (Figure 6).

A comparison of experimental and numerical curves led to the conclusion that both approaches gave consistent results. This also proved the appropriateness of the assumption of adhesive material parameters. To track the theoretical dispersion curves of Lamb waves in the investigated media, our own code was developed in the Matlab® software (9.3.0.713597, The MathWorks, Inc., Natick, MA, USA), implementing the transfer matrix method [54,55]. Figure 7a shows wavenumber–frequency relations for both media (samples D1 and D2). The shape of the curves is approximately the same as that shown in the maps in Figure 6. However, the possibility of the effective excitation of certain modes was not the same in the results of the measurements (in both experimental and numerical curves for the single plate and the joint). In sample D1 (Figures 6a and 7, black curves), only fundamental  $S_0$  and  $A_0$  modes can propagate in the considered frequency range, notwithstanding that the  $S_0$  curve is not as strongly exposed as  $A_0$  in the maps, which may be the result of the acquisition of only out-of-plane components on the upper surface that are related mainly to antisymmetric modes. In sample D2 (Figures 6b and 7, red curves), in addition to the fundamental pair,  $A_1$  and  $S_1$  modes are present starting from the frequencies of about 130 and 260 kHz, respectively. Moreover, the shape of the  $S_0$  curve changes meaningfully compared with the single-layer plate. The shape of the  $A_0$  curve does not change significantly in comparison to sample D1. The differences between the two types of media are also clearly visible on group velocity–frequency relations (Figure 7b), which will be useful in further considerations.

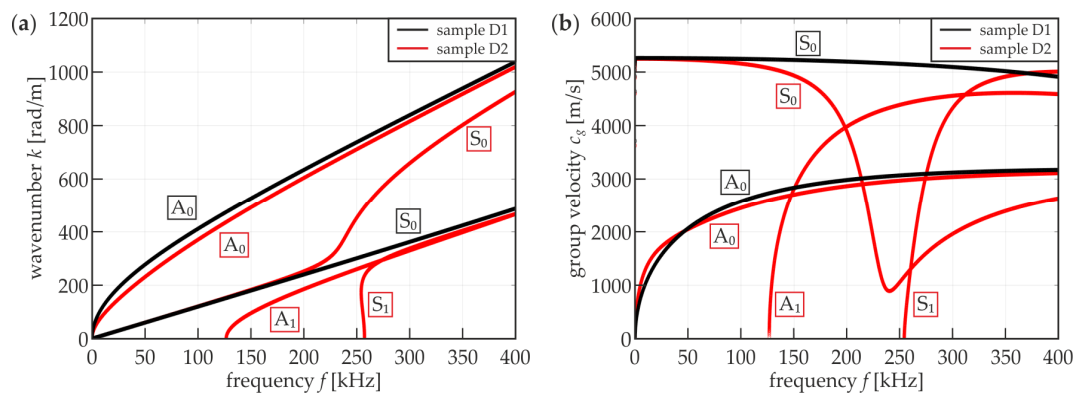
**Figure 7.** Theoretical dispersion curves for a steel plate (D1, black curves)–single layer medium ( $d_s = 3$  mm,  $E_s = 195.2$  GPa,  $\nu_s = 0.3$ ,  $\rho_s = 7741.7$  kg/m<sup>3</sup>) and adhesive joint (D2, red curves)–three-layer medium consisting of two steel plates (parameters same as above) and adhesive film ( $d_a = 0.2$  mm,  $E_a = 5$  GPa,  $\nu_a = 0.35$ ,  $\rho_a = 1330$  kg/m<sup>3</sup>): (a) wavenumber–frequency relations; (b) group velocity–frequency relations.

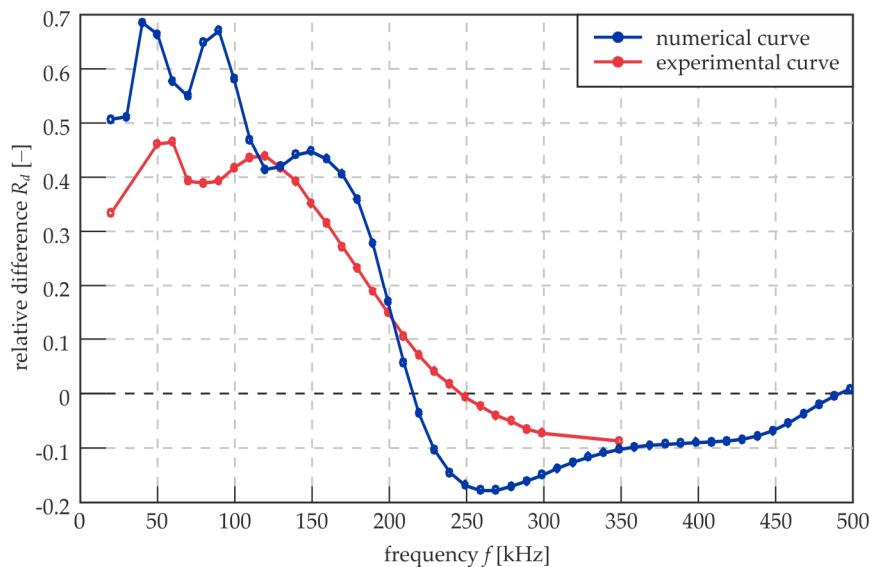
**Figure 10.** Relative difference between mean RMS values for damaged and intact areas of overlap for experimental (frequency range from 20 to 350 kHz) and numerical results (frequency range from 20 to 500 kHz).

Figure 10 shows the relation between  $R_d$  and excitation frequency for experimental and numerical results. The curves are slightly different, but both have some characteristic points. The first one is a local maximum for 50 kHz. For this value, the  $A_0$  modes for single and three-layer plates are crossing on dispersion curves (cf. Figure 7b). Then, there are some fluctuations that differ between the two curves. Another peak repeating for both experimental and numerical curves is for about 120 kHz, when the  $A_1$  mode for the three-layer plate appears. Further, the curves are falling monotonically. The numerical curve has the root equal to approximately 215 kHz, and this is the frequency value for which the damaged area and intact joint are not distinguishable (cf. Figure 9). For the experimental curve, the root is translated to approximately 250 kHz. This may be the result of the energy intensification on the edges of the defect (cf. Figure 9d). The global minimum for the numerical curve is attained for approximately 260 kHz (the appearance of the  $S_1$  mode for the three-layer plate). This is the frequency for which the joint and the defect can be distinguished with maximal efficiency in the frequency range above 210 kHz. Further, the curve is slightly rising until obtaining another root (about 500 kHz) at the end of the frequency range. The experimental curve does not obtain the local minimum above 210 kHz; instead, it is constantly falling to the end of the assumed frequency range up to 350 kHz. Generally, the positive values of  $R_d$  are obtained when the damaged area is characterized by higher RMS values than the intact joint. Negative values indicate on the inverted relation. If  $R_d$  equals zero, there is no possibility of identifying the defects. What is important is that the absolute values of  $R_d$  are higher below the first root (about 215 kHz), which suggests that the lower frequencies allow obtaining a better differentiation of three-layer and single layer media. However, the above-mentioned decrease in map resolution cannot be neglected. To compromise both of these factors (the differentiation between defect and intact joint and the map resolution), the excitation frequency should be chosen from an approximate range of 120 to 180 kHz. The determination of an optimal frequency value requires mathematical optimization and a proposition of an objective function containing components linked with the image resolution and the  $R_d$  value.
