Technical Limitations in Merging Secular and Sacred Functions in Monumental Churches

To cite this article: Ksenia Piatkowska 2017 *IOP Conf. Ser.: Mater. Sci. Eng.* **245** 052079

Ksenia Piatkowska¹

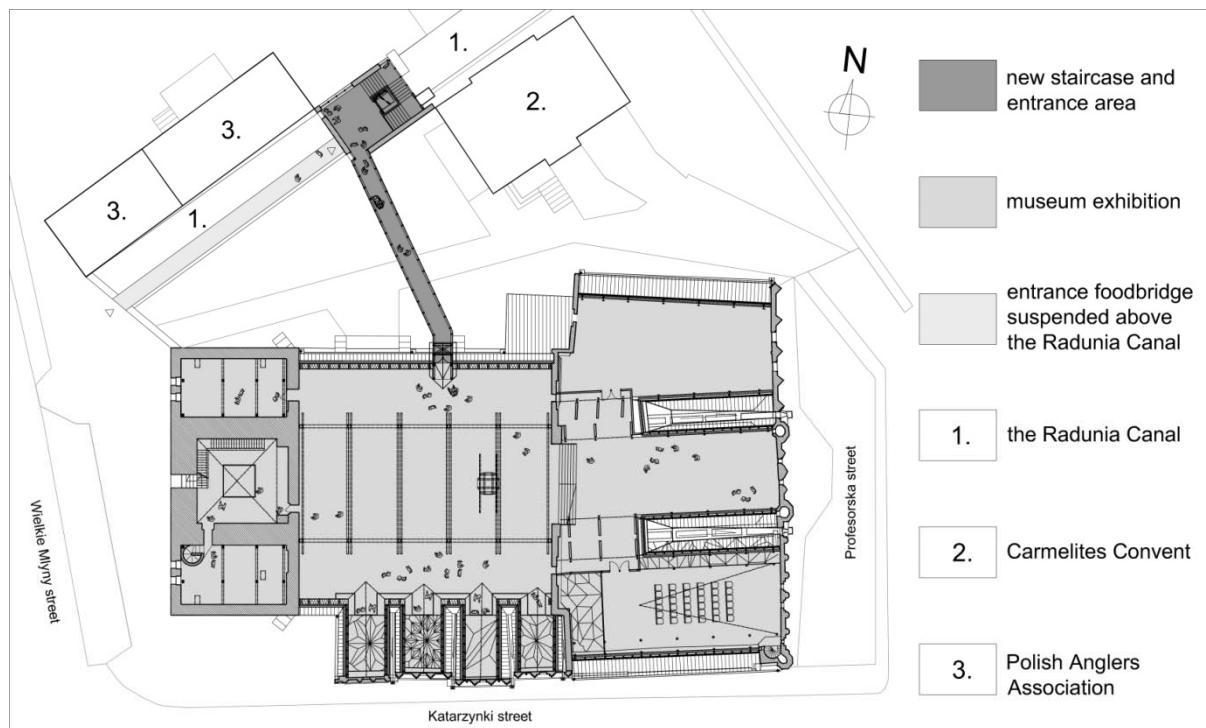
Figure 1. The museum exhibition and the new staircase building with the entrance area - plan on the level +11.70 m.

The scheme of functionality relevant to the architectural design for the New Museum of Science was developed by the Historical Museum of the City of Gdansk. It consisted of the following areas: entrance area for ticket sales and info point, a small museum shop and cloakroom, a zone for permanent and temporary exhibitions, conference hall and educational zone, areas for preparing exhibitions, toilets for visitors, museum offices and social facilities for the museum staff (figure 1).

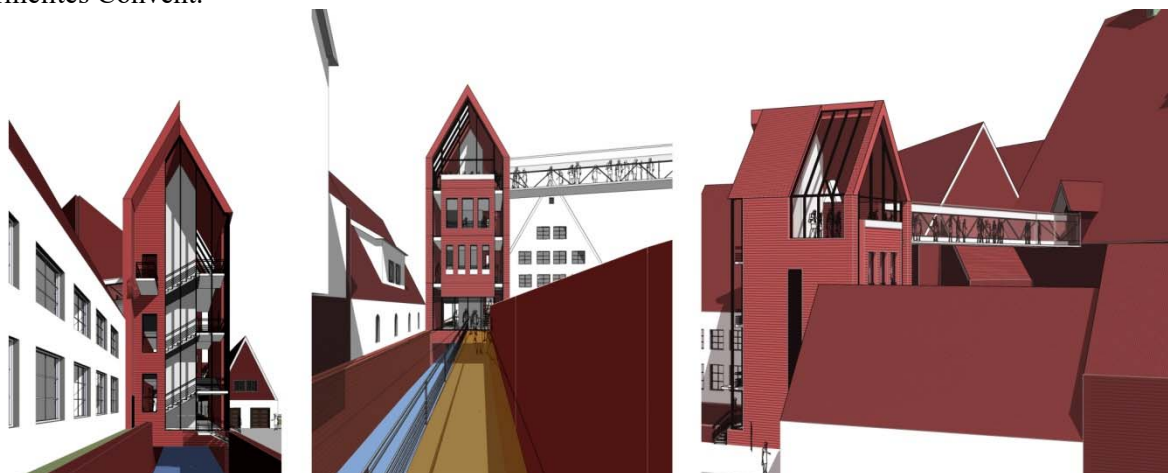
Figure 2. The new staircase building with the entrance area viewed from different perspectives.

building of the monumental Small Mill. The new construction was designed over the Radunia Canal, based on both sides of its structural walls (figure 2). This made it possible to ensure a representative approach to the entrance of the museum, while preserving the privacy of the site belonging to the Carmelites Convent.
