Detection and Imaging of Debonding in Adhesive Joints of Concrete Beams Strengthened with Steel Plates Using Guided Waves and Weighted Root Mean Square

Department of Mechanics of Materials and Structures, Faculty of Civil and Environmental Engineering, Gdansk University of Technology, Narutowicza 11/12, 80-233 Gdansk, Poland; magdalena.rucka@pg.edu.pl (M.R.); s168197@student.pg.edu.pl (M.K.)

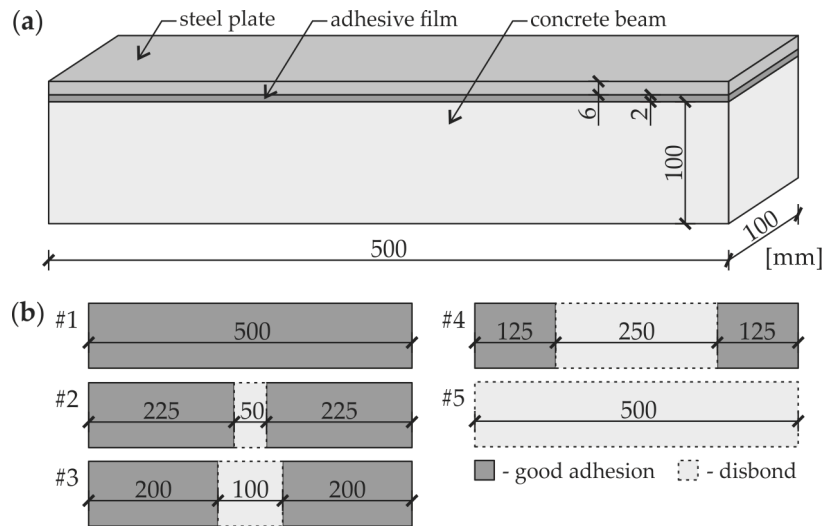
Figure 1. Analyzed specimens: (a) geometry of beams and (b) variants of defects.

The object of investigations (Figure 1a) was a beam with a square cross section of 100 mm × 100 mm and a length of 500 mm. The beam was made of concrete class C30/37 and strengthened with a steel plate of dimensions 100 mm × 6 mm × 500 mm fixed to the upper surface of the beam by an adhesive film. Five specimens were analyzed (Figure 1b). The first specimen was an intact composite beam (#1) with a full connection between both elements. Three partially damaged beams (#2, #3, and #4) had defects in the form of a debonding, covering a different area of the joint (relative defect surface was 10%, 20%, and 50%, respectively). The last sample was a steel plate (#5), which was laid freely on the beam to simulate a fully debonded joint. The defects were obtained by sticking a Teflon (PTFE) tape

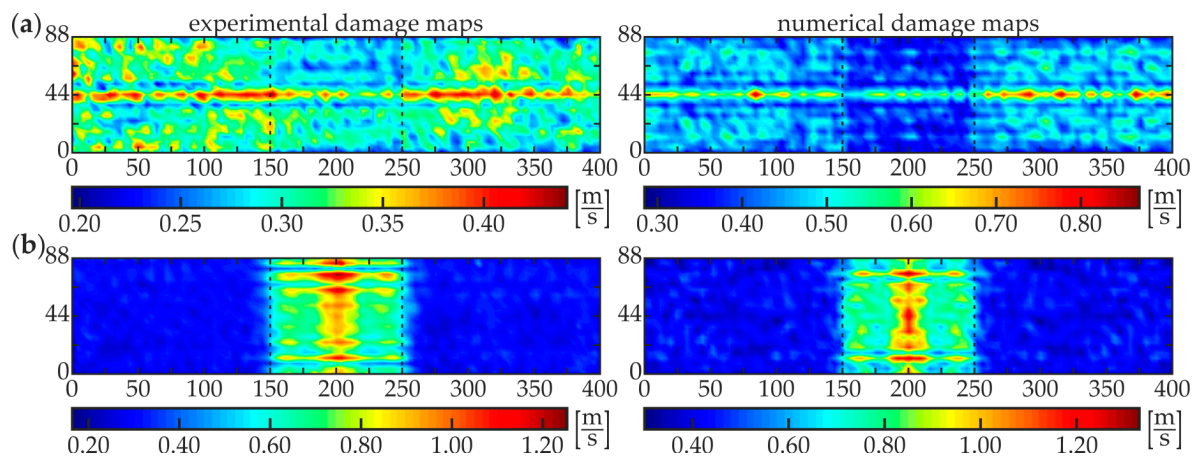
Figure 11. Experimental and numerical WRMS damage maps for specimen #3: (a) excitation P3 and (b) excitation P4.
