The Mechanisms of Degradation of Titanium Dental Implants

Agnieszka Ossowska * and Andrzej Zieliński

Department of Materials Engineering and Bonding, Gdansk University of Technology, 80233 Gdańsk, Poland; azielins@pg.edu.pl

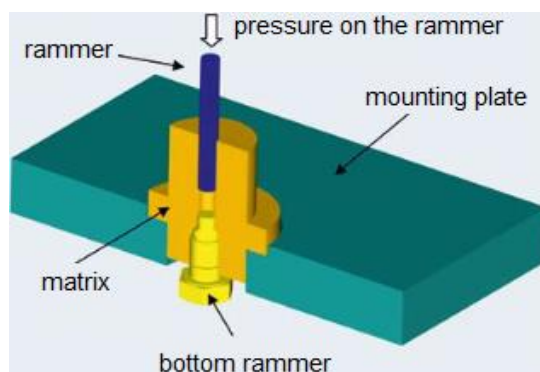
Figure 1. The cold pressing scheme for manufacturing the titanium dioxide specimens by powder metallurgy.

In the second stage, the tests of the dissolution rate of rutile (titanium oxide) were performed in two simulated body fluids (SBF). The starting material was the titanium oxide powder (purity of 98.0%–100%) delivered by Acros Organics (Morris Plains, NJ, USA). Cylindrical samples, of dimensions 6 mm \times 3 mm (diameter \times length), were prepared using the classical powder metallurgy method without a filler. The material was formed in a single-axis pressing process using a force of 2 kN acting on the stamp for 60 s at the position shown in Figure 1.

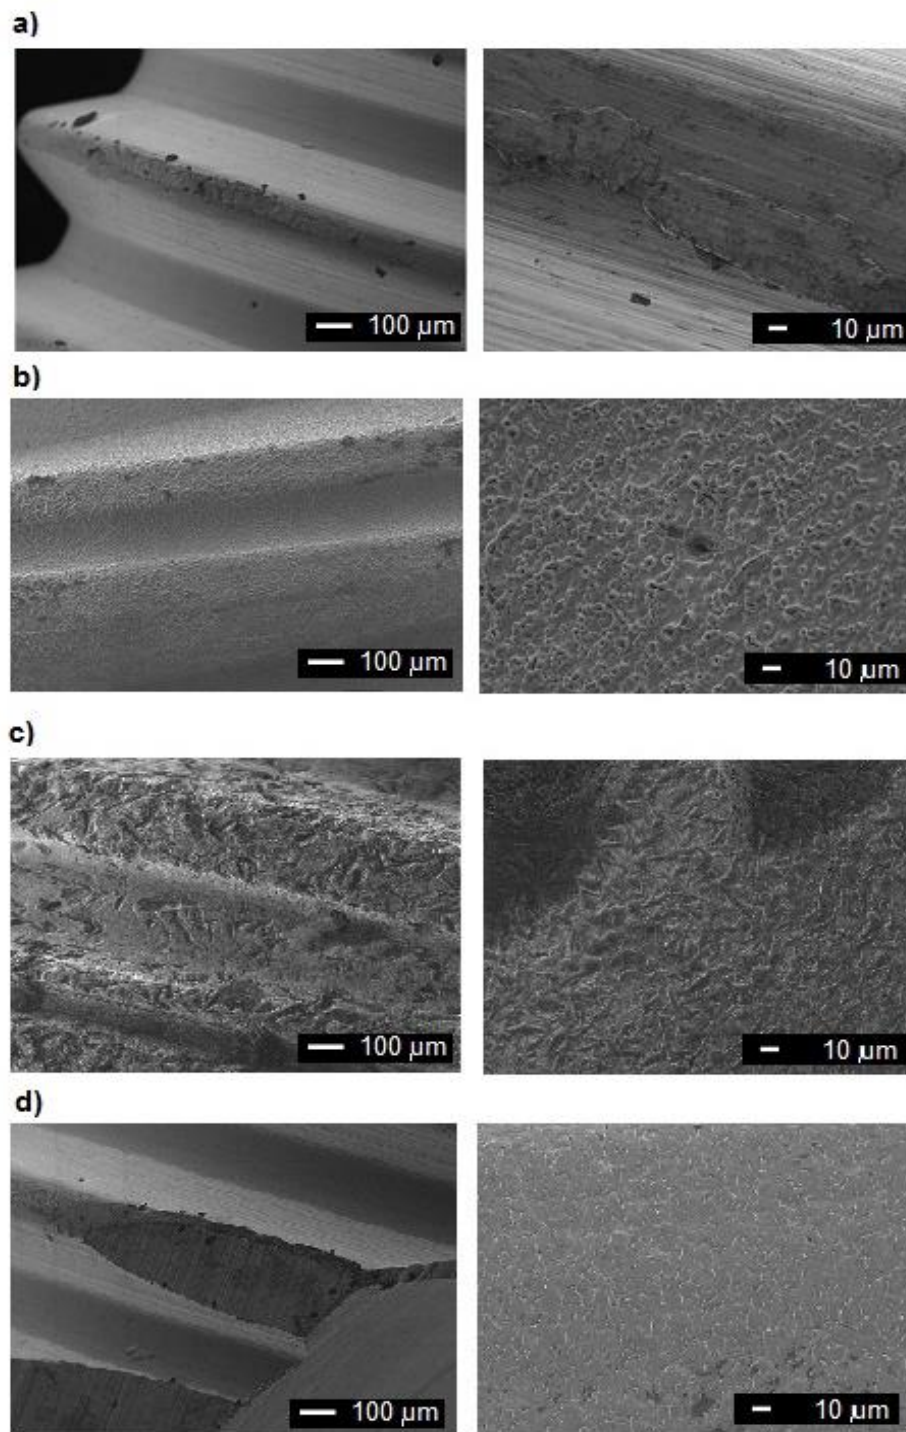
Figure 2 presents the surfaces of different three new implants, produced by two companies, A and B. The layer discontinuities, material defects appearing in the layer, unevenness, numerous rolling scratches, and material allowances resulting from the surface treatment processes are visible before implantation.

Figure 2. Surfaces of new dental implants: (a) A company; (b) B company; (c) C company; (d) D company. SEM.

It is a damage that certainly locally destroys the titanium coatings. However, our investigations showed that several implants before any implantation possessed already imperfect surfaces with such damage forms of the oxide coating as the layer discontinuities (holes/pits), large unevenness,

and rolling scratches. Such defects may initiate the local degradation of an implant, in particular the cracking and pitting corrosion.

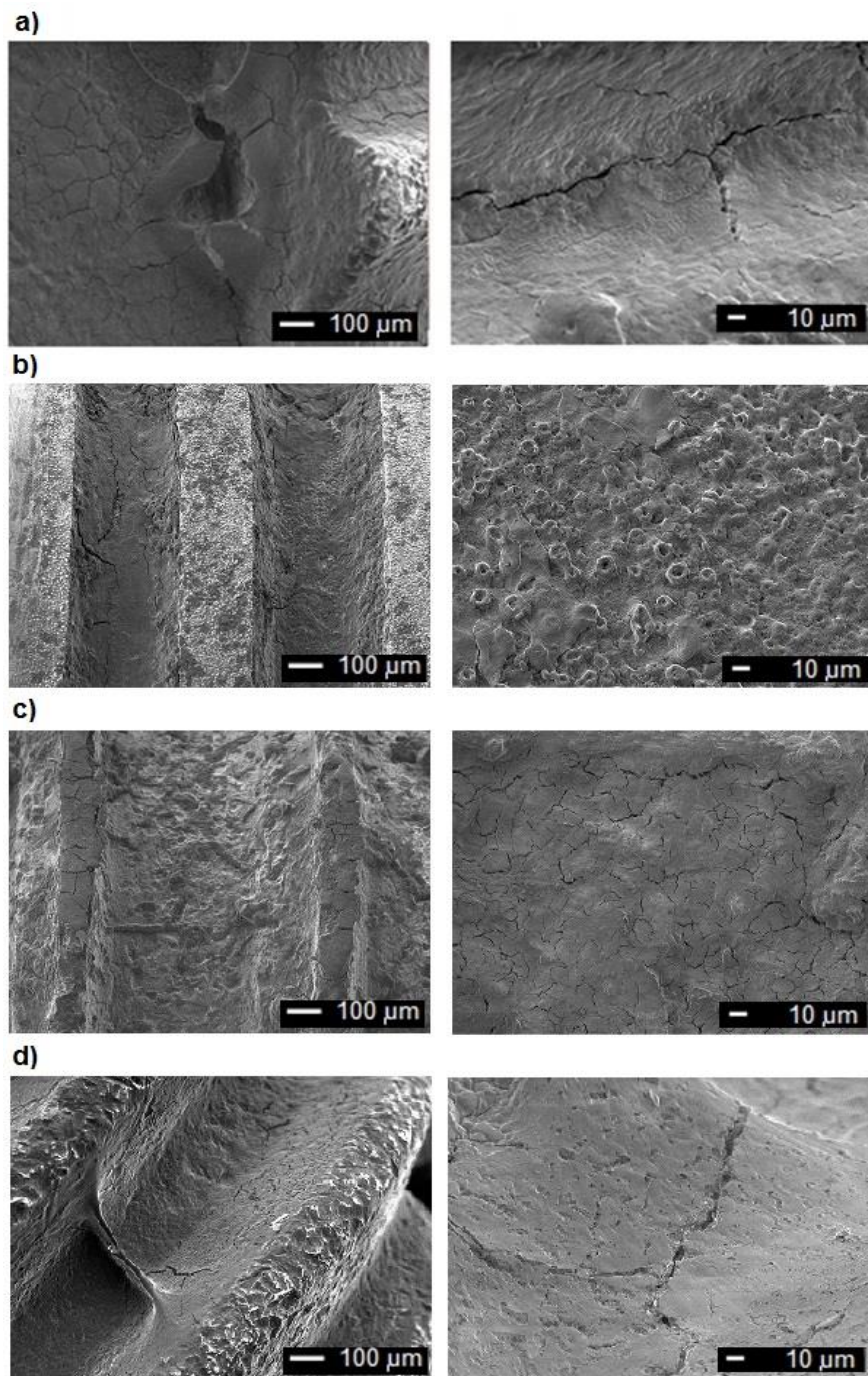
The used implants were obtained from surgeons from the Warsaw Medical University. Only removed implants, among all, which demonstrated clear signs of damage, were selected. When examinations of the used implants (Figure 3) were made, two areas of surfaces could be distinguished. The first was the top of the threads, with characteristic flattened, rubbed bumps, with clearly visible pits on the surface. The second type was the bottom of the threads, in which there is a detachment of the material of the layer from the ground, and numerous deep cracks are visible likely arisen as a result of stress concentration, which are potential places of corrosion

initiation and development of corrosion processes in the environment of body fluids and particularly aggressive saliva.

Figure 3. Surfaces of used dental implants: (a) A company; (b) B company; (c) C company; (d) D company. SEM.

The examinations of implants used for a relatively short time confirmed the above assumption, even indirectly. The pits are visible on the tops of the threads, and the detachment of the coating on the bottoms. The numerous deep cracks are likely arisen as a result of stress concentration, and can serve as potential places of corrosion initiation and development in the environment of body fluids and particularly aggressive saliva.

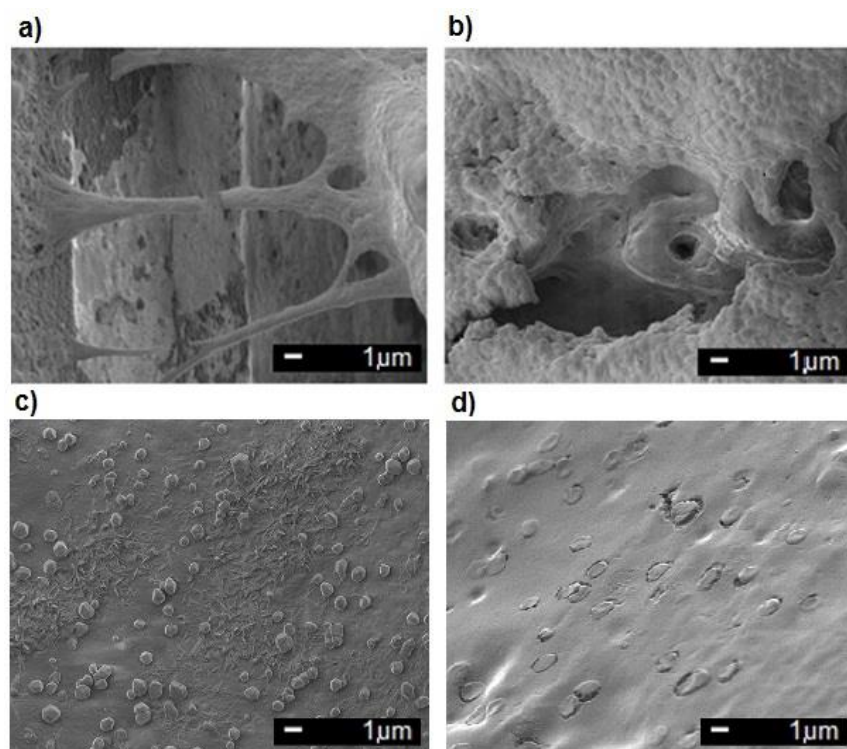
The surfaces of the used implants were subjected to purification or sterilization processes, thanks to which we can observe traces of organic residues on the surface—bacteria and tissues. Surprisingly, the largest clusters of bacterial colonies are located between the tip and the bottom of the thread, on the lateral surfaces. Perhaps this phenomenon is caused by adverse conditions at the tops and bottoms of the threads. Pits are visible on the surface of the thread tops, numerous and deep cracks in the thread cavities, which may indicate a significant impact of the environment and continuous operation of the implant—the influence of tensile forces and friction forces that affect the implant placed in the bone. On the implant surfaces, discontinuities of bone formation (Figure 4a,c) and bacterial colony residues (Figure 4b,d) can be observed, which tightly cover the material.

Figure 4. Organic remains on the surfaces of used dental implants: (a) A company; (b) B company; (c) C company; (d) D company. SEM.

The traces of organic residues on the surface were between the tops and the bottoms of the threads. Perhaps this phenomenon is caused by adverse conditions at the tops and bottoms of the threads due to a significant impact of the environment and continuous influence of tensile and friction forces that affect the implant placed in the bone. The detailed mechanism of this phenomenon cannot, however, be proposed at the moment.

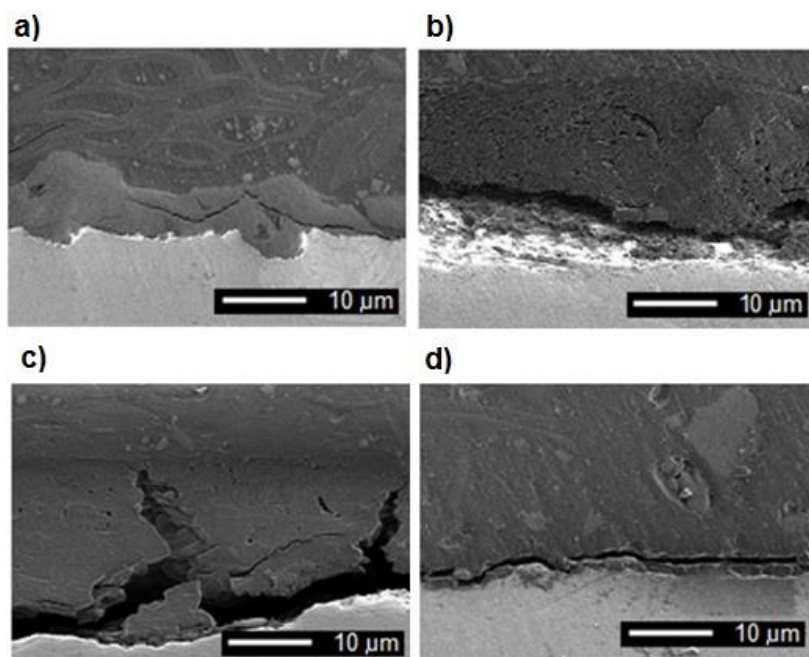
The implant cross-sections (Figure 5) illustrate surface unevenness, numerous discontinuities characterizing the layers produced, material stratification, a significant number of cracks of varying lengths, and arrangement occurring in the coating. They can be ideal for corrosion progress.

Figure 5. Cross-sections of used dental implants: (a) A company; (b) B company; (c) C company; (d) D company. SEM.

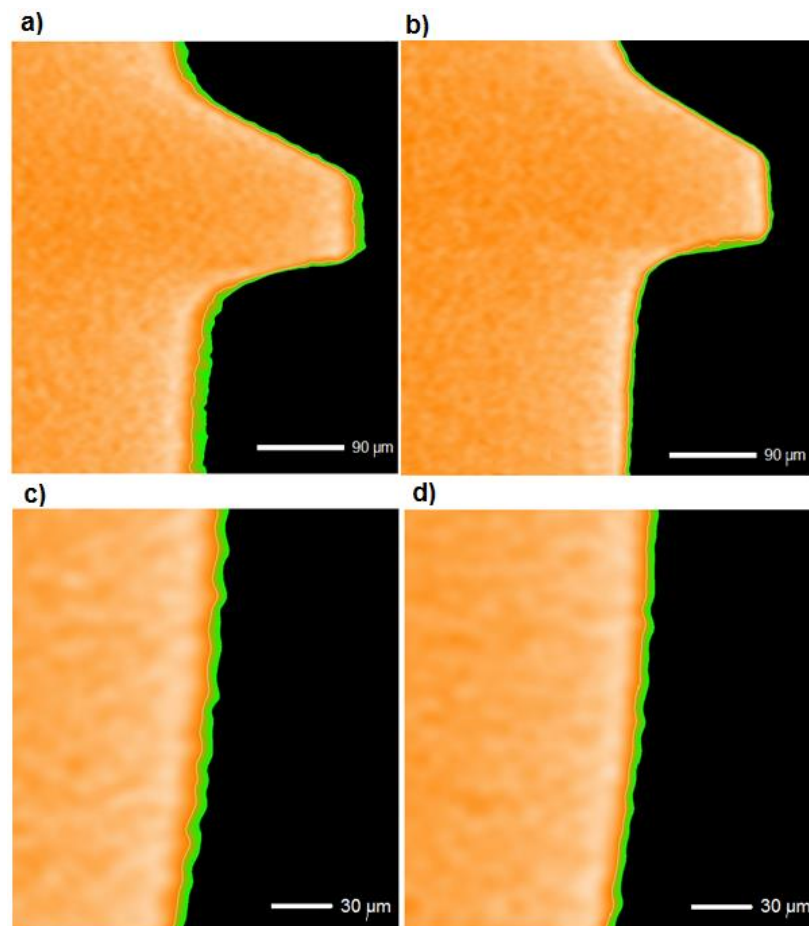
Using computed tomography, the layer thickness distribution on dental implants was depicted (Figure 6). The analysis shows that the thickness of the layers formed on the surface of the implants is diverse and does not evenly distribute. The surfaces of the vertices and thread cavities are characterized by a larger thickness of the coating. The images of the layer thickness distributions on the surface of the dental implants were very similar.

Figure 6. Images obtained by the computed tomography study of the sections: —longitudinal: (a) D company; (b) A company; —transverse dental implants: (c) D company; (d) A company.

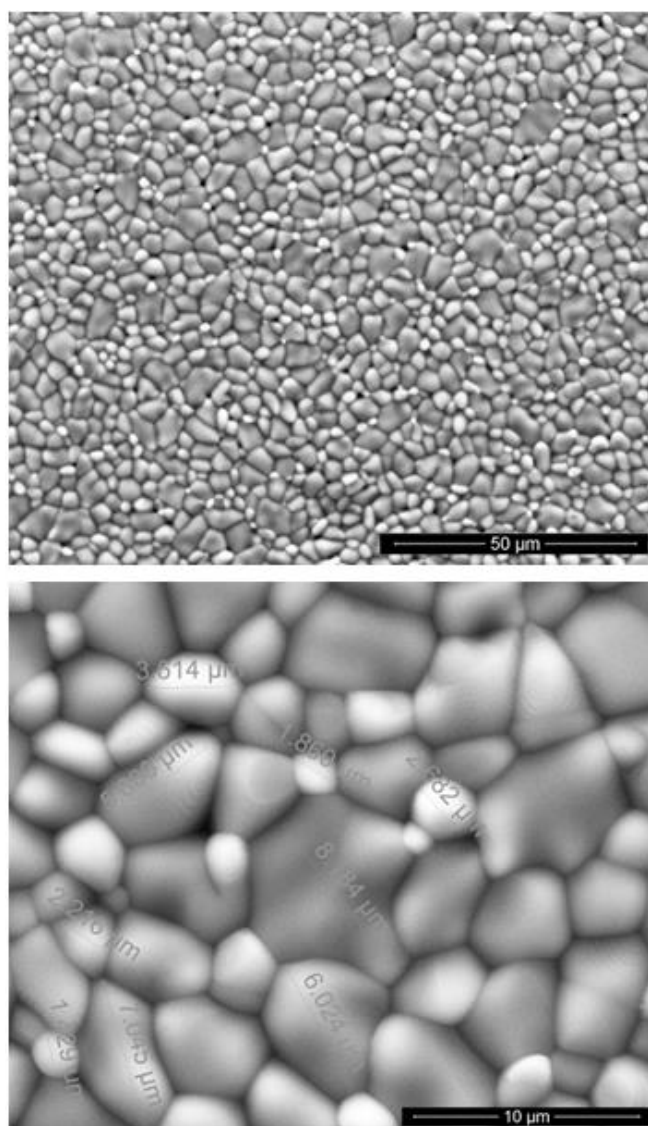
The surface of the samples produced, featuring a slight degree of porosity, is shown in Figure 7. The samples vary in grain size from 1.429 to 8.184 μm .

Figure 7. SEM microstructures of the sample surface after pressing with a force of 2 kN.
