## Water-lubricated stern tube bearing - experimental and theoretical investigations of thermal effects

Wodtke M.<sup>a</sup> and Litwin W.<sup>b</sup>

<sup>a</sup> *Gdansk University of Technology, Faculty of Mechanical Engineering, 80-233 Gdansk, Narutowicza 11/12, Poland*

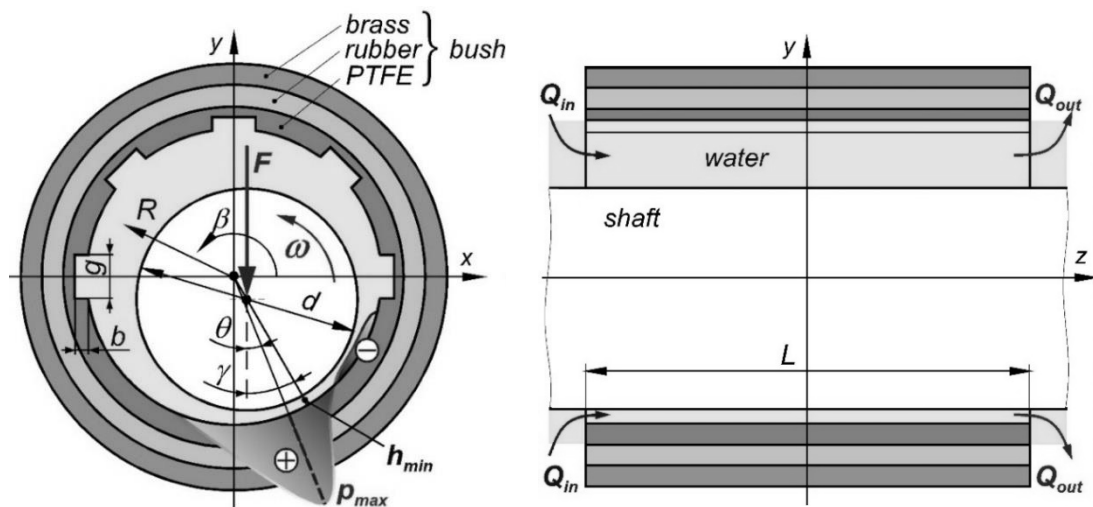
Fig. 1. Schematic operation of the water-lubricated journal bearing with axial grooves.

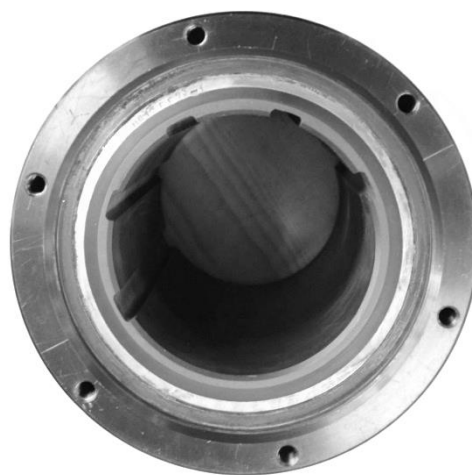
Fig. 2. Side view of the tested stern tube water-lubricated bearing assembled in the test-stand housing.

An industrial three-layer journal bearing was selected as an object of investigation. This bearing type is accepted by ship classification societies and is used in the shipbuilding industry. It is composed of three layers (each 5 mm thick), made of different materials, PTFE, Rubber (NBR) and Brass. The tested bearing after assembly in the test stand housing (in the form of a heavy and massive sleeve) is shown in Fig. 2.

the water flow was changed, according to the procedure described in the next section, starting at 15 l/min. The operating conditions during tests were similar to those in industrial applications. The bearing was lubricated by pure water supplied from one side (see  $Q_{in}$  in Fig. 1). In real applications, filtered outboard water or freshwater circulating in a more complex, sealed and closed system can be used. It is also worth noting that lubrication grooves were only in the upper half of the bushing, as shown in Fig. 2.

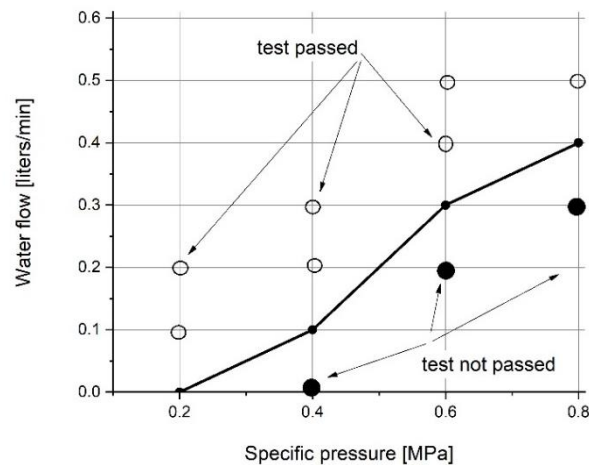
Fig. 6. Diagram of bearing safe operation under limited lubrication conditions (for 2000 rpm case).

Interpretation of obtained results was summarised in the form of a diagram of safe bearing operation under limited lubrication. An example of such diagram for 2000 rpm case was presented in Fig. 6. The most important line is the boundary line, which divides the diagram into two parts - the upper one (including points belonging to the boundary line) contains 'passed' cases and the lower part contains 'not passed' cases, for which thermal stability was not observed. For selected boundary cases (points on boundary line between 'passed' and 'not passed' zones) measured temperature was not fully stabilized in 40 minutes, however showed clear trend to achieve stabilization. Such tests were also assumed as 'passed' in the case, when measured temperature increase was lower than 40°C. This type of diagram seems very simple for interpretation and provides an easy method to assess bearing safety under operation with limited axial water flow.
